**BEFORE THE PUBLIC SERVICE COMMISSION  
OF THE STATE OF MISSOURI**

In the Matter of Laclede Gas Company                     )  
Concerning a Natural Gas Incident at                     )  
5730 Mango Drive in Oakville, Missouri                     )

**File No. GS-2016-0160**

**STAFF GAS INCIDENT REPORT**

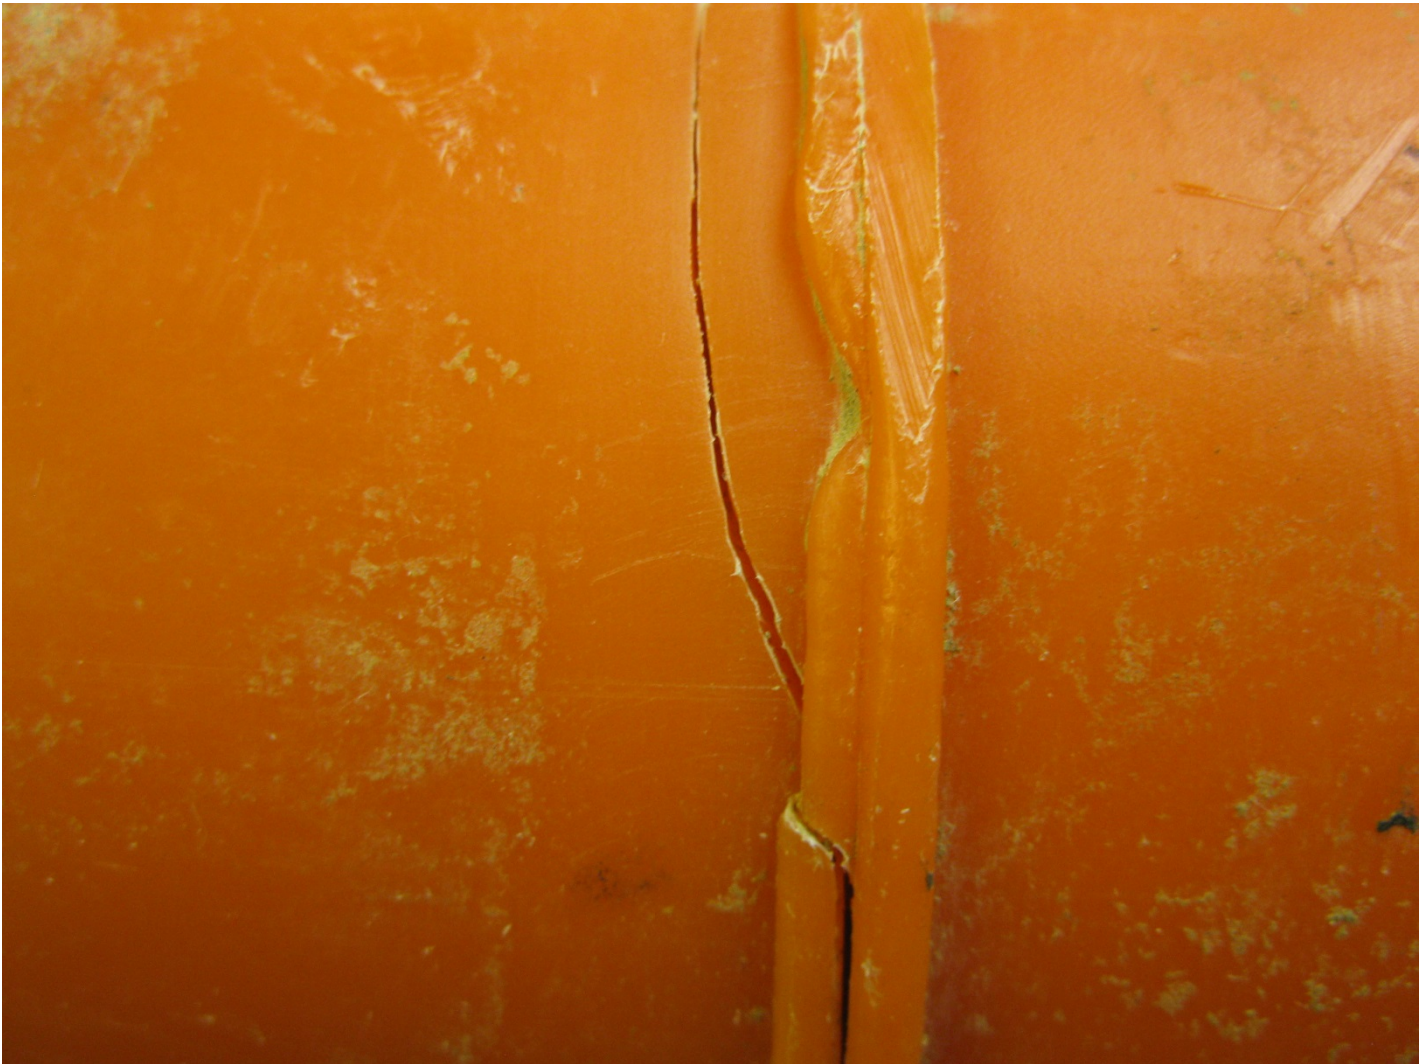
Based on Staff's visual examination of the butt heat-fusion joint involved in this incident, it was observed that there was a location of discontinuity in the roll back bead.<sup>3</sup> If this discontinuity had existed at the time the pipe was installed, it would not have met the requirements of the contemporaneous procedure which included observation of the joint formation while still applying pressure to ensure that a uniform double bead is forming all around the pipe. However, it is unknown if this discontinuity was present at the time of installation or resulted from later damage. Further, at this particular location (in the vicinity of

the bead discontinuity) on the pipe, the failure did not occur in the joint but rather in the body of the pipe. (See Appendix C, Photograph 1).

Photograph #1 –Failed Butt heat-fusion joint showing void in fusion bead (upper part of photo) and failure in the fusion joint (lower part of photograph). The failure in the fusion joint indicates that the joint was not stronger than the body of the pipe at this location.  
(Photograph taken by Staff, September 12, 2016).

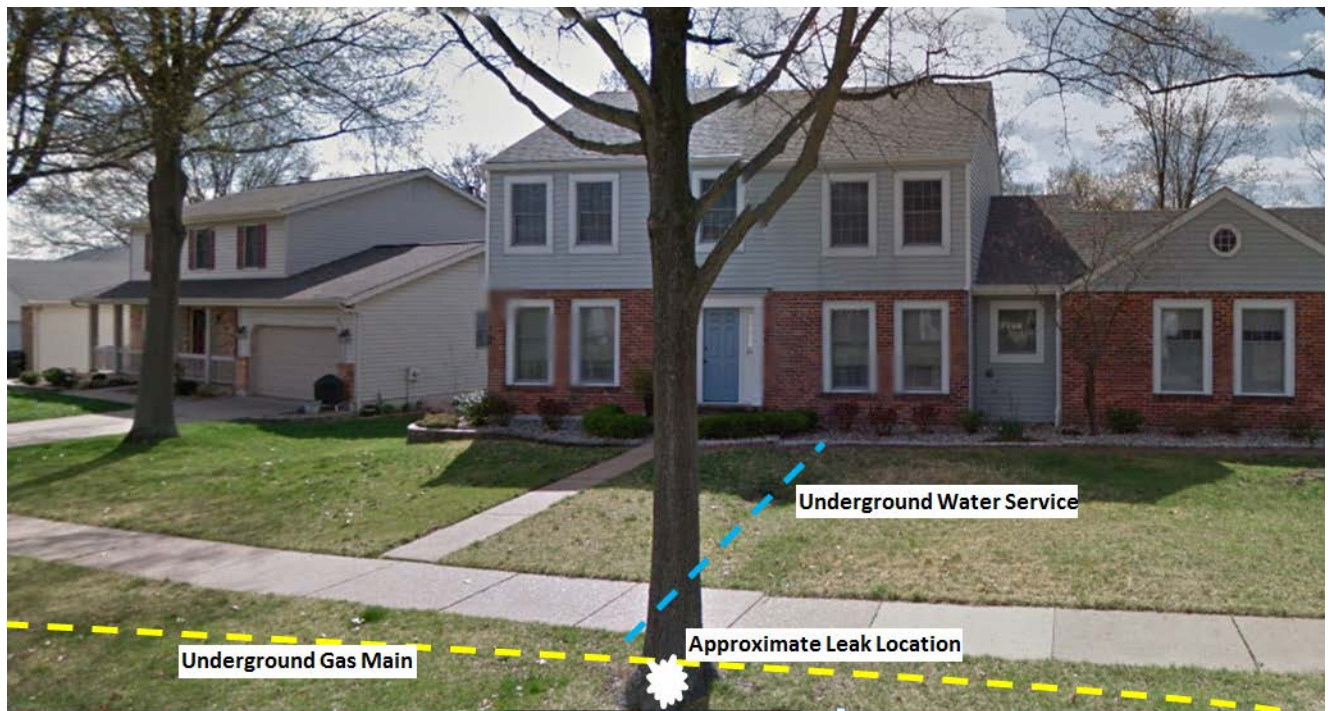
Photograph #2 – The 3-inch PE main and subject butt heat-fusion joint were under this tree (Photograph by google maps).

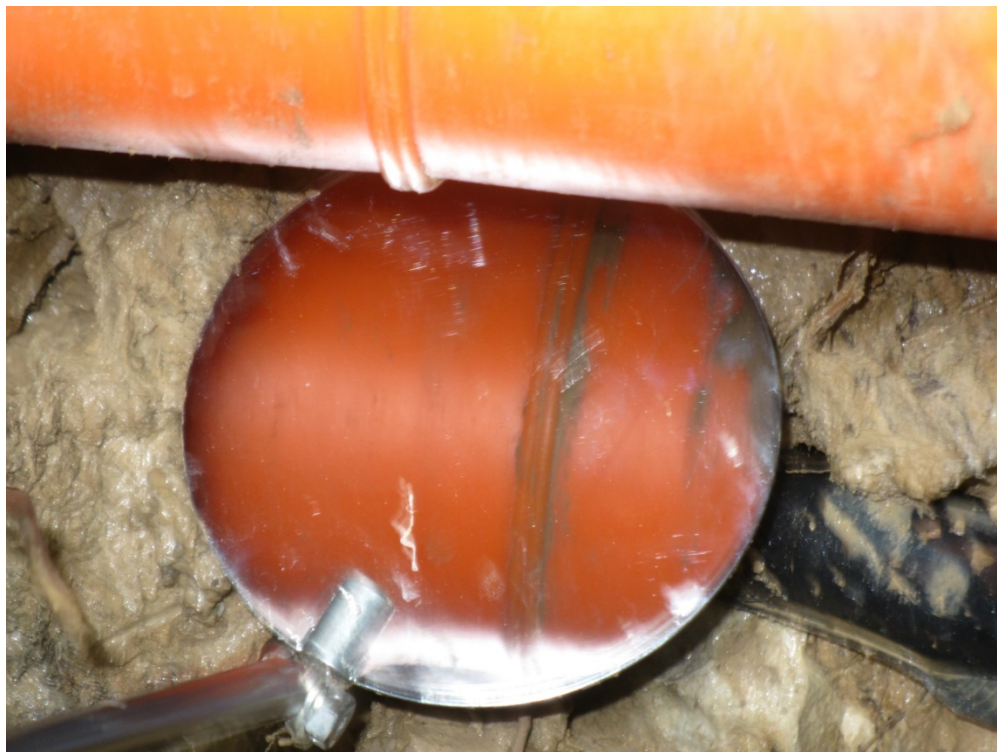
1. Cleaning the exposed pipe of any residual mud.
2. Using a pipeline inspection mirror, and examining the whole circumference of the fusion.
3. Leak detecting soap solution was applied to the fusion area so any leaks, if present, would be evident.
4. Using a steel bar, pipe straps, and wooden blocks for leverage, the pipe was deflected latterly and then vertically by hand in an attempt to reveal any defects present.
5. Leak detecting soap solution was applied again, and the pipe was observed for any leaks. (See Appendix C, Photographs 3-5).

Photograph #3—3-inch main fusion inspection (Photograph taken by Staff)

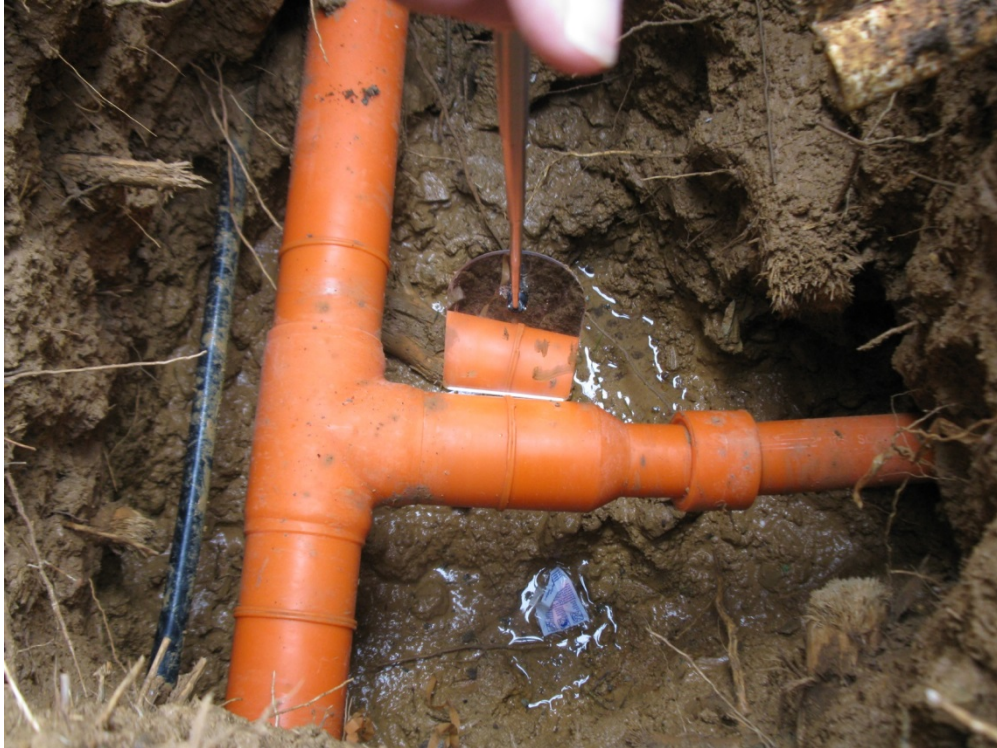
Photograph #4—3-in Main Fusion inspection (Photograph taken by Staff)

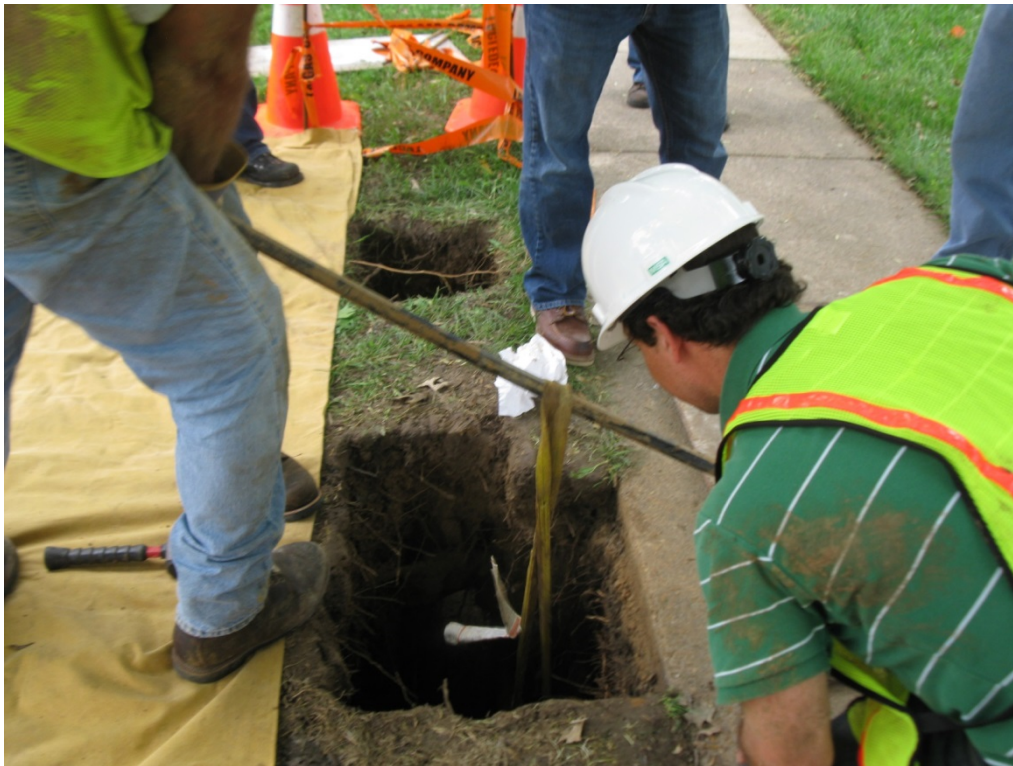
Photograph #5—3-inch main Fusion Inspection (Photograph taken by Staff)

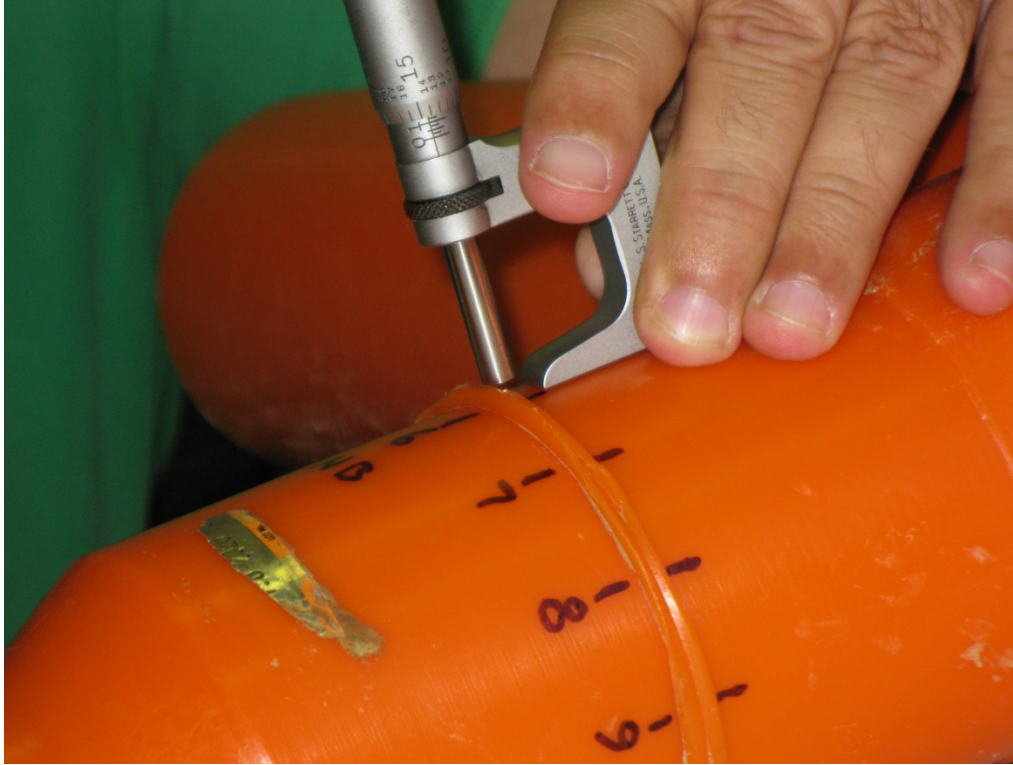
Photograph # 6—Fusion bead height measurement testing (Photograph taken by Staff)

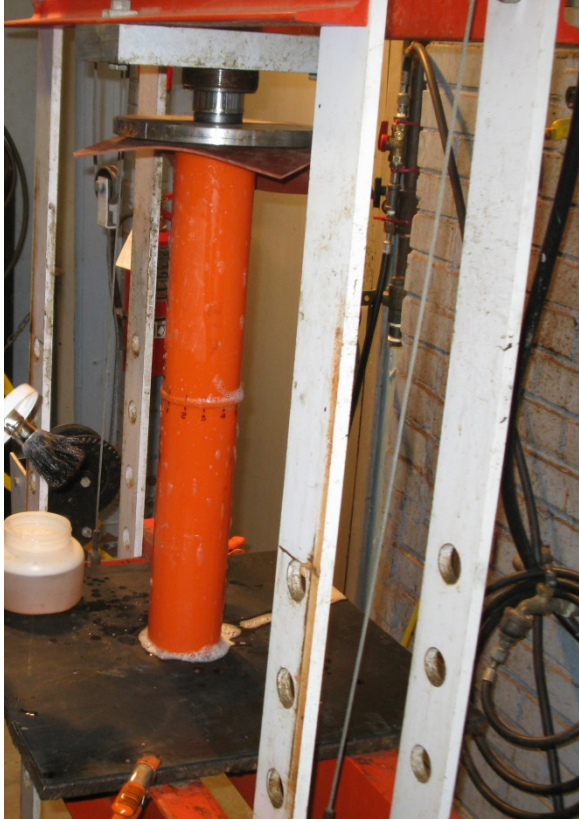
Photograph #7—Pressure test with air medium (Photograph taken by Staff)

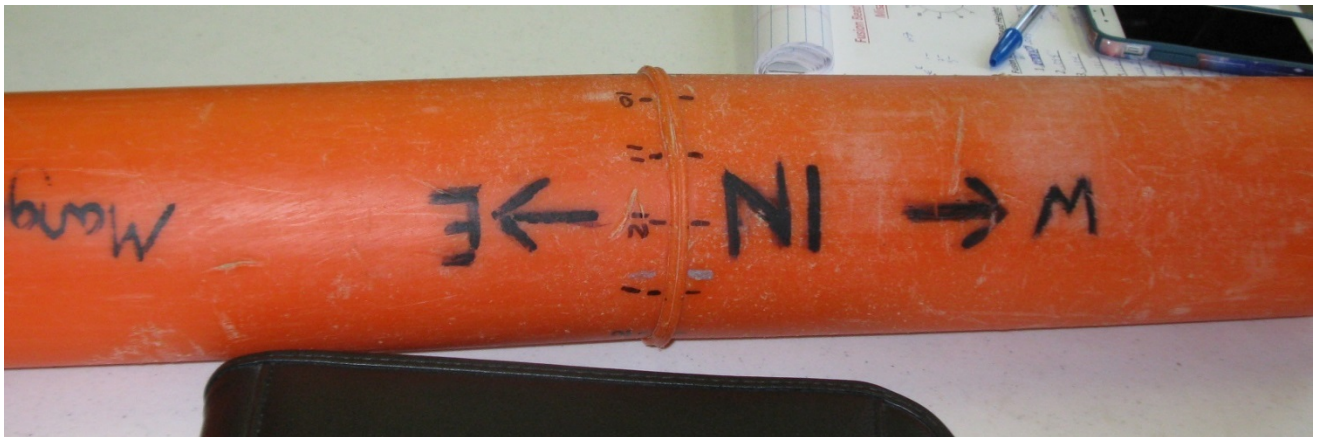
Photograph #8—3-inch main segment (Photograph taken by Staff)

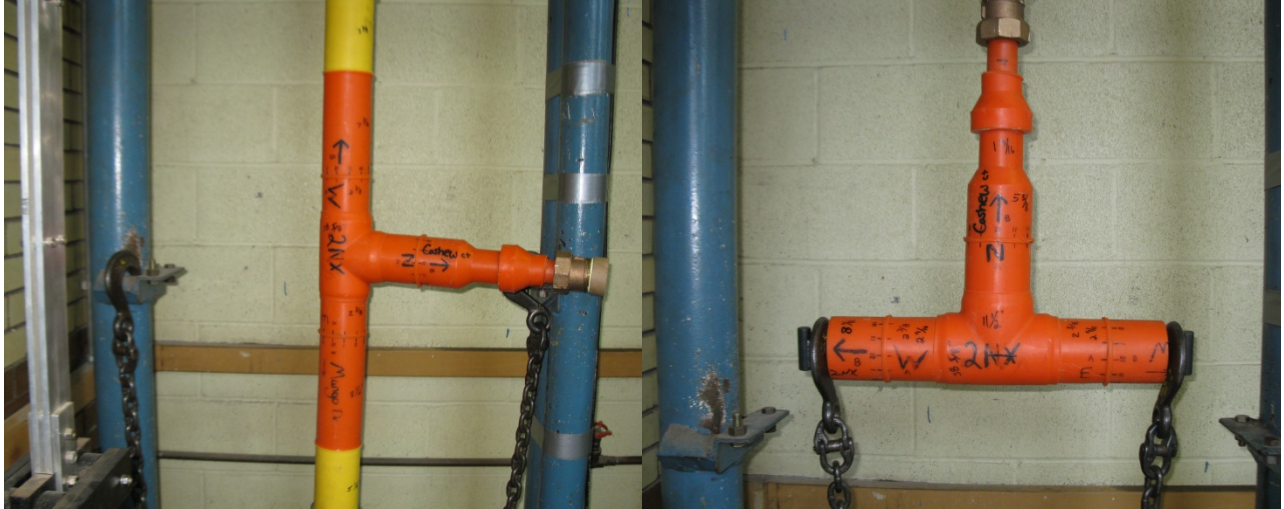
Photograph #11 Pull testing T-main segments (Photograph taken by Staff)

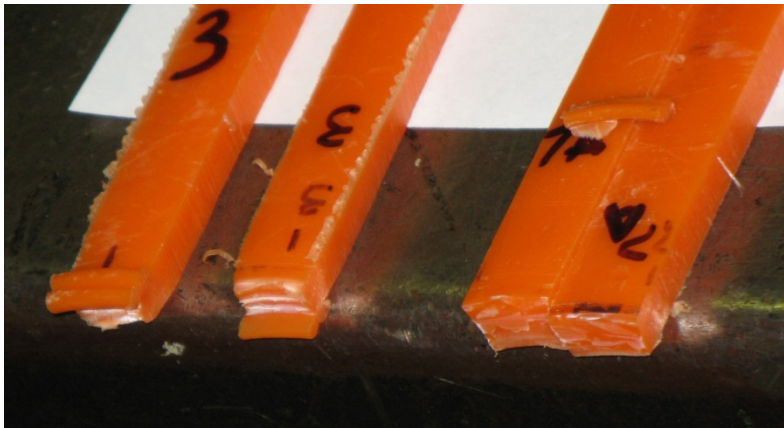
The four test section that were kept intact, and tested with a floor to ceiling tensile testing machine designed for plastic pipe passed the destructive tensile tests. Two of the four straps taken from the only in-line joint, sample 1N, failed the torsional tensile test. Prior to testing, the circumference of the pipe near the fusion was labeled with numbers 1-12, spaced approximately 1-inch apart. Regarding orientation, 12 was labeled at the top of the pipe, as if it was lying in the ground, and 6 at the bottom. During the tensile/torque test, the fusion failed between the #6 and #7 locations, and also at the #3 location (See Appendix C, Photograph 12).

Photograph #12 Segment 1N failure inside fusion area (Photograph taken by Staff)

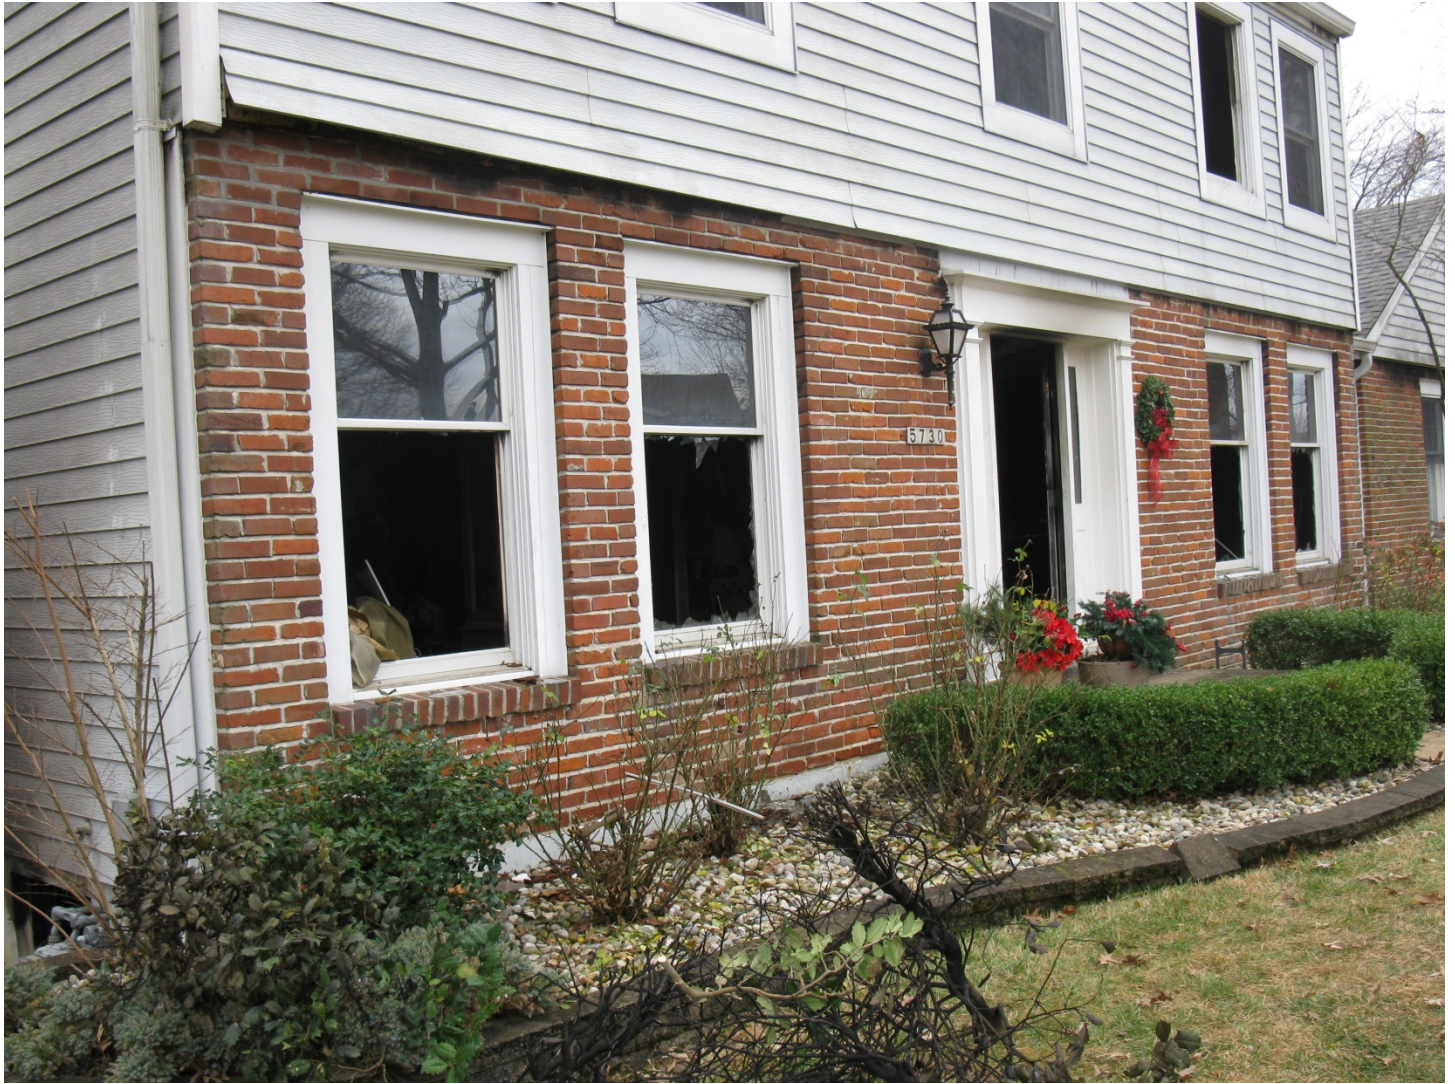
The home at 5730 Mango Drive was damaged as a result of the natural gas explosion and subsequent fire (See Appendix C, Photographs 13-16). While not completely destroyed, due to the explosion, fire, and subsequent smoke damage, an estimated \$300,000 in property damage was incurred<sup>16</sup>.

Photograph #13 - Front Side of 5730 Mango Drive, showing damage at front of house (Photograph taken by Staff).

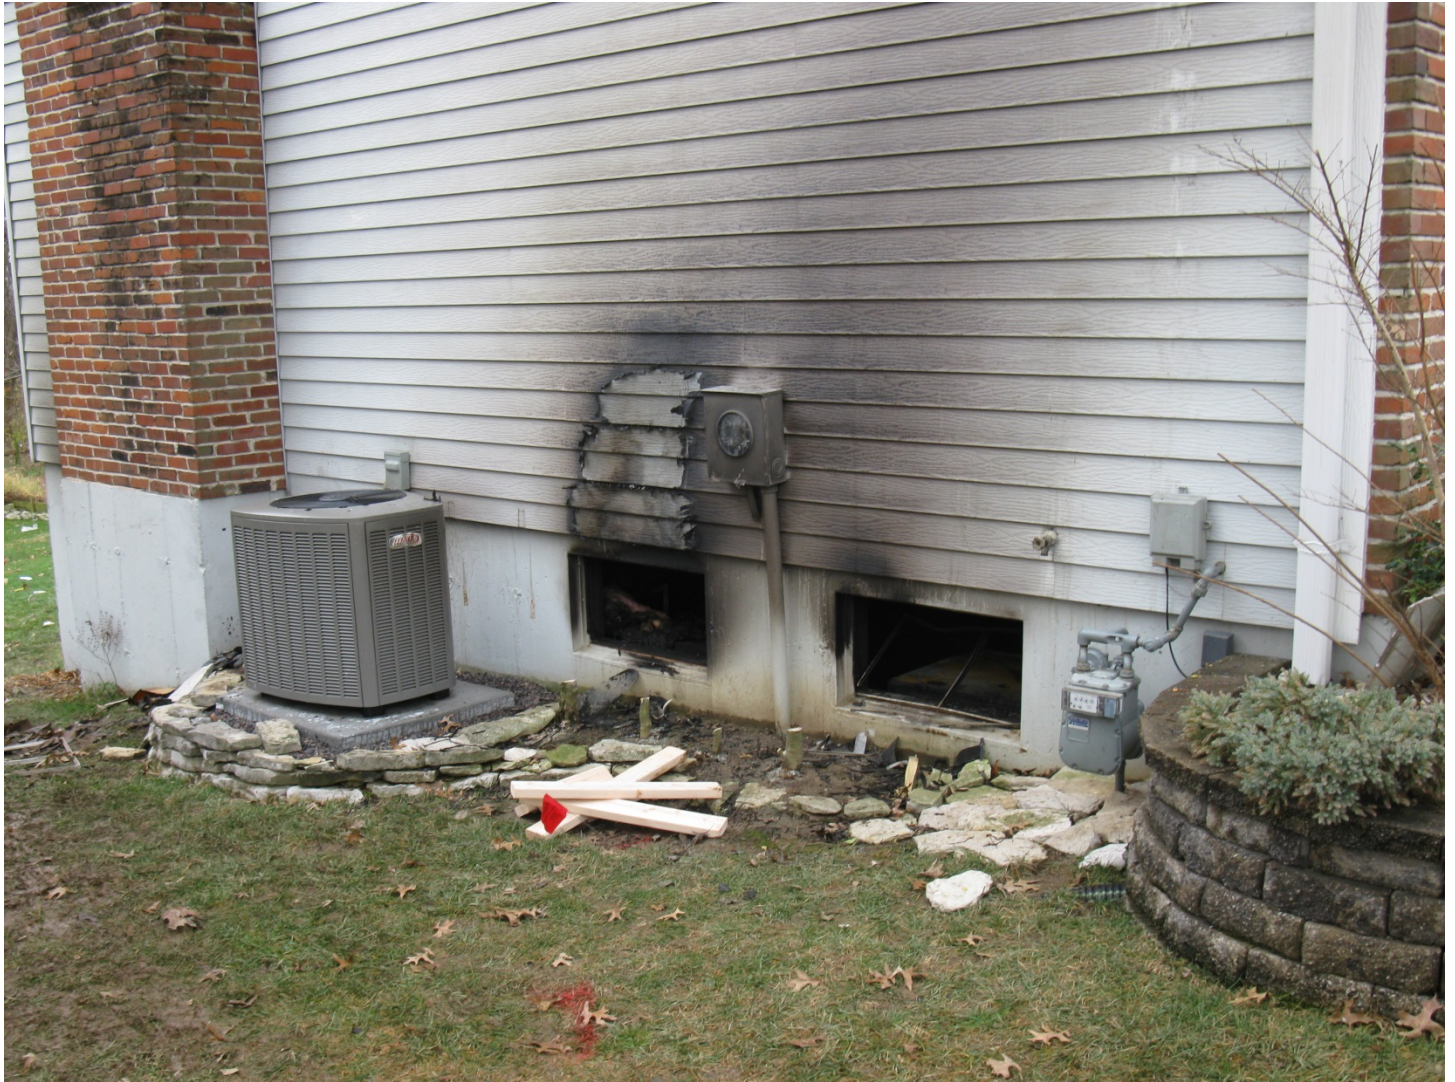
Photograph #14-- Showing damage at left front side (location of gas meter) of 5730 Mango Drive (Photograph taken by Staff).

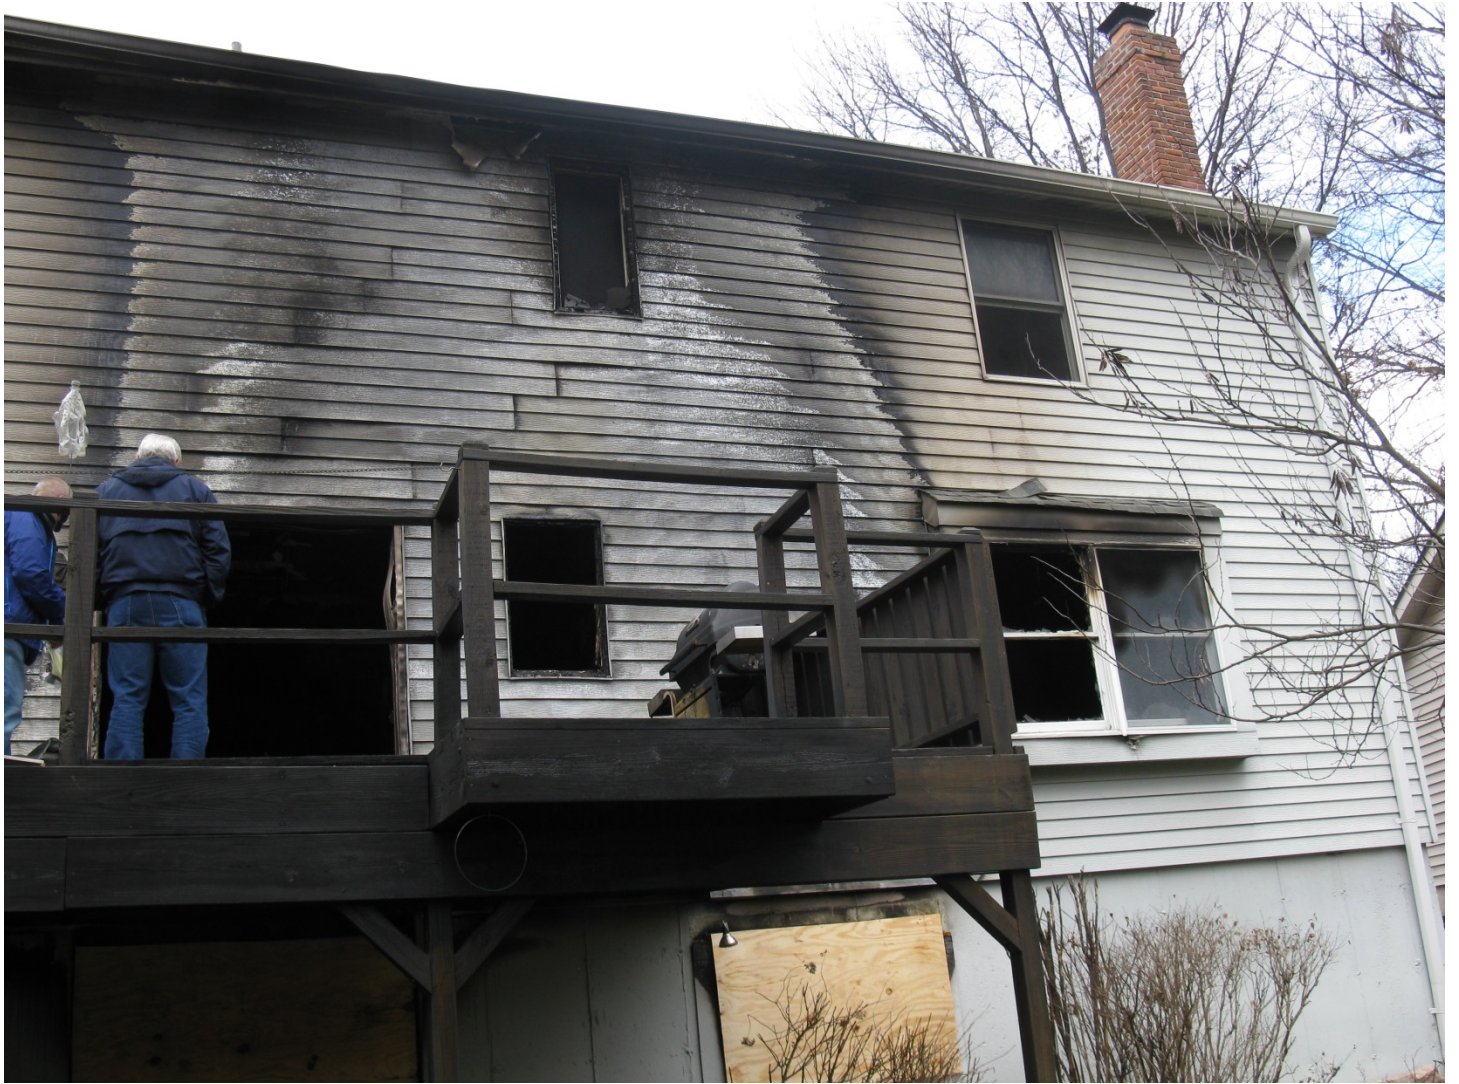
Photograph #15—Showing damage to back side of 5730 Mango Drive (Photograph taken by Staff).

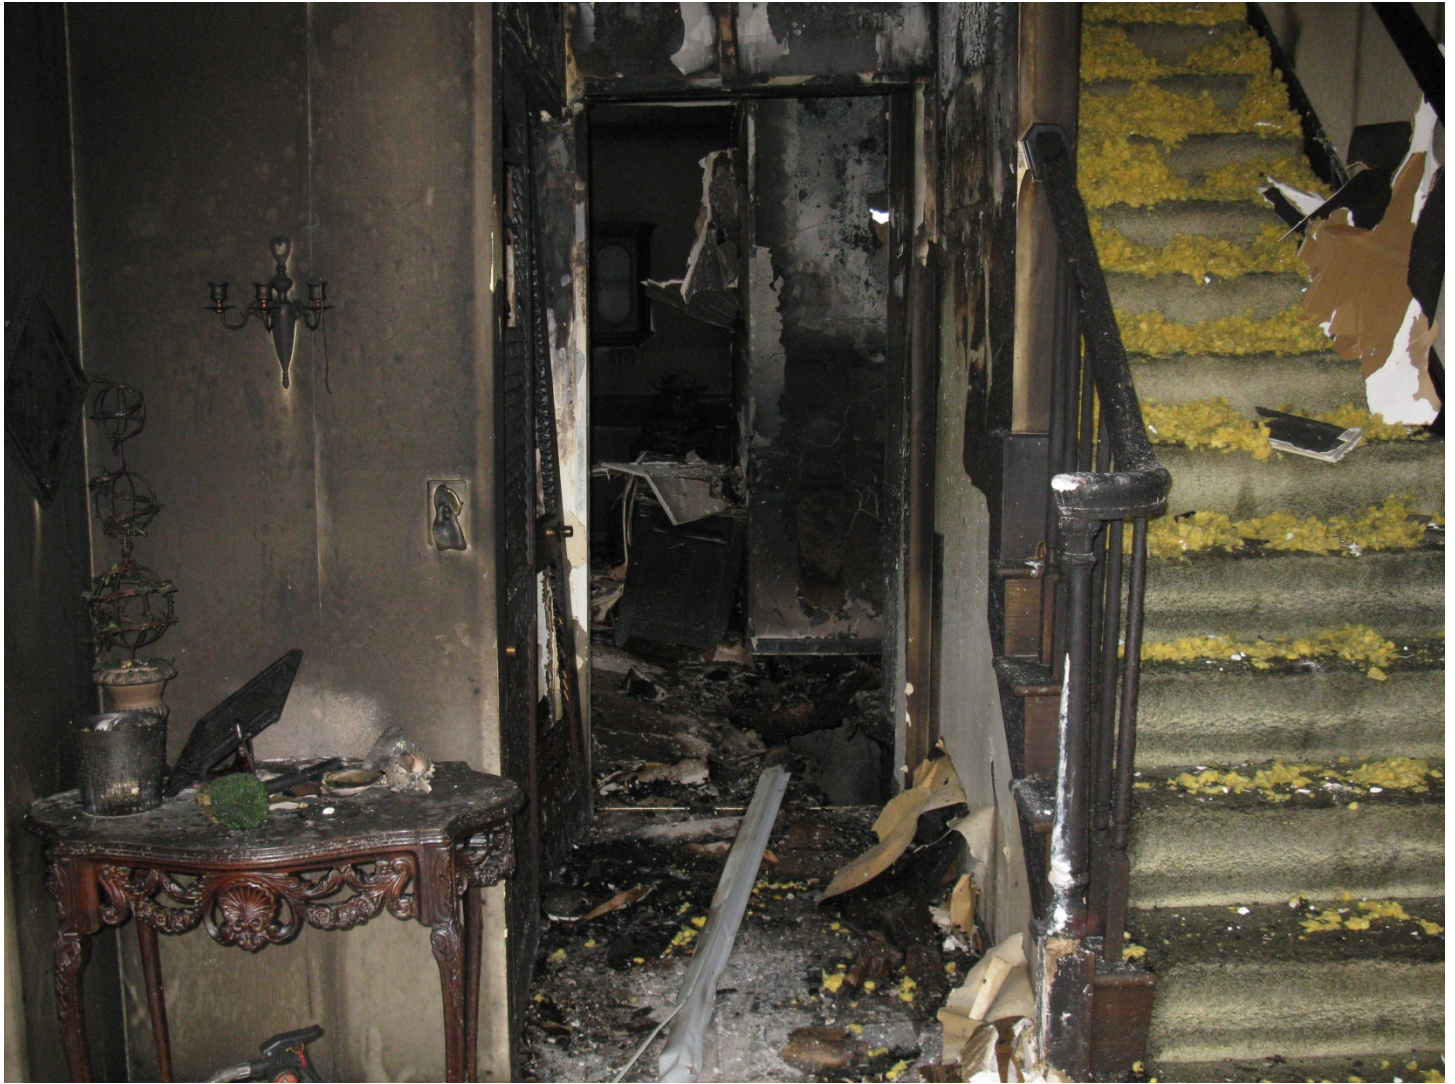
Photograph #16—Showing damage inside at front entrance to 5730 Mango Drive (Photograph taken by Staff).

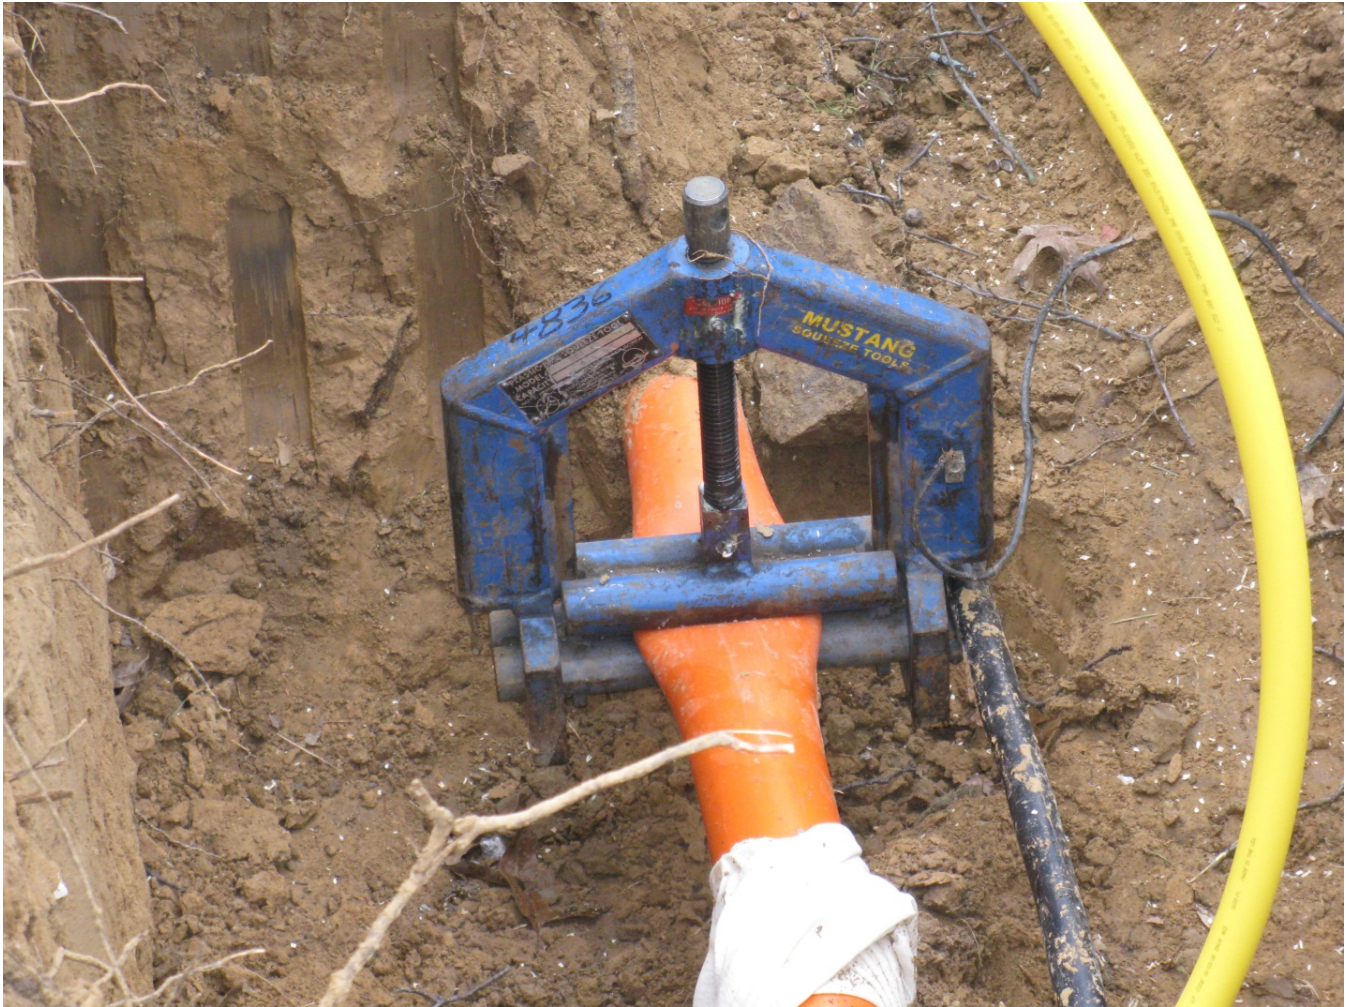
Photograph #17—Viewing the squeeze off location just upstream of the leak location on the main (Photograph taken by Staff).

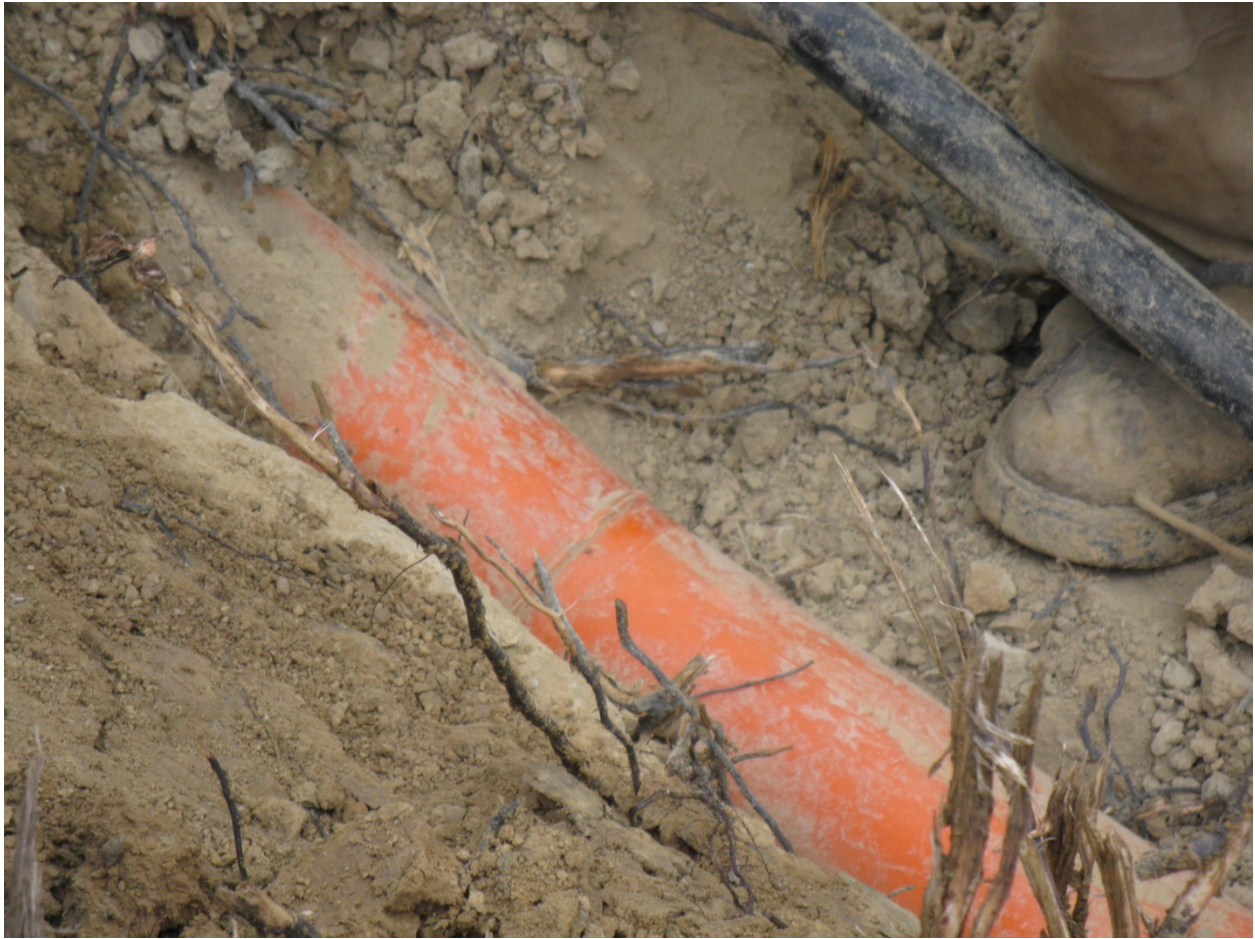
As the excavation approached the vicinity of the leak location on the main, the soil in the excavation appeared to be dry and absent of moisture (See Appendix C, Photograph 18), a possible indication that a leak had been present at that location for an extended amount of time<sup>26</sup>. Once the leaking butt heat-fusion joint was exposed, a Laclede employee pulled up on the

Photograph # 18 – 5730 Mango Drive, looking down at the leak location on the main. Note the dry soil around the leak location (Photograph taken by Staff).

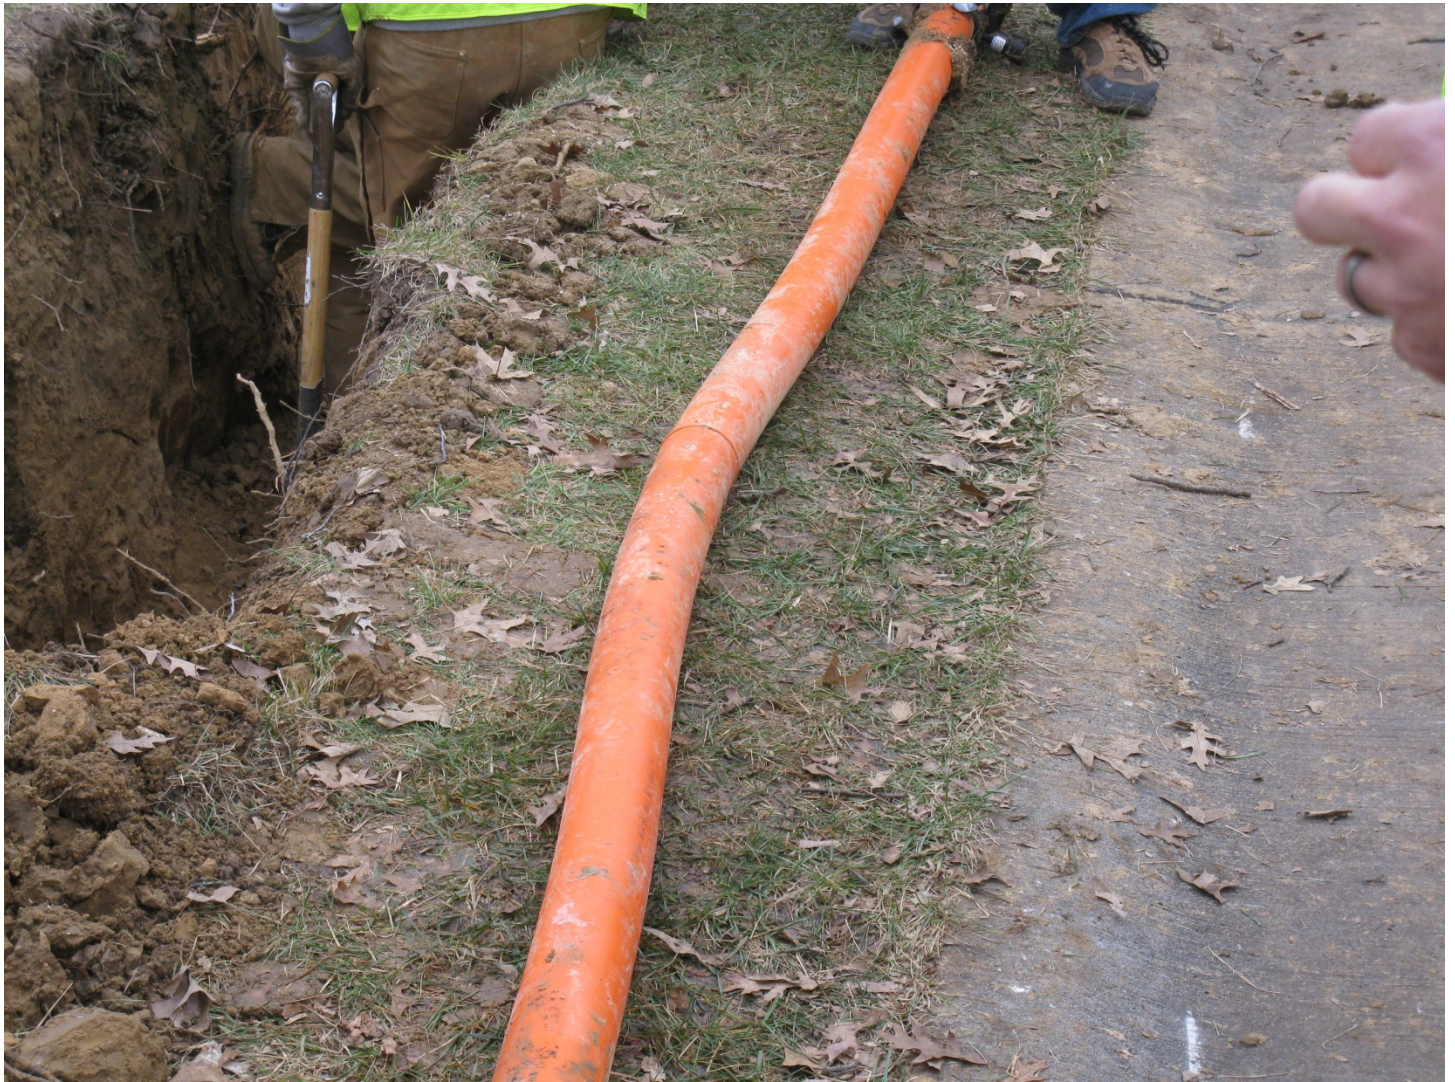
Photograph #19– Leaking Section of 3-inch PE main removed from beneath the oak tree – note that section around the joint appears to be bent where tree roots exerted downward force. (Staff Photograph).
