**BEFORE THE PUBLIC SERVICE COMMISSION  
OF THE STATE OF MISSOURI**

**STAFF'S REPORT**

## Gas Incident Report

**West Central Energy  
Case No. GS-2005-0246**

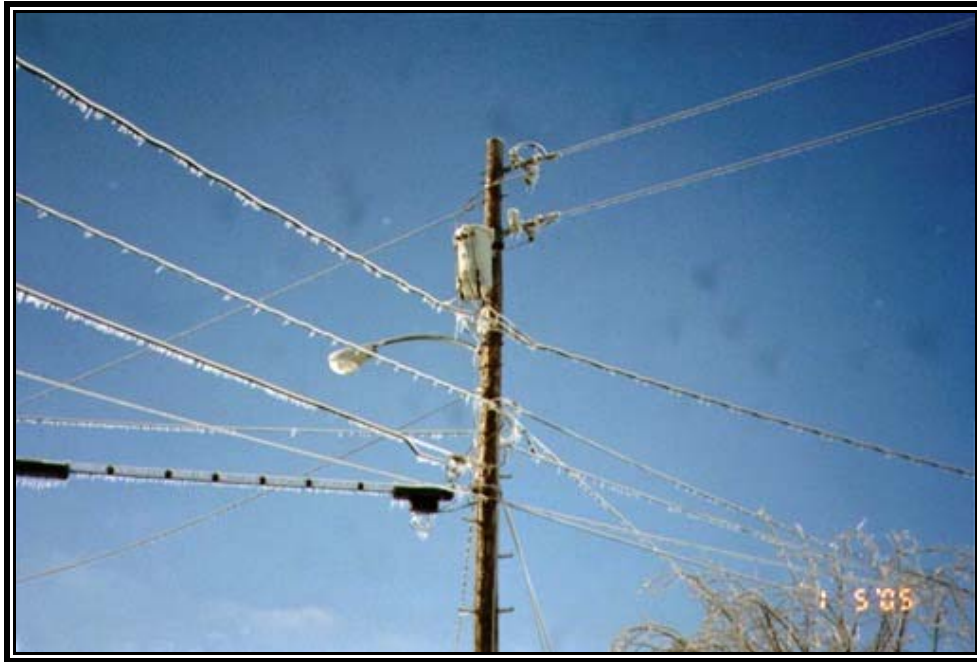
**Photograph 1** View looking at the electric and telephone lines in Unionville that were covered with a heavy layer of ice. This power pole is located at the northwest corner of the intersection of Main Street and 14<sup>th</sup> Street. Observe the ice that had formed on the tree in the lower right-hand portion of this photograph. The date displayed in the lower right-hand corner should be “1 6 ‘05” (January 6, 2005).

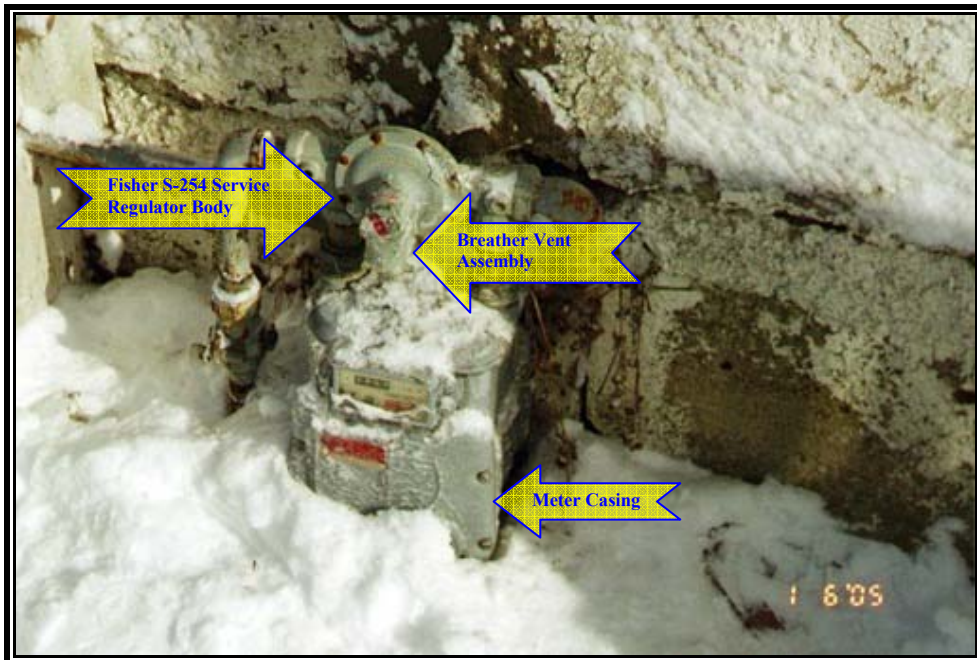
As the WCE serviceman approached the residence at 1328 Main Street, (12:40 a.m.) he observed that the natural gas meter set<sup>7</sup> was completely covered with ice and the service riser valve had been shut off (see **Appendix A-5, Photograph 9**). The WCE serviceman attempted to knock most of the ice off of the top portion of the meter set and then spoke with one of the responding Unionville Fire Department personnel who indicated that an explosion had occurred. The serviceman then went inside the doorway along the west side of the building and, no gas odor or fire was observed but smoke was present. The serviceman then proceeded to perform combustible gas indicator (CGI)<sup>8</sup> readings with bar holes<sup>9</sup> near the natural gas meter set and another bar hole about 10 feet south of the meter set. All bar hole readings indicated 0% gas-in-air readings. An additional aboveground check was made near the door entrance along the west side and no gas reading was observed.

**Photograph 2** View of the natural gas meter set that served 1328 Main Street in Unionville. Observe the ice build-up on the outside of the meter casing, as well as, the underneath side of the breather vent assembly where the breather vent check valve is housed.

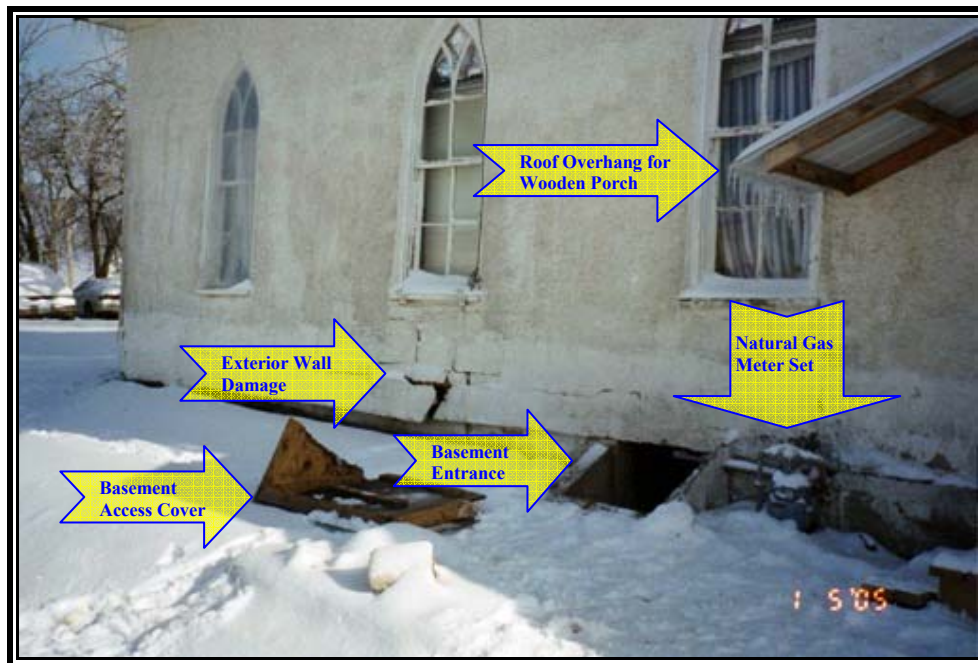
The largest portion of the structure consisted of a former church sanctuary that had eight tall windows (four windows each on the east and west sides), and another window just above the south entrance to this building. The top portion of the windows in the main church sanctuary consisted of single pane glass that appeared to have been displaced outwards. Also, a section of the top window above the south entrance also appeared to have been displaced outward. The Staff also observed that a basement access cover along the west side of the building was laying in the yard near a sidewalk and appeared to have been displaced from the basement location (see **Appendix A-2, Photograph 3**).

**Photograph 3** Looking at the west wall of 1328 Main Street. Observe the icicles that were hanging down from the roof overhang that was built for the wooden porch. No guttering system was installed for any portion of the roof line overhangs. The natural gas meter set was located directly beneath the roof overhang of a wooden porch. The date shown in the lower right-hand corner of this photograph should be “1 6 ’05” (January 6, 2005).

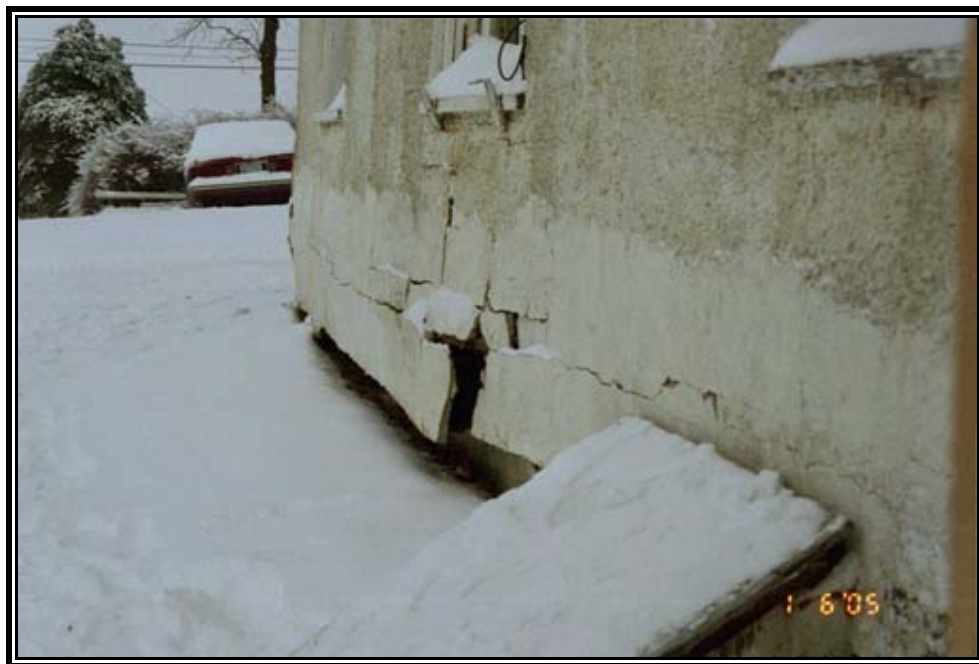
The residence at 1328 Main Street appeared to have been a church at one time that had been remodeled and converted for a family residence. Only the northwest corner of the building and a portion of the west wall near the basement entrance showed exterior damage to the structure. The exterior damage along the west wall was located between the door to the porch on the west side and the northwest corner of the structure and just above the concrete block foundation. The west wall in this area was pushed outwards and cracked in several locations (see **Appendix A-2, Photograph 4**).

**Photograph 4** Close-up view of the damage to the exterior west wall. Note how the wall was buckled and displaced outwards from the foundation. The greatest damage to the west wall was observed from approximately the basement entrance to the northwest corner of the building. The basement access cover was placed over the entrance just prior to taking this photograph.

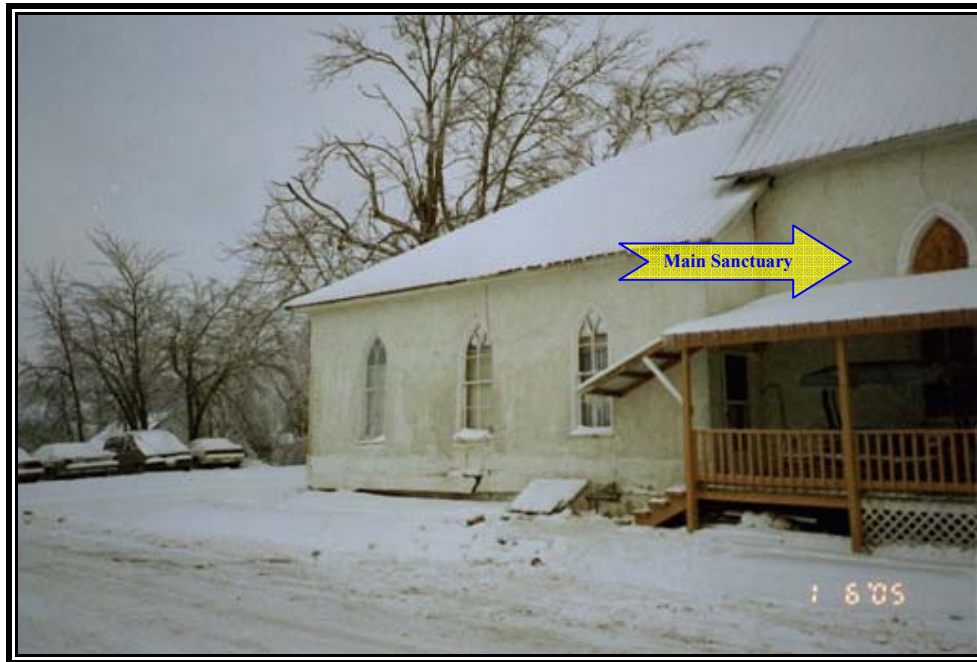
**Photograph 5** This view is looking to the northeast at the west side of 1328 Main Street. The street seen in this photograph is 14<sup>th</sup> Street which runs north and south. The entire roof structure consisted of a metal roof. Note how the roof overhang from the main sanctuary portion of the residence drained onto the below roof for the wooden porch area.

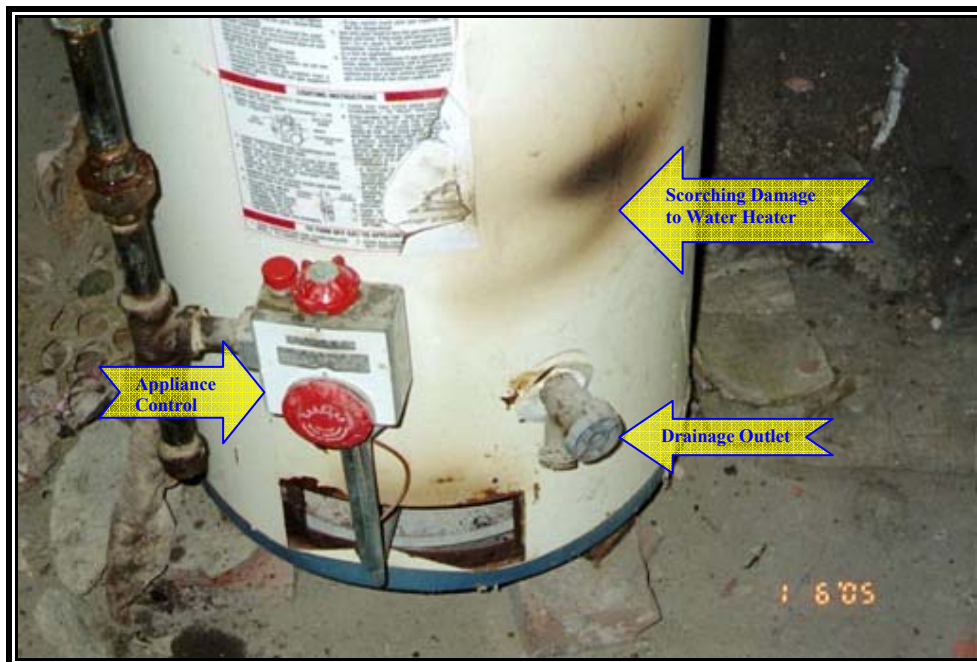
Slight fire damage was observed on the natural gas water heater exterior just above, and to the right of the appliance control. The operating instructions label for the water heater was also singed and burned just above the appliance control assembly (see **Appendix A-3, Photograph**

**Photograph 6** View of the natural gas water heater that was located near the southeast corner of the basement. The appliance control was physically intact and did not appear to have been damaged. Observe the slight burn mark on the water heater just above and to the right of the drainage outlet, as well as, the light burn mark that was just above the access panel. The “Operating Instructions Label” (just above the appliance control) was singed and slightly burned.

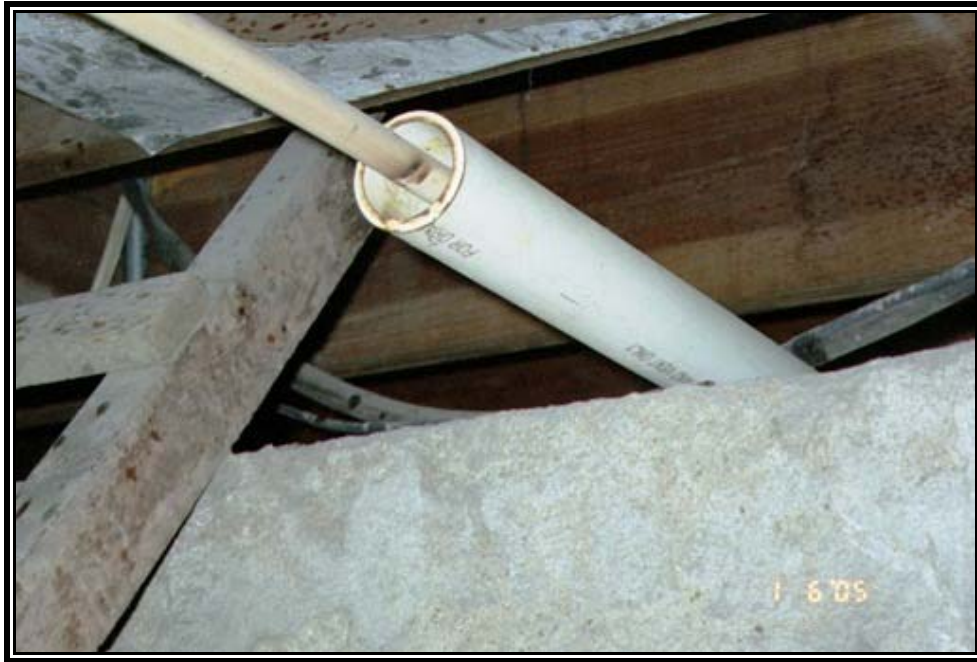
**Photograph 7** View of the PVC water line that traversed east from the outlet side (hot) of the water heater to the kitchen sink that was also located east of the living room. The larger diameter PVC pipe was used as a conduit to protect the water line. Observe the light brown discoloration of the PVC water line as it entered into the PVC conduit.

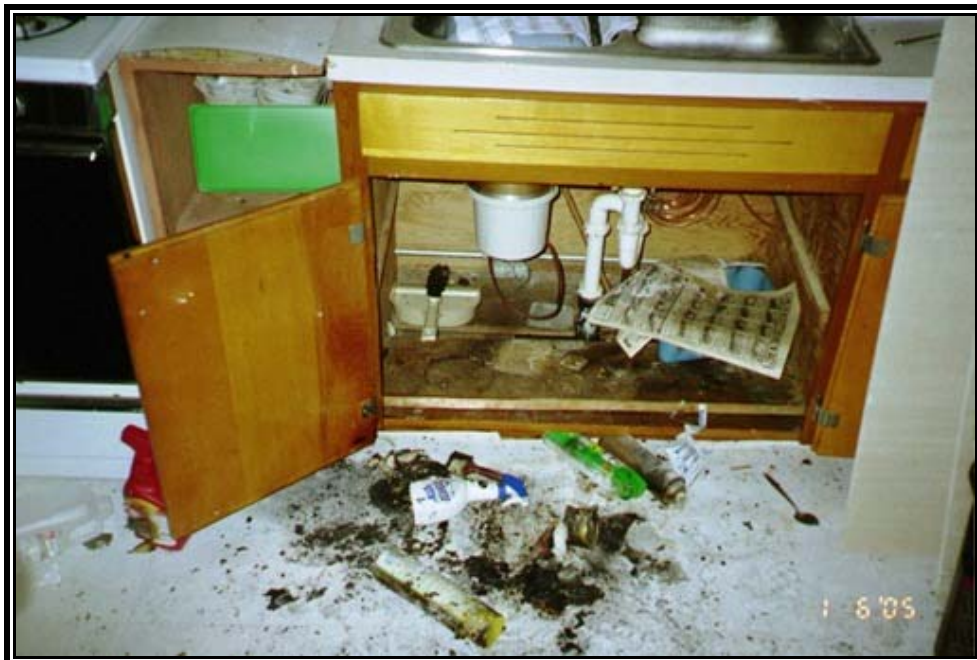
**Photograph 8** Looking at the area beneath the kitchen sink. A light blue plastic tub can be seen covered by newspapers (to the right of the P-trap). The kitchen cleaning items on the floor were inside of the light blue plastic tub, but were later removed by fire department personnel in order to extinguish the fire. This was the only indication of fire damage on the main level. The gas range can be seen to the left of the kitchen sink.

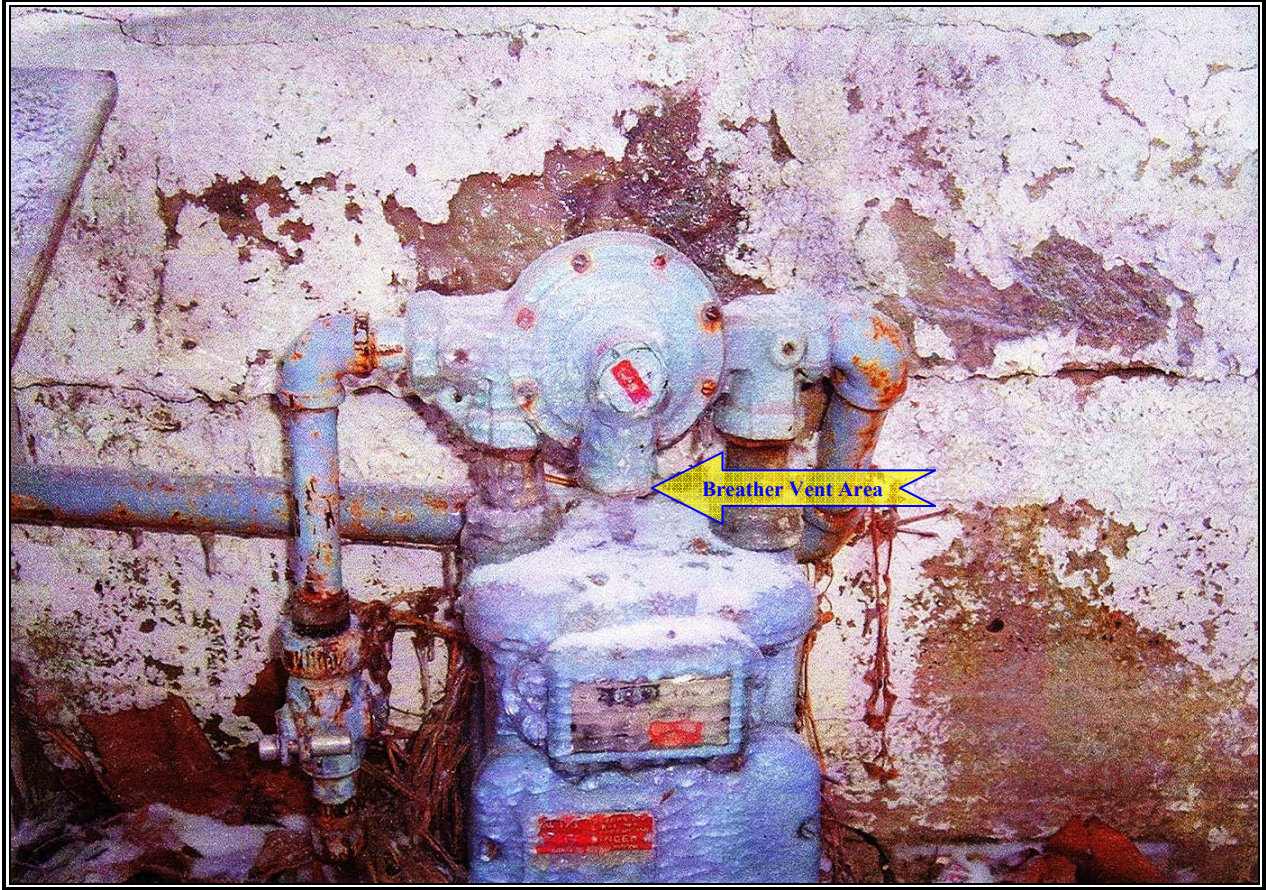
**Photograph 9** Close-up view of the natural gas meter set for 1328 Main Street in Unionville. This picture was taken by WCE personnel on January 5, 2005 during their initial response to the incident site. Observe the icicle that hangs from the breather vent area of the regulator and connects to the top of the meter. A layer of ice surrounds most of the regulator body and meter casing.

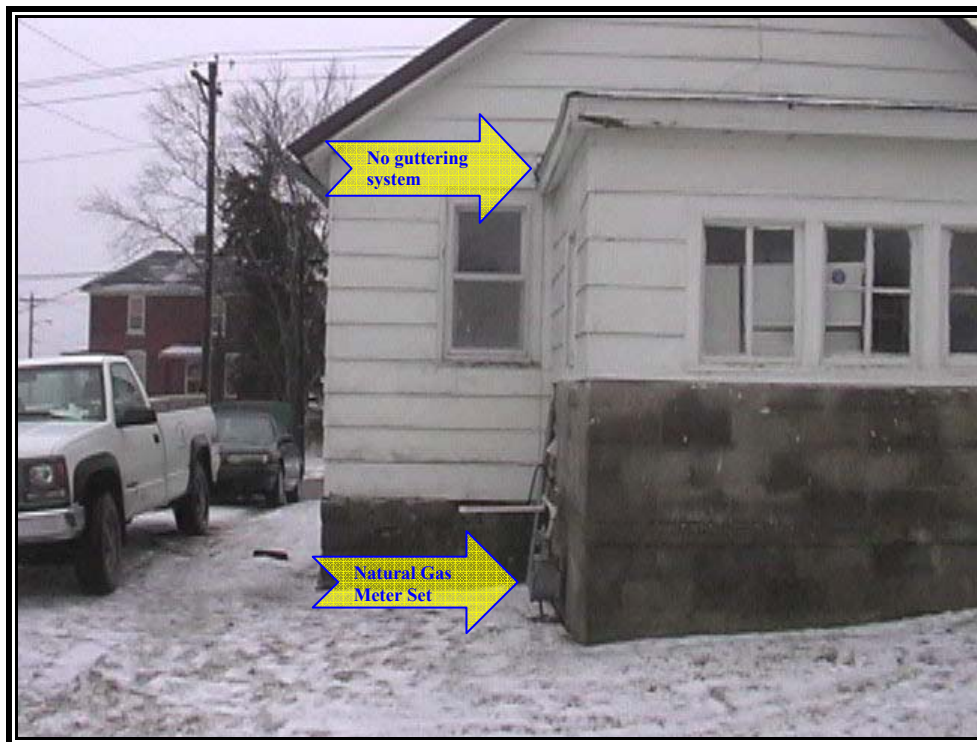
**Photograph 1** Looking south at the north side of 715 E. 4<sup>th</sup> Street. The natural gas meter set is located on the east wall of the mud room. Observe the roof overhang in relation to the location of the natural gas meter set. No guttering system was installed on any portion of the roof.

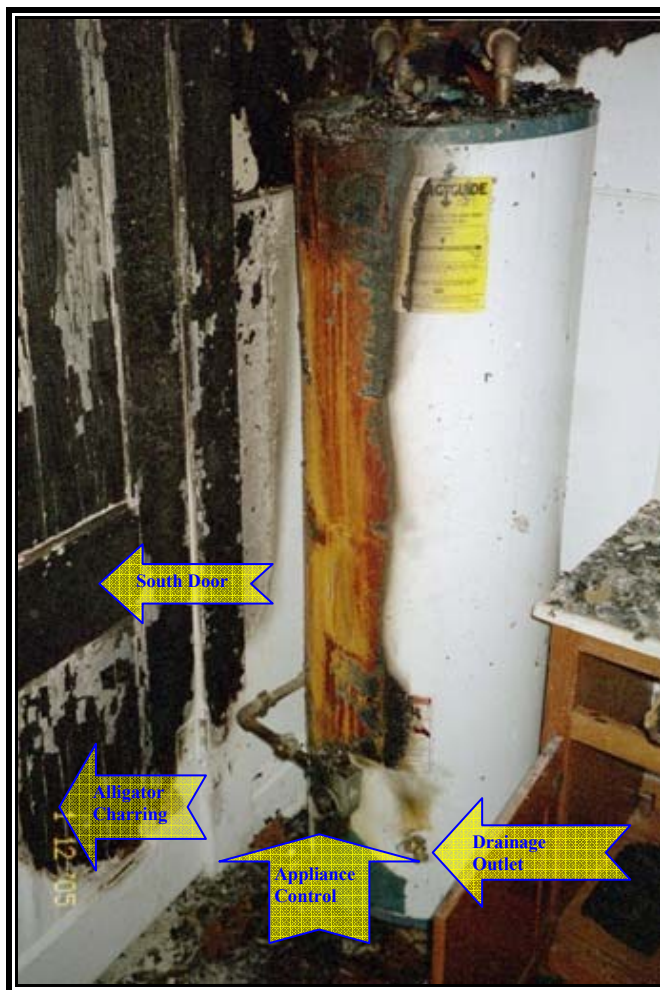
The residence located at 715 E. 4<sup>th</sup> Street in Milan received extensive fire and smoke damage to the bathroom area of the residential structure (see **Appendix B-1, Photograph 2**). No displacement of the foundation or any wall structures was observed for this residence. The property damage amount based on the repair cost was estimated to be \$5,800 by the owner of the residence.

**Photograph 2** View of the southwest corner of the bathroom area where the natural gas water heater was installed. This room had the most severe fire damage. Note the v-pattern burn on the wall between the water heater and the south door. Also observe how the water heater area just above the appliance control was burned. Also note the scorching and discoloration just above the drainage outlet. Alligator charring was observed near the bottom of the south door just southeast of the appliance control.

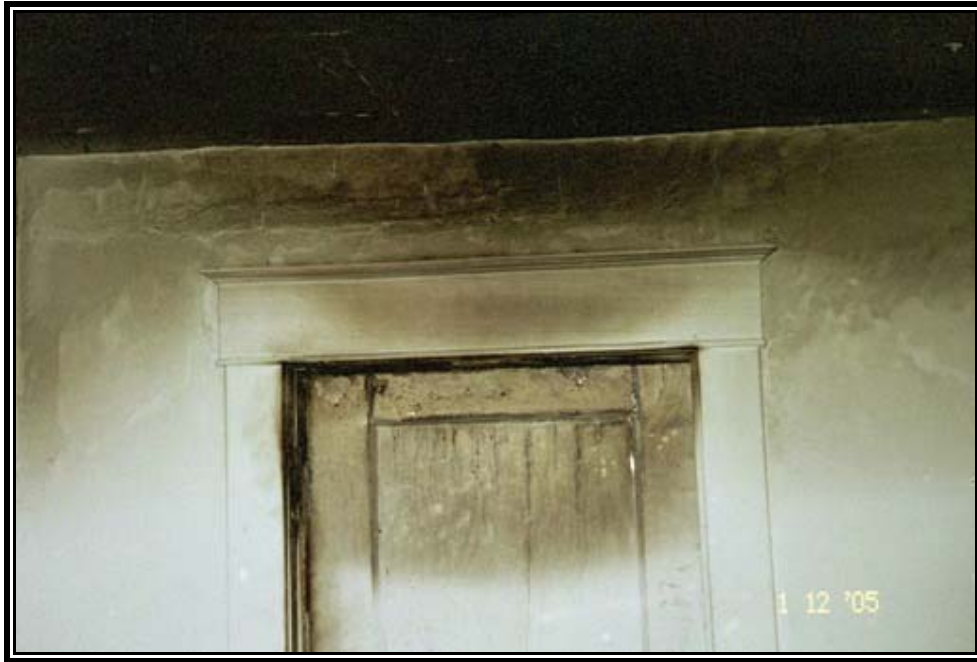
**Photograph 3** View looking north (from the dining room) at the south door for the bathroom area. This door was closed at the time of the natural gas incident. The top portion of the door received heat and smoke related damage. The dining room received smoke related damage.

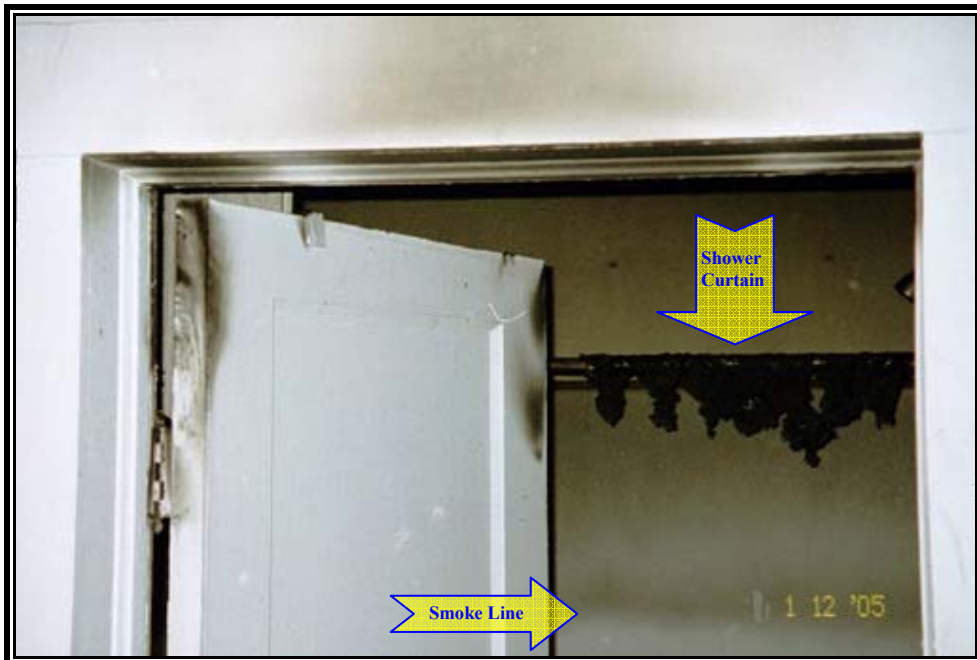
**Photograph 4** Looking to the east at the bathroom area that received the most severe fire and smoke related damage in the home. This photograph was taken from the kitchen area of the residence. This west door to the bathroom was also closed at the time of the natural gas incident.

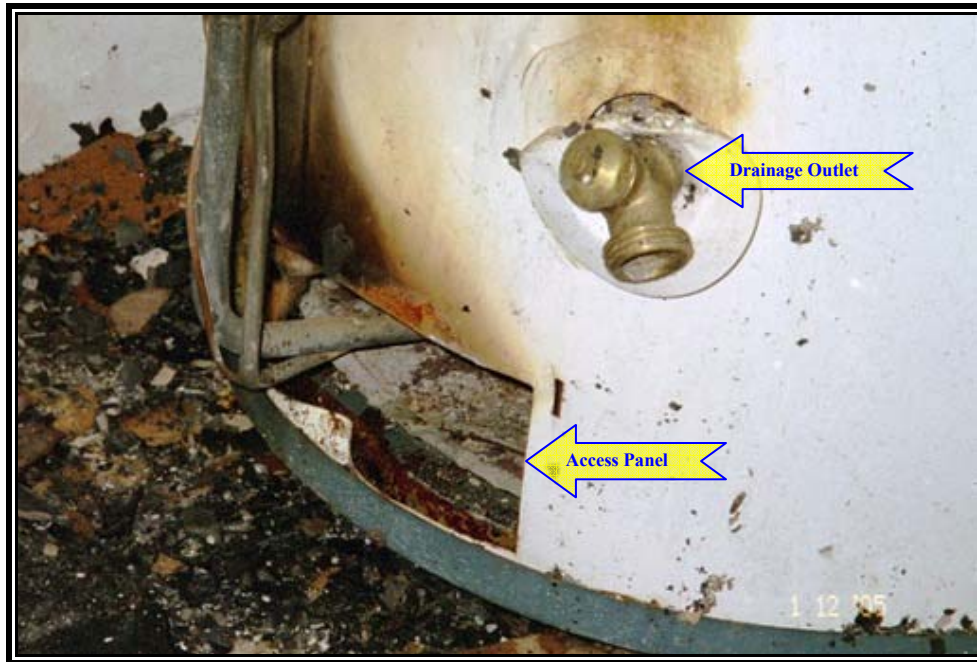
**Photograph 5** Looking at the lower portion of the natural gas water heater that was located in the southwest corner of the bathroom area. Indications of scorching and burning were found on the interior portion of the firebox for the water heater. Observe the burn mark that is directly above the access panel and the slight melting and discoloration area near the drainage outlet.

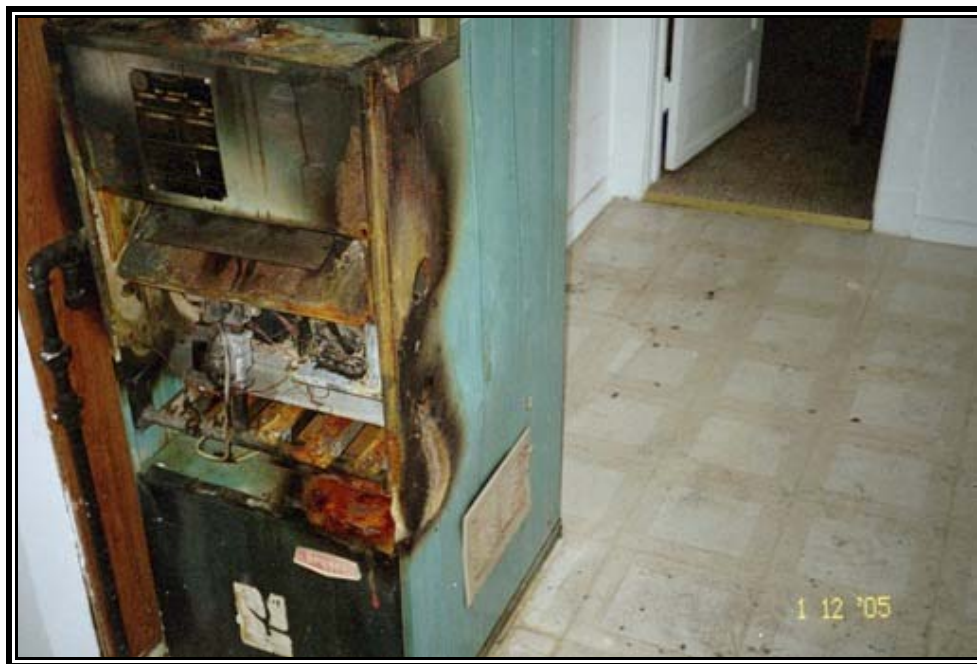
**Photograph 6** View of the natural gas furnace that was located in a room along the west side of the residence. This room was located to the west of the dining room area. Note the severe fire damage to the main burner assemblies, as well as, the top and side portions.

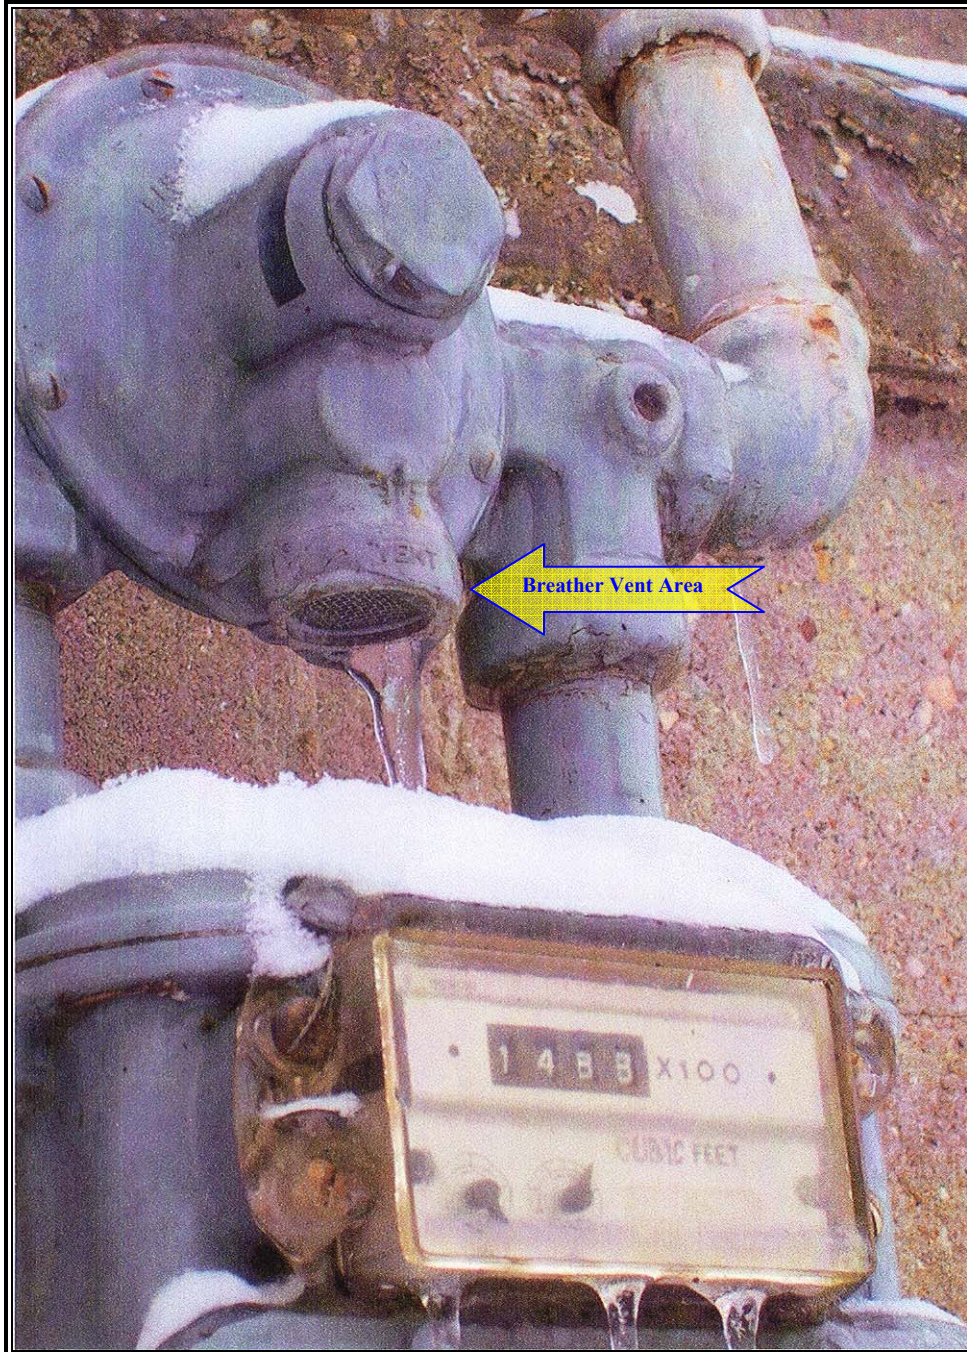
At approximately 12:00 p.m., the Manager made a trip to Milan to check on some regulator stations and to stop by 715 E. 4<sup>th</sup> Street. The Manager during this time verified that all of the regulator stations in Milan were operating correctly, and then drove to 715 E. 4<sup>th</sup> Street to check for external damage. He observed that the house was locked, but had no signs of external damage and the gas service valve had been shut off. He also observed that the top of the regulator body was covered by a layer of ice. The Manager then placed his finger beneath the breather vent screen to see if any ice had accumulated, but did not feel any ice covering the vent screen area (breather vent) of the regulator. The Manager then locked the service valve off.

**Photograph 7** Close-up view of the natural gas meter set for 715 E. 4<sup>th</sup> Street in Milan. This picture was taken by WCE personnel on January 8, 2005 after learning that the house fire may have involved natural gas. Observe the icicles hanging from the breather vent area of the regulator and the meter index cover. On this date, WCE personnel verified that the regulator vent screen (breather vent) had been iced over and blocked.

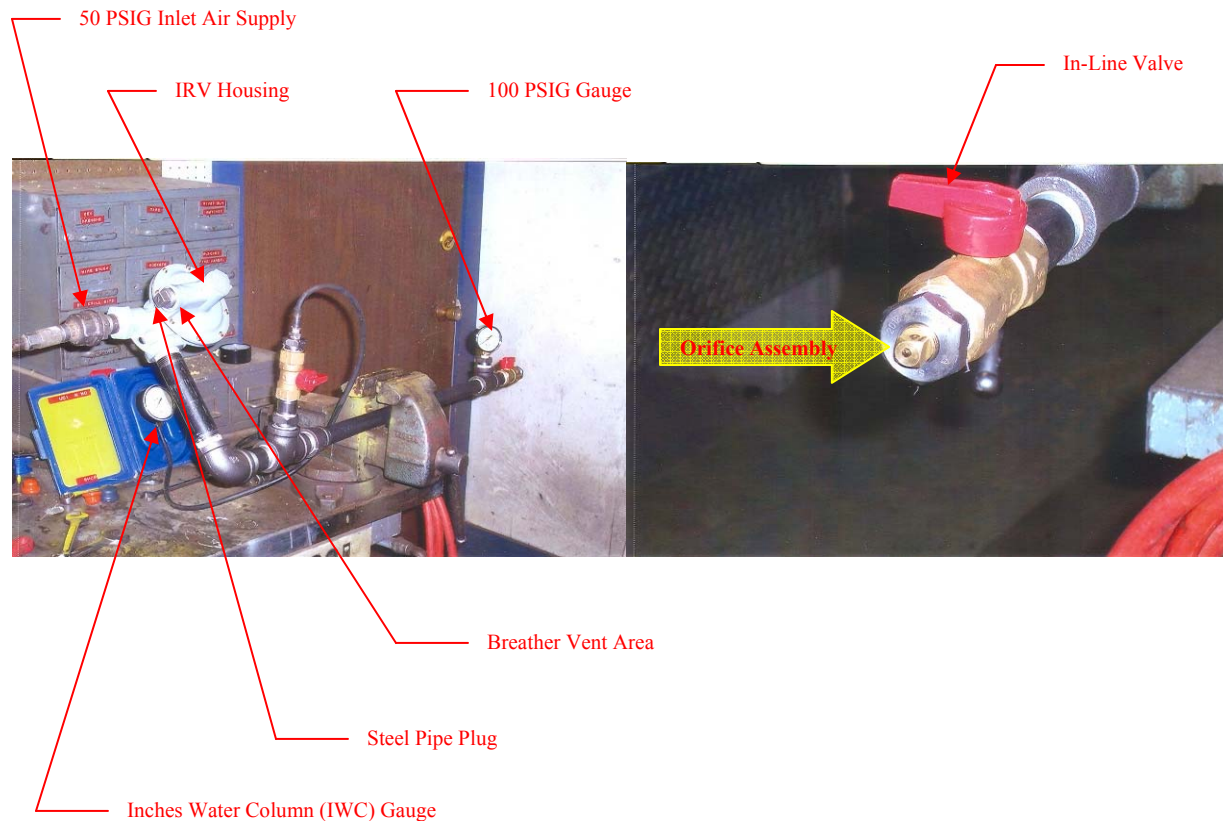
50 psig was then connected to the inlet side of the regulator body. The two photographs below were taken during the failure testing of the Fisher S-252 service regulator. The photograph on the left shows the breather vent plugged and the photograph on the right is the orifice that was used to simulate the combined load demand of both a natural gas water heater and a furnace.

With the orifice installed at the far pipe end, and open to simulate the water heater and furnace loads, the outlet pressure was determined to be 26 psig. A second test was conducted to simulate the downstream pressure in the steel piping when a device, such as, an appliance control for a water heater or furnace had closed the valve (control valve) to its' main burner assembly. The same testing conditions applied as above except an in-line valve (located upstream of the orifice assembly and downstream from the regulator) was shut-off to simulate a no-flow operating condition (also denoted as lock-up). The downstream pressure in the steel piping between the regulator and the in-line valve was determined to be 48 psig during this test.
