STAFF ACCIDENT REPORT

NATURAL GAS EXPLOSION

2208 VINE STREET

CASE NO. GS-83-236

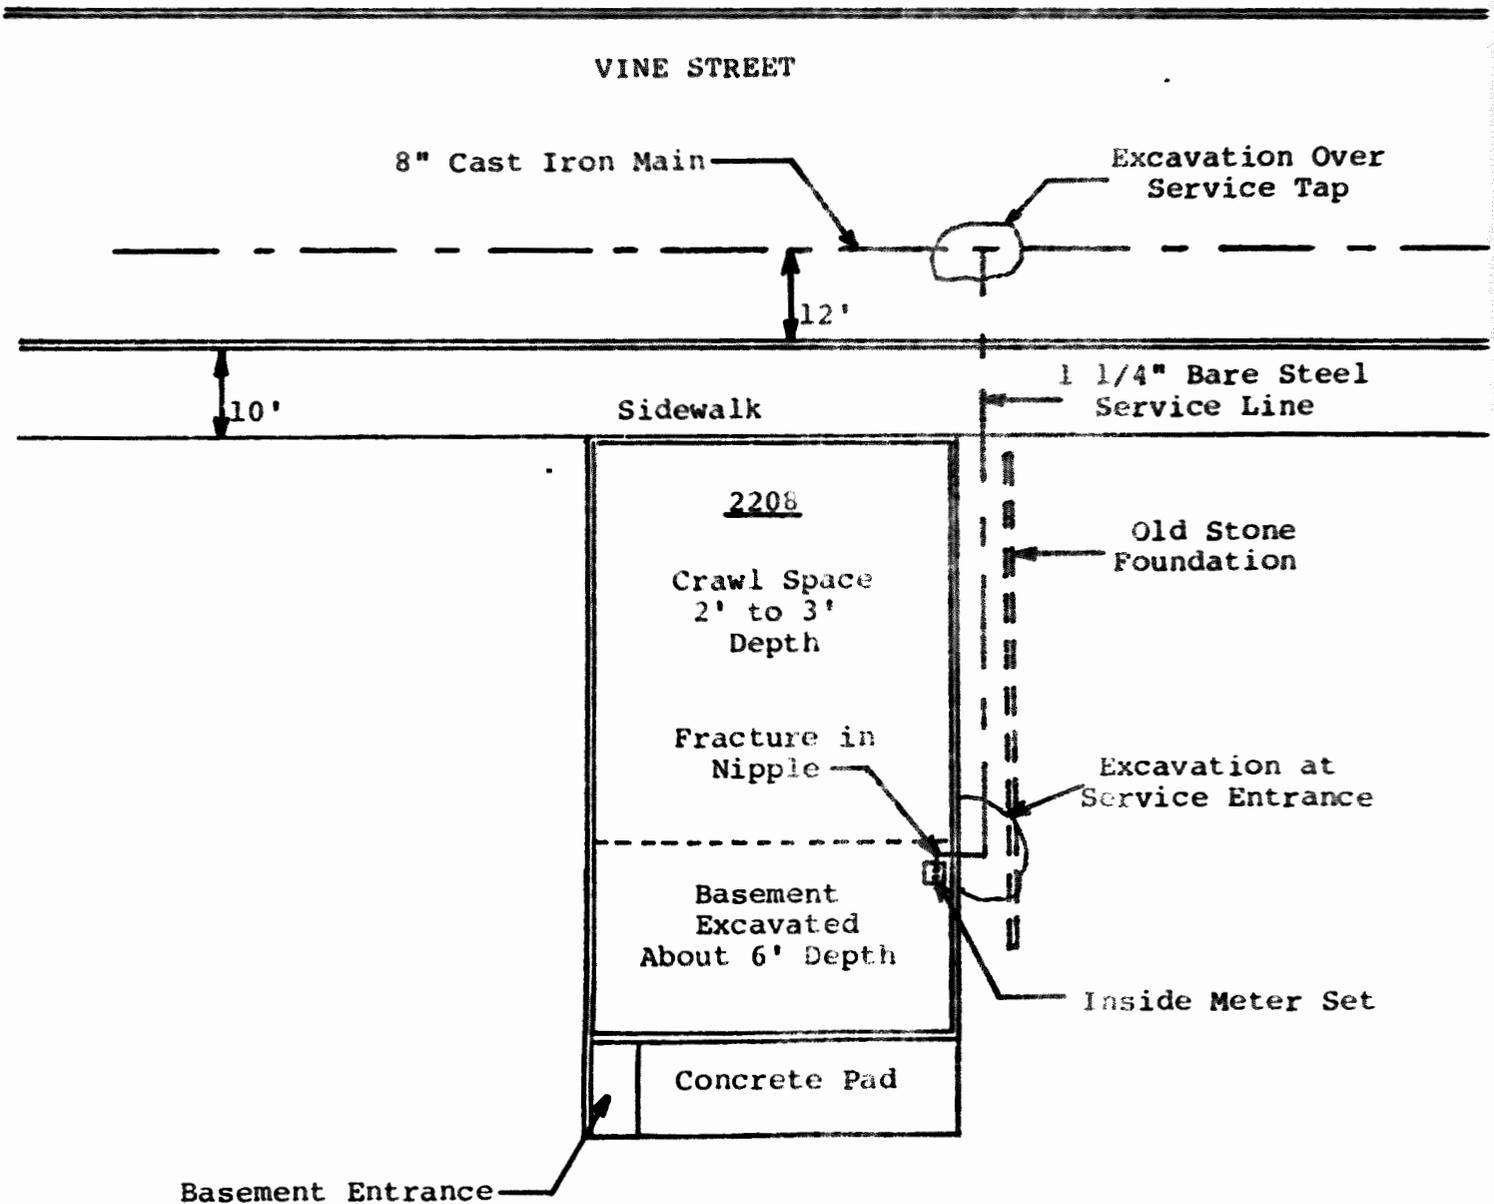
FIGURE 1
PLAN OF GENERAL AREA

The structure is constructed of brick and built on a stone foundation with a 2 to 3 foot high crawl space under approximately 3/4 of the structure. The area under the rear 1/4 of the structure had been excavated to a depth of about 6 feet. An entrance to the basement was located on the northwest corner of the building. (See Figure 1.)

Service to the Vine Street area is provided by an 8 inch cast iron main with bell and spigot joints, many of which have been clamped since installation. The main is buried parallel to and approximately 12 feet east of the west curb of Vine Street at a depth of 4 feet. (See Figure 1.)
