MISSOURI DEPARTMENT OF NATURAL RESOURCES
REPORT OF INSPECTION
COMMUNITY PUBLIC WATER SYSTEM
KIMBERLING CITY WATER COMPANY
STONE COUNTY, MISSOURI
PUBLIC WATER SYSTEM ID NUMBER MO5036046

July 6, 2012

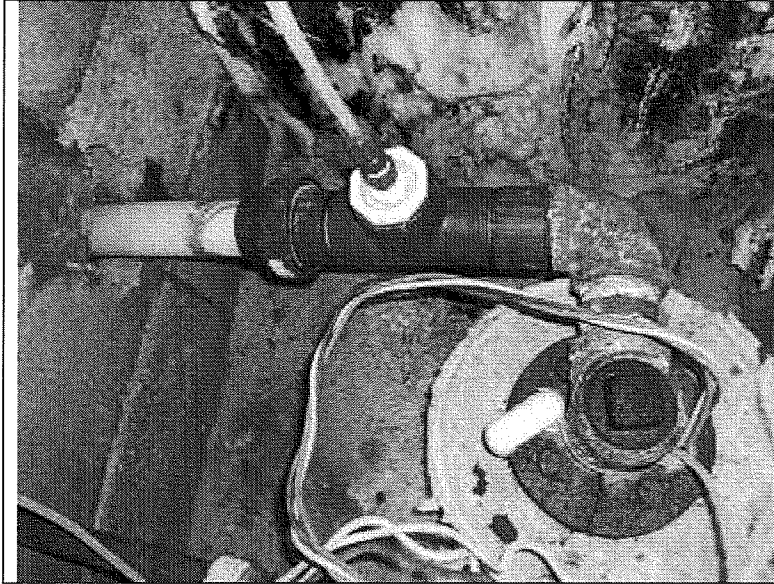
3. The well is not equipped with a source water sample tap located at a point where positive pressure is maintained (prior to treatment). The system's current configuration does not allow for a raw water to be sampled from the well. This was cited during the previous inspection.

11. The well casing was not protected against physical damage.

The well casing and discharge piping must be protected against deterioration, physical damage, and freezing. Paint protects the metal casing from corrosion. An insulated well house prevents freezing.

Location: Kimberling City Water Company
Photographer: Bailey Pearson
Photograph Date: June 21, 2012
Comments: Well head with chlorine injection port

The Department recommends installing a sample tap (prior to treatment) at a point with positive pressure on the well.

The Department recommends painting the exterior of the well casing and discharge piping.

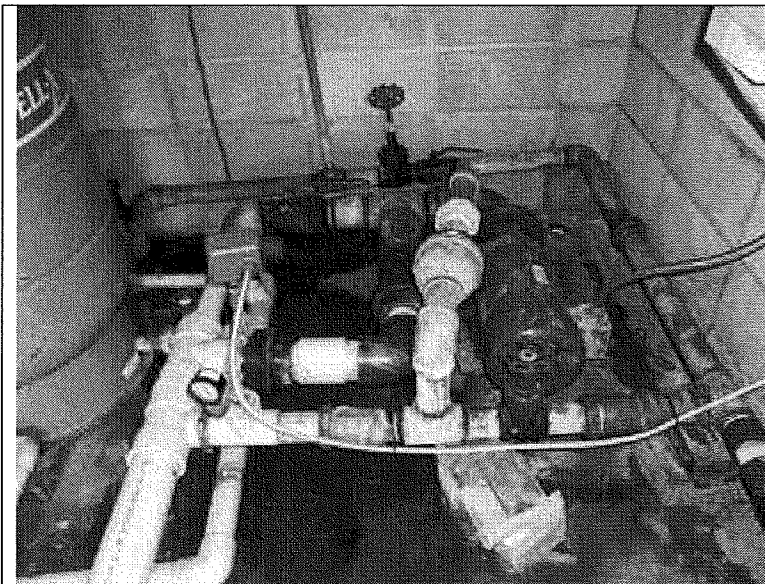
9. Duplicate high service pumps are not provided. This was cited during the previous inspection.

Each booster pumping station shall contain not less than two pumps with capacities such that peak demand can be satisfied with the largest pump out of service.

10. The booster pump is not sufficiently valved to permit bypassing. Specifically, there are not valves on the inlet and outlet piping to the booster pump.

Booster pumps should and piped to allow pumps to be taken offline and repaired without causing a loss of pressure in the distribution system. This shall include sufficient valves to the storage tank to permit continuous operation of the system even with the booster pump offline.

Location: Kimberling City Water Company
Photographer: Bailey Pearson
Photograph Date: June 21, 2012
Comments: One high service booster pump and piping to storage tank

The Department recommends installing duplicate high service pumps.

The Department recommends installing the necessary valves on the inlet and outlet piping to the booster pump to allow it to be taken offline without causing a loss of pressure in the distribution system.

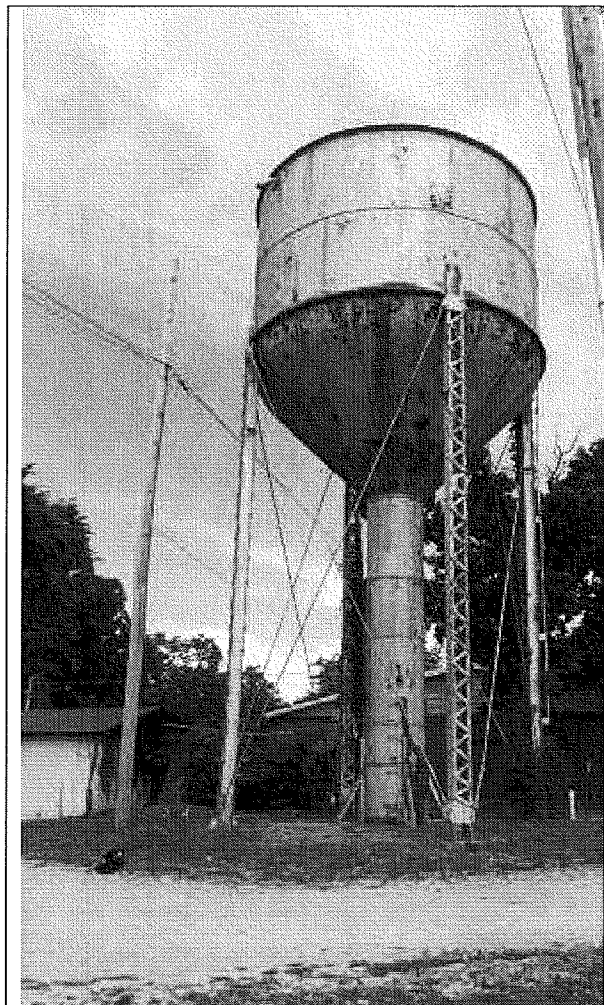
4. The overflow pipe on the elevated storage tank does not terminate at an elevation between 12 and 24 inches above the ground. This was cited during the previous inspection.

The storage tank overflow pipe must terminate near the ground so that the screen can be readily checked and replaced and so that dangerous accumulation of ice does not form during winter overflows.

7. The public water system does not have a ladder gate on the storage tank ladder. Due to the design of the tower, the legs and ladder are accessible and pose a safety hazard. This was cited during the previous inspection.

Location: Kimberling City Water Company
Photographer: Bailey Pearson
Photograph Date: June 21, 2012
Comments: Ground storage tank

The Department recommends modifying the overflow pipe on the elevated storage tank to terminate at an elevation between 12 and 24 inches above the ground surface.

The Department recommends installing a ladder gate on the storage tank ladder, and constructing a chain link fence with a lockable gate around the storage tank to prevent access to the remaining tower legs.
