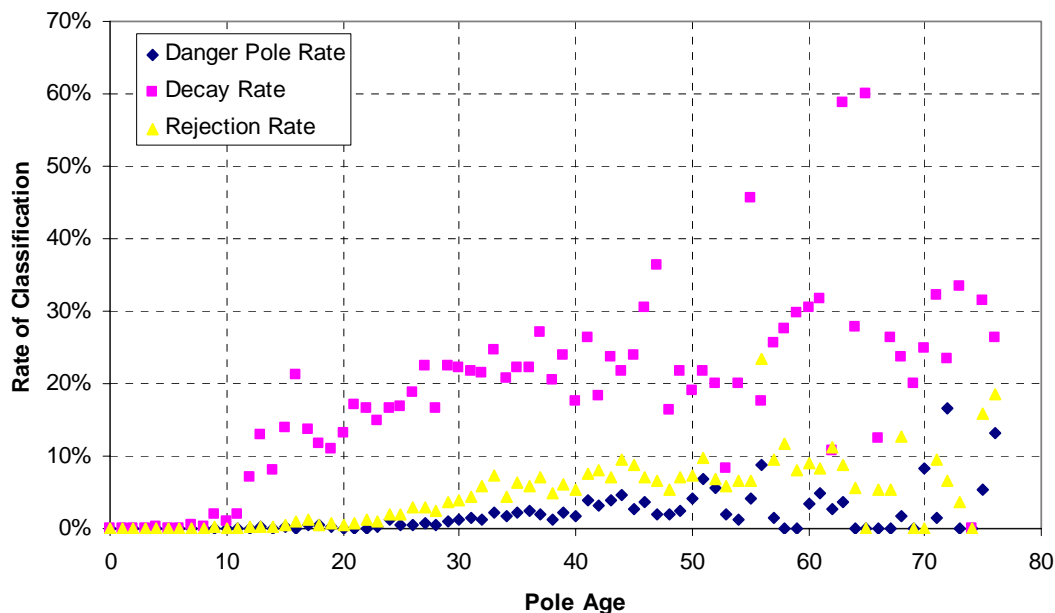
**Exhibit 3-13: Pole inspection and treatment results as a function of pole age (1999-2002 data).**

As seen from Exhibit 3-12, there is a strong positive correlation between average pole age at inspection and the rejection and decay rates for the data between 1999 and 2002. The rates are higher at elevated average ages per district. This is also true for the general trend per pole as can be seen from Exhibit 3-13.

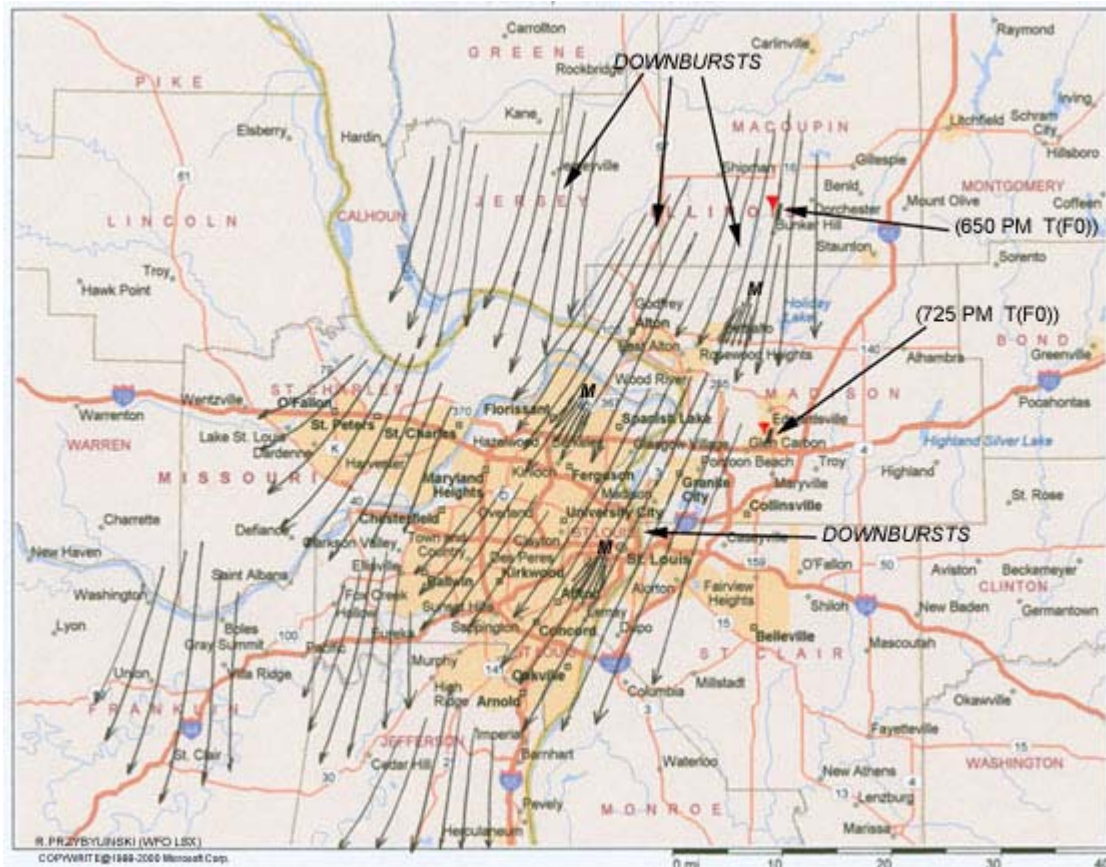
**Exhibit 3-16: STORM DAMAGE MAP: Wednesday, July 19, 2006. M represents locations of microbursts and T signifies locations of tornado touchdowns.**

On July 19<sup>th</sup>, after reaching a high temperature of 100 degrees, a cluster of thunderstorms, also known as a mesoscale convective system, formed across Northern Illinois and propagated southwest across West Central Illinois and Eastern Missouri. The outflow boundary and the thunderstorm complex produced straight-line winds and downbursts that created widespread wind damage from Central Illinois across the St. Louis Metropolitan Area and into the Eastern Ozarks. The damage sustained in the St. Louis Metropolitan Area was consistent with wind speeds between 70 and 80 mph. Areas of damage across Illinois suggested that wind speeds could have approached 90 mph. Two tornado tracks were also uncovered across Southwest Illinois near the towns of Bunker Hill and Edwardsville. Over 500,000 customers lost power, and thus no air conditioning.

A State of Emergency was declared for the St. Louis Area, and the Governor called in the National Guard to help with heat evacuations and clean-up efforts from the severe thunderstorms. The temperature rose near 100 degrees once again on Thursday and heat index values were as high as 115 degrees in the affected region.

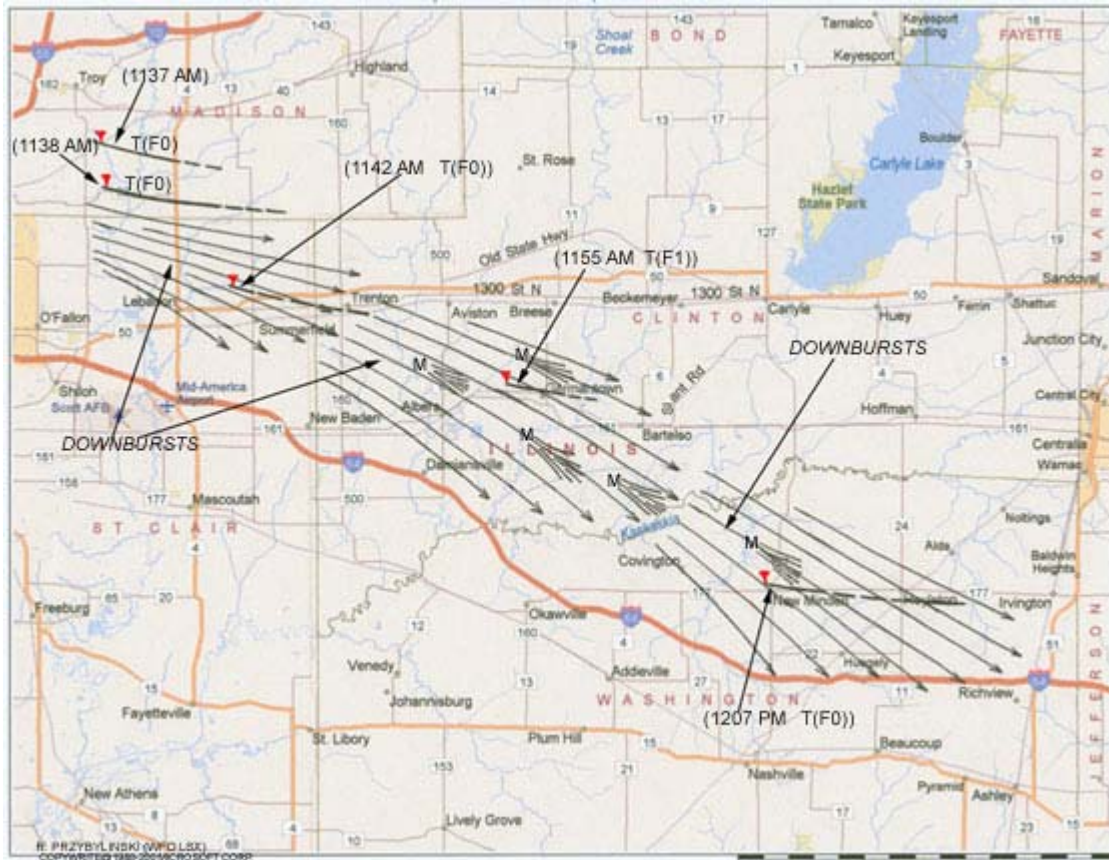
**Exhibit 3-17: STORM DAMAGE MAP: Friday, July 21, 2006. M represents locations of microbursts and T signifies locations of tornado touchdowns.**

Another complex of severe thunderstorms formed across Central Missouri during the morning of July 21<sup>st</sup> on the trailing end of an outflow boundary from overnight convection across Southern Iowa and Northern Missouri. This cluster of thunderstorms formed into a bow echo as they pushed across the St. Louis Metropolitan Area producing another swath of wind damage from Central Missouri to Central Illinois. To the north of the apex of the bow a strong circulation produced several tornadoes. This led to many additional power outages and complicated clean up efforts from the July 19<sup>th</sup> storm damage. Some people who had just gotten their power back

from the previous storm suddenly found themselves in the dark once again. The number of customer outages once again rose above 500,000.

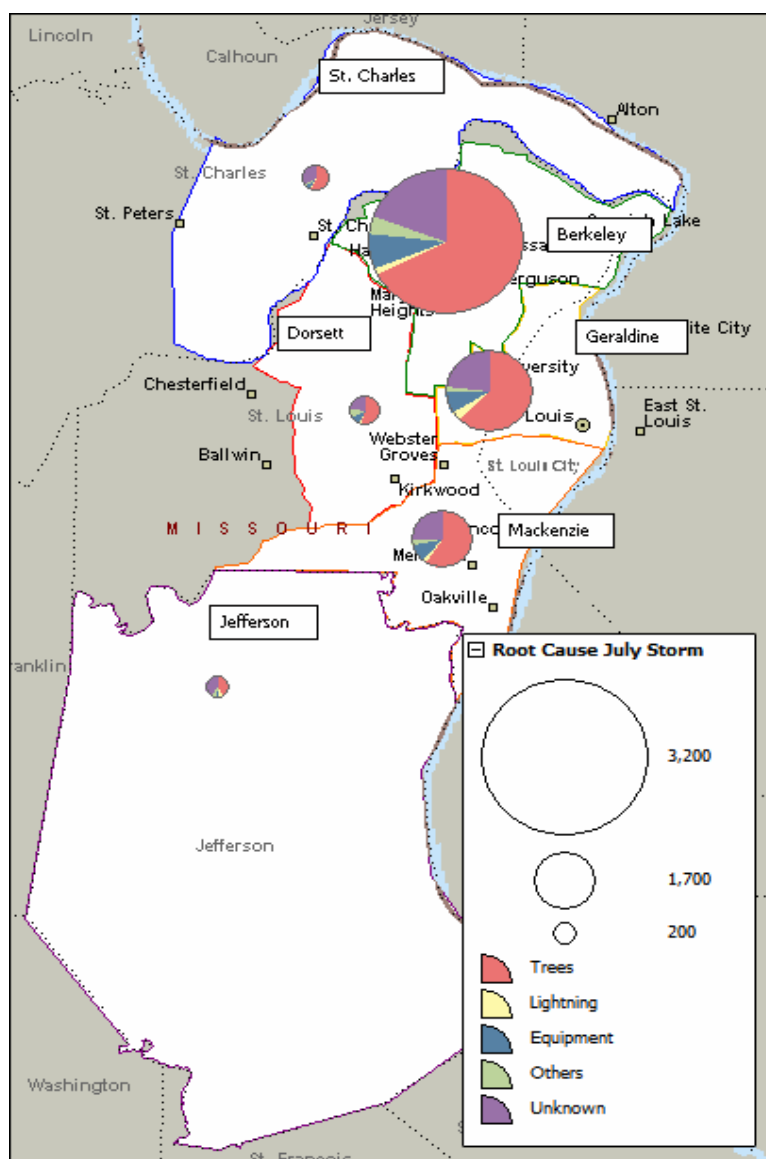
**Exhibit 3-22: July Storm, Root Cause by District**

- KEMA re-analyzed the data to identify the distinction between Tree Broke, Tree Contact and Tree Other. These tree related root causes were deduced from root cause codes TB, TC and 'tree other', which refers to any other tree related code. Tree total is a summation of all tree related root causes.
- There is a substantial percentage of root causes, 23%, defined as unknown. If unknowns were removed from the analysis, the average root causes for all districts would be approximately 81% tree, 3% lightning, 11% equipment and 5% others.

It is important to understand what components are affected due to the respective root causes. This may help define whether the damage was preventable or not, and to what extent. Damage was primarily to wire or equipment related (i.e. transformer). There appears to be little structural damage; minimal pole breakage due to wind only. As the recorded wind speeds did not exceed 92 mph, this indicates that pole overloading and/or pole deterioration did not play a role; however,

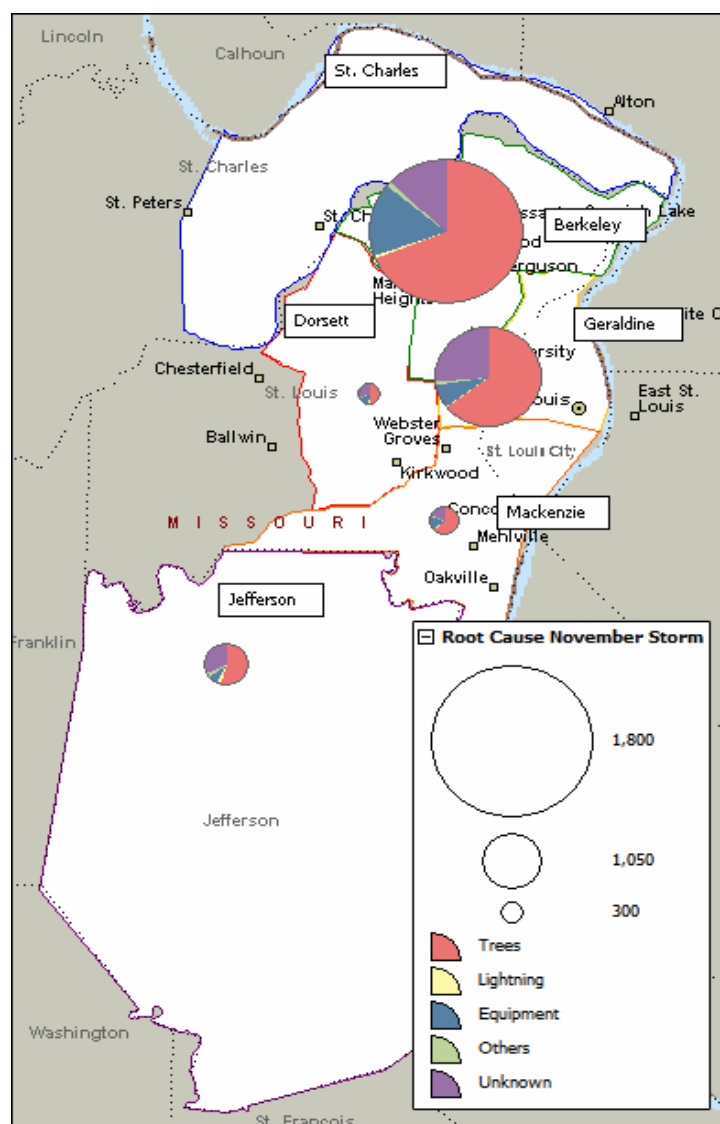
**Exhibit 3-30: December Storm, Root Cause by District**

As displayed in Exhibit 3-29, the dominant root cause for this event, similar to the July storm, was tree related with a substantial 60%. A graphical summary of outage event root causes by district is shown in Exhibit 3-30. Note that the size of each pie chart is relative to the number of outage events.

- Note that there is a substantial percentage, approximately 24%, of root causes defined as unknown. If unknowns were removed from the analysis, the average root causes for all districts would be approximately 79% tree, 2% lightning, 17% equipment, 3% others.
