Missouri Public Service Commission

Staff's Gas Incident Report

910 W 48<sup>th</sup> Street  
Kansas City, Missouri  
February 19, 2013

**Missouri Gas Energy**  
**Case No. GS-2013-0400**

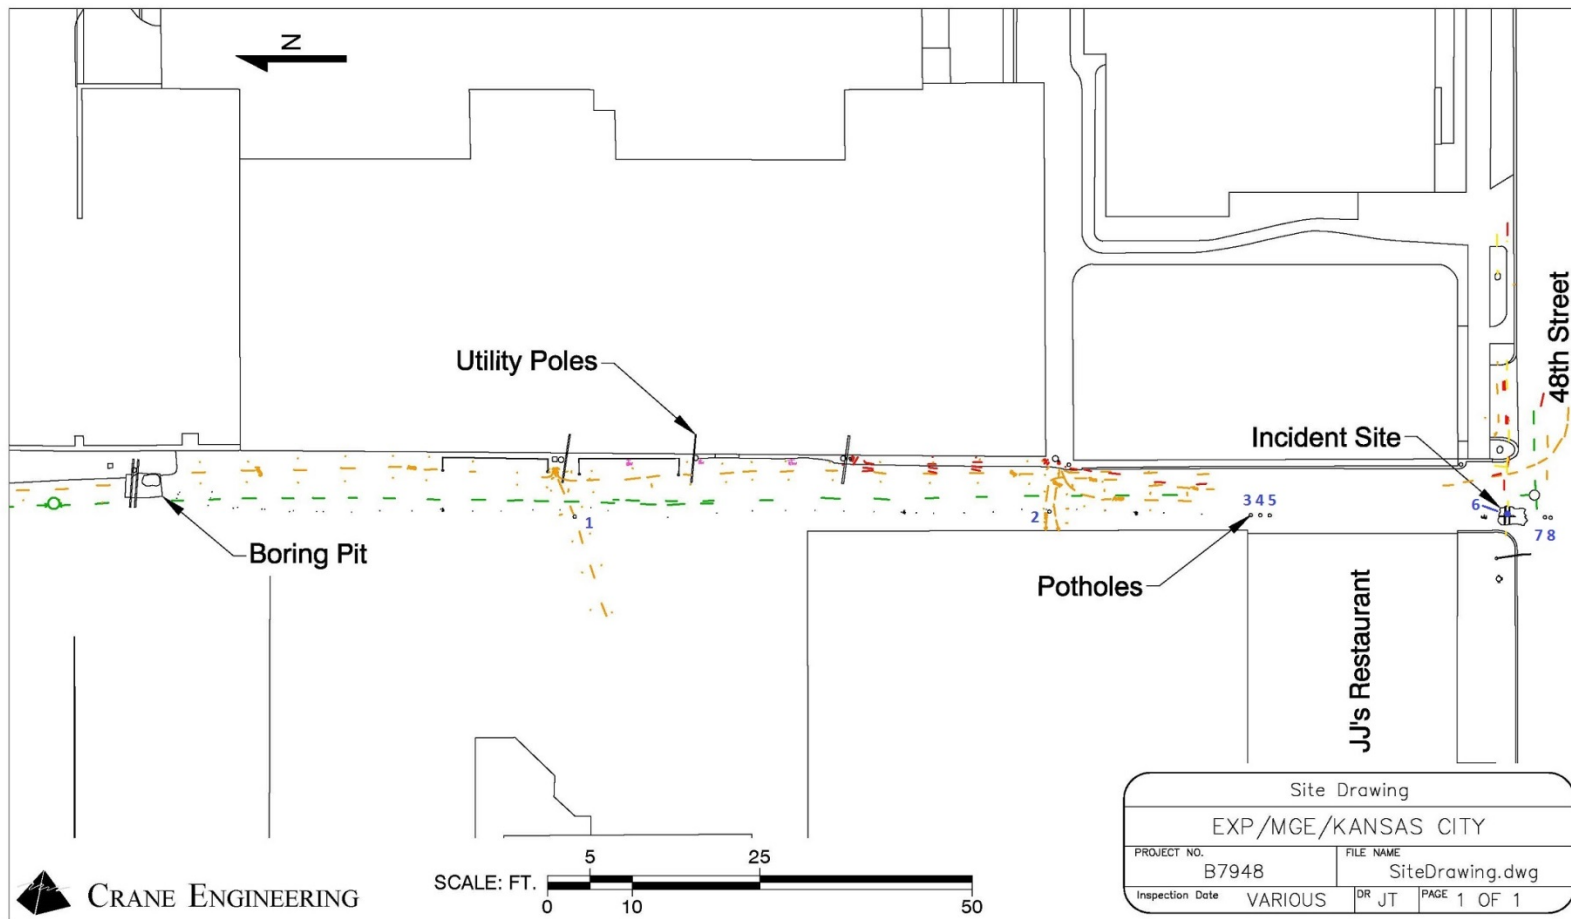
Figure 1 – Detailed schematic of the alley from the boring pit to the third party damage (Provided by MGE)

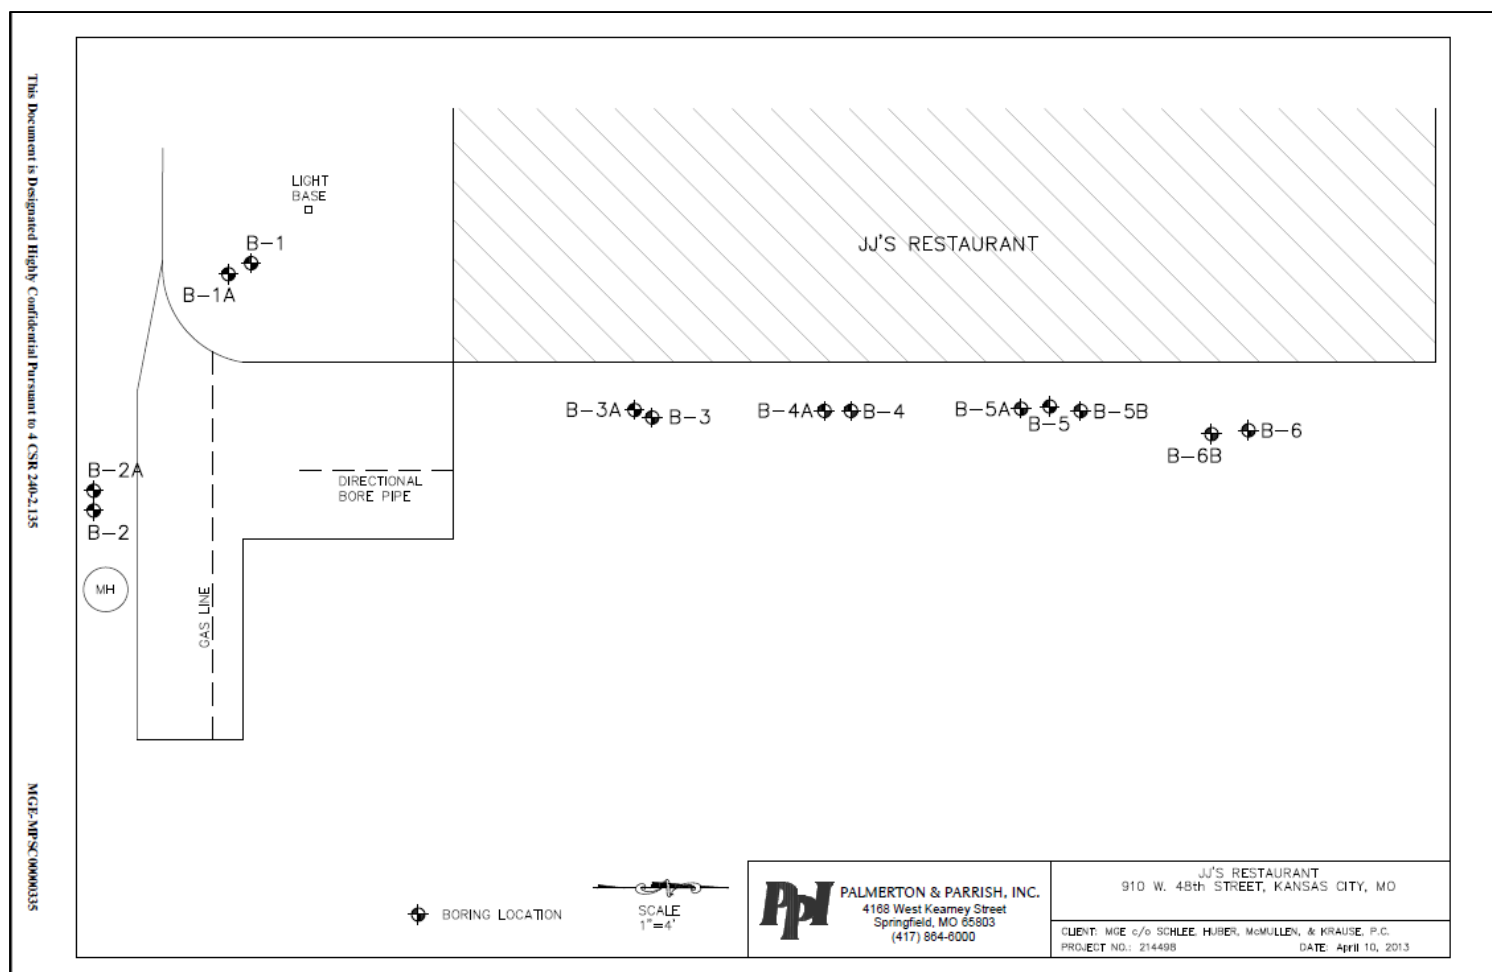
2 Natural gas leaking from an underground pipe would tend to migrate along paths of least  
3 resistance. Staff's investigation revealed the soil contained a layer of aggregate, and also  
4 revealed large voids providing possible paths of migration for the gas.

Figure 2 - Various soil samples taken near the manhole and in the alley between JJ's Restaurant and the House of Elan (Provided by MGE)

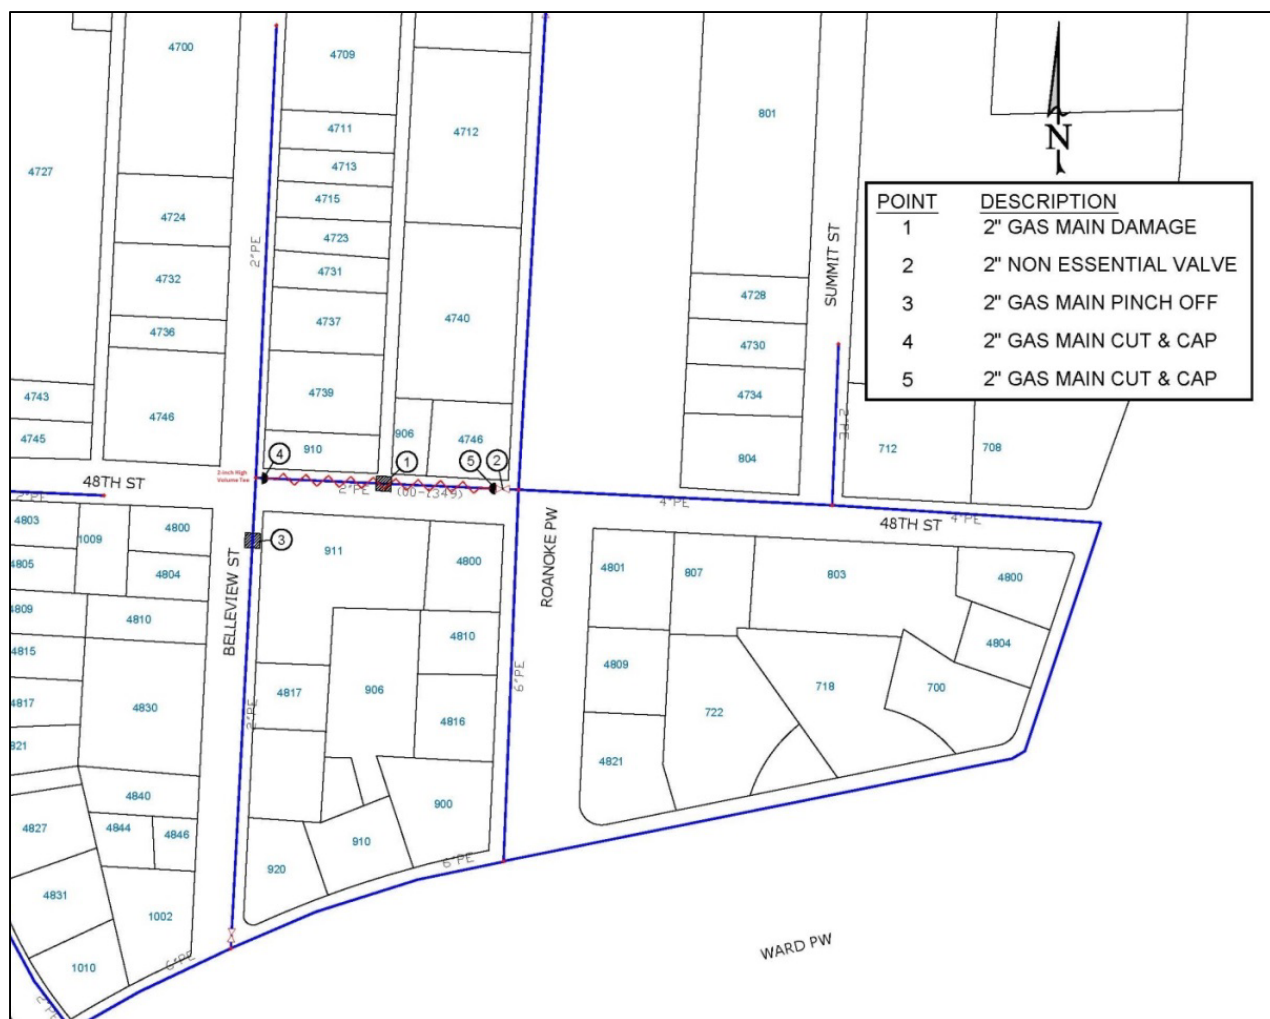
1           The valve located at Roanoke Parkway and W. 48<sup>th</sup> Street was closed at approximately  
2 7:20 p.m. on February 19, 2013 and MGE personnel attempted to locate and close a valve at  
3 Ward Parkway and Belleview Avenue. However, the valve at Ward Parkway and Belleview  
4 Avenue was inaccessible at the time of the incident because the valve was paved over with  
5 asphalt. Closing the valve at Ward Parkway and Belleview Avenue and the valve at Roanoke  
6 Parkway and W. 48<sup>th</sup> Street, would have isolated the damaged section of main. If MGE  
7 personnel would have closed these two valves, natural gas would have continued to escape for an  
8 unknown amount of time from the damaged main until line pressure equalized to atmospheric  
9 pressure.

10           Since the valve at Ward Parkway and Belleview Avenue was inaccessible, MGE  
11 personnel exposed and squeezed-off the natural gas main on Belleview Avenue and W. 48<sup>th</sup>  
12 Street at approximately 8:00 p.m. on February 19, 2013. With the valve closed at Roanoke  
13 Parkway and W. 48<sup>th</sup> Street and the main squeezed off at Ward Parkway and Belleview Avenue,  
14 the damaged section of the main was isolated and natural gas service was interrupted to  
15 approximately 35 customers. The amount of time for the natural gas to escape from the system  
16 to equalize with atmospheric pressure was minimal with this approach because the isolated  
17 section was small and the volume of gas in the isolated section is small.

Figure 5 – Actions Taken to Isolate the Damaged Section of Main on W. 48<sup>th</sup> Street (Provided by MGE)

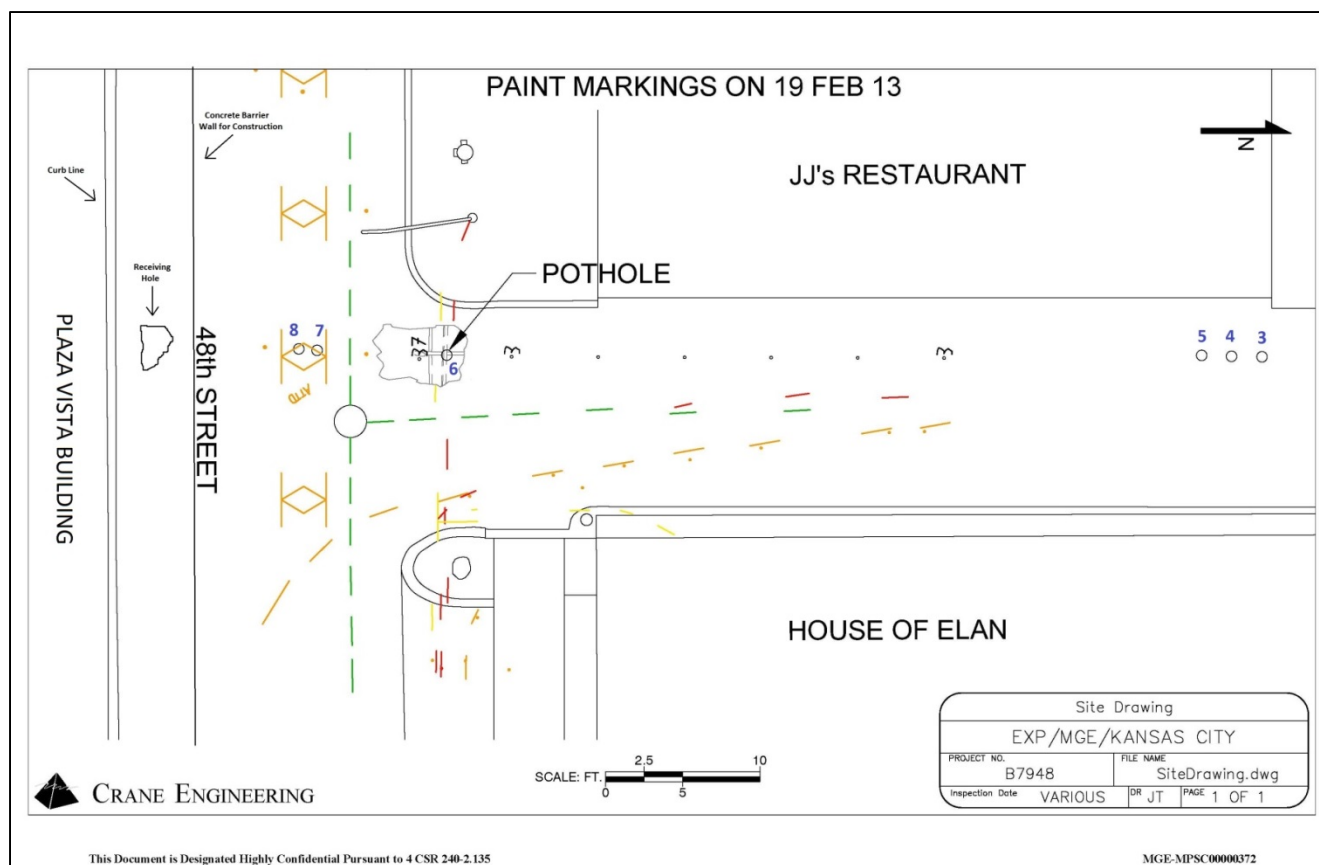
Figure 6 – Schematic of Potholes and Utility Markings around the third party damage (Provided by MGE)

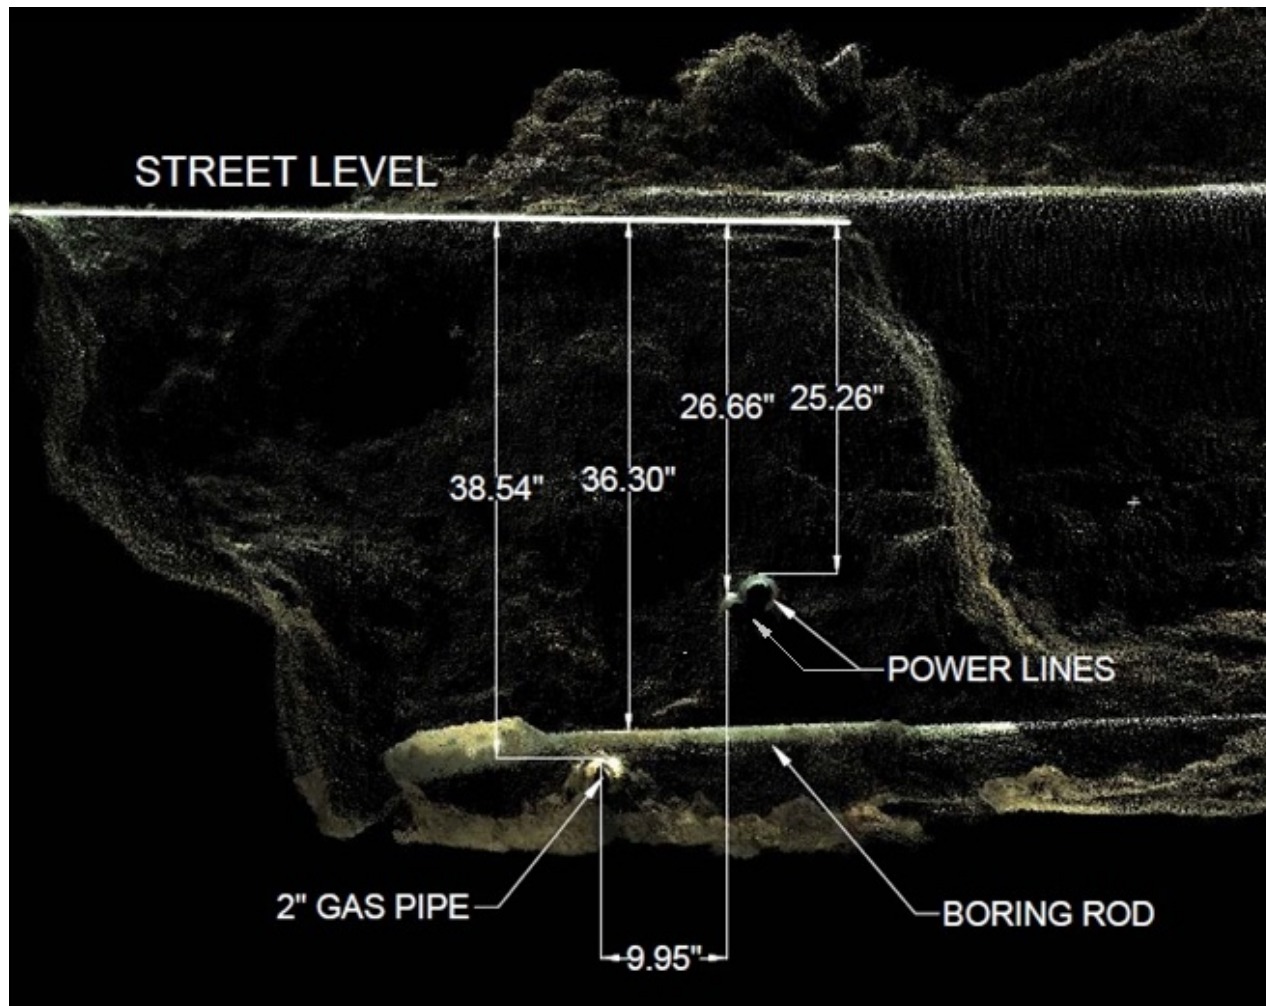
Figure 7 – 3-D Laser scan of third-party damage (Provided by MGE)

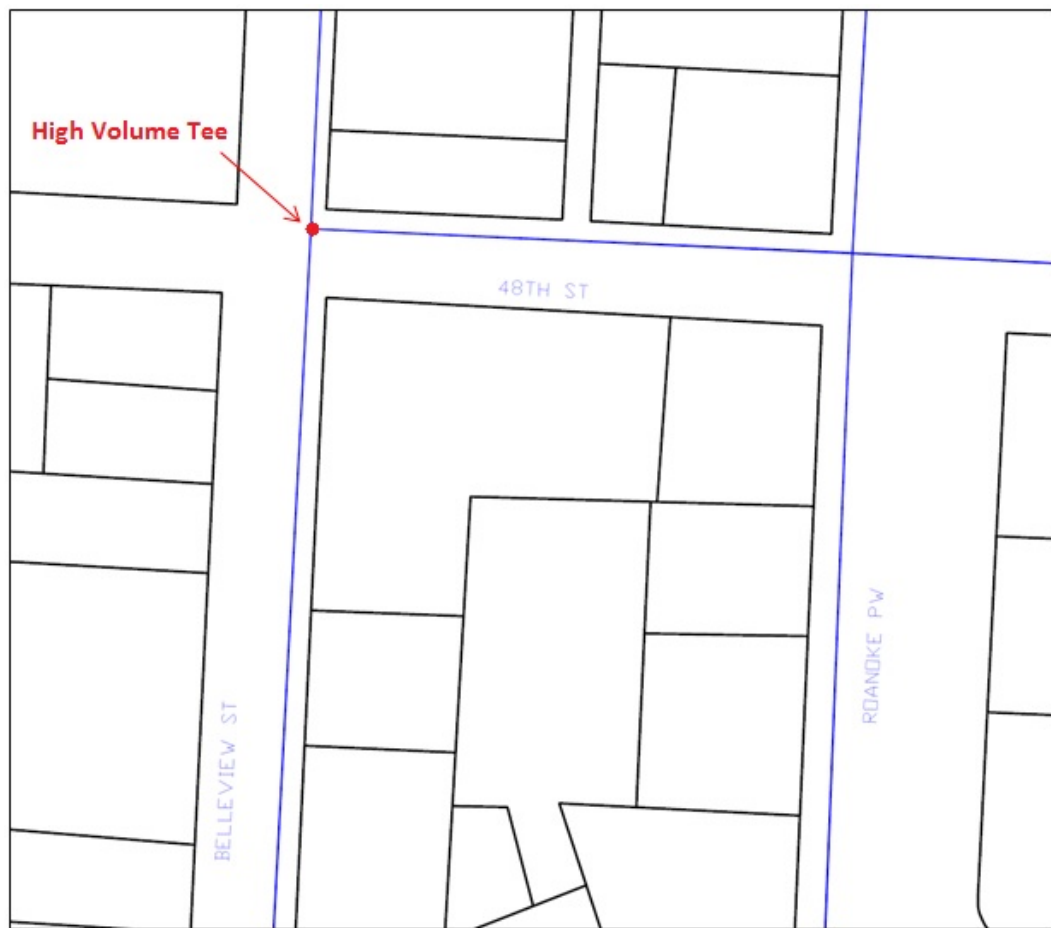
Figure 8 – Location of the High Volume Tee Connecting Mains on W. 48<sup>th</sup> Street and Bellevue Avenue (Provided by MGE)

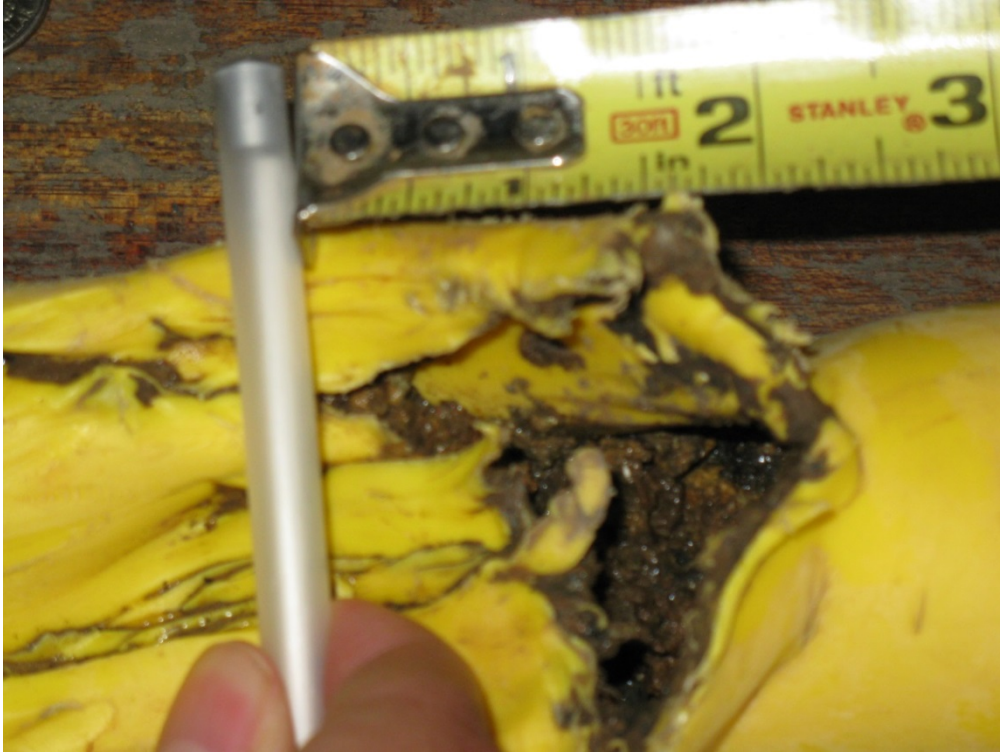
1 48<sup>th</sup> Street. Upon excavating the 2-inch diameter PE main, an approximate 2-inch by 2-inch hole  
2 was found in the top of the main (See Appendix C, Photographs 1 and 2).

The natural gas escaping from the third-party damaged 2-inch diameter PE natural gas main exited at a pressure of approximately 25 psig, according to pressure charts provided by MGE. The approximate 2-inch by 2-inch (See Appendix, Photographs 1 and 2) hole in the natural gas main would have allowed the natural gas to escape at a rapid rate. Natural gas leaking from an underground pipe would tend to migrate along paths of least resistance laterally through the soil and upward through the soil toward the atmosphere because natural gas is lighter than air (natural gas has a specific gravity of 0.6 while air has a specific gravity of 1.0).

**Photograph #1 – Approximate 2-inch wide hole in damaged section of main oriented west (left side) to east (right side) (Staff Photo)**

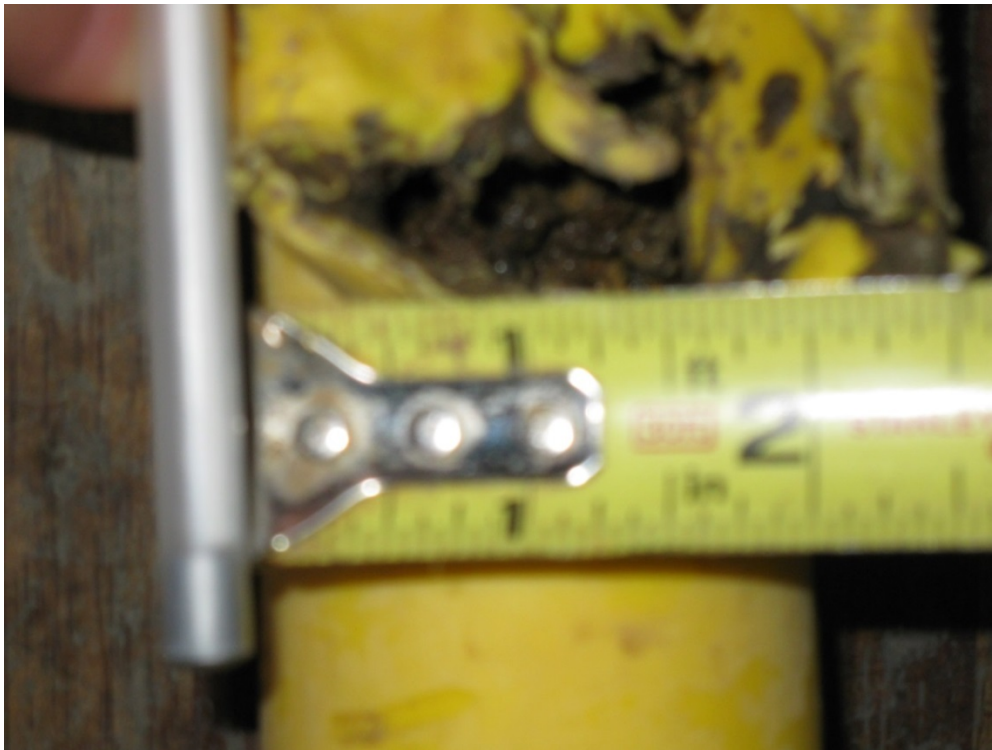
**Photograph #2 – Approximate 2 inch wide hole in damaged section of main oriented south (left side) and north (right side) (Staff Photo)**

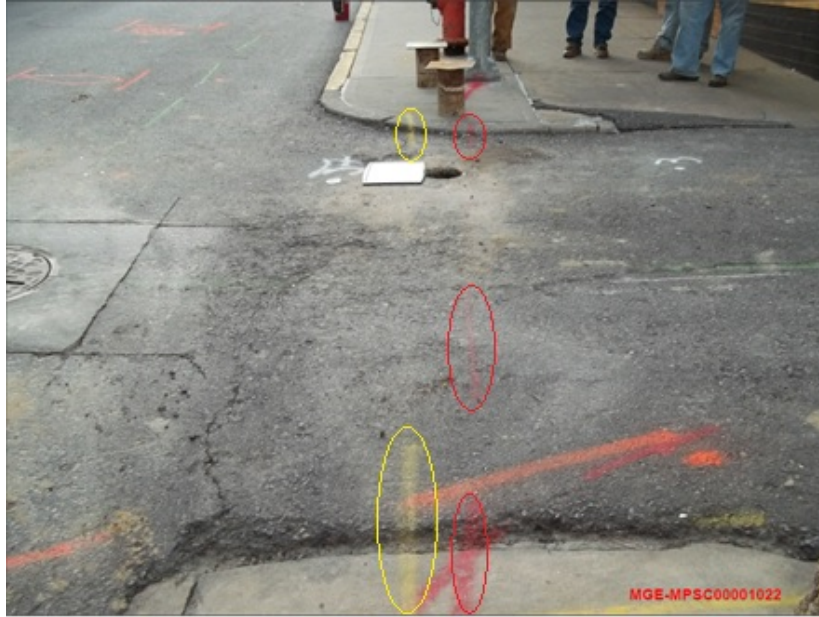
5 In the area where the third-party damage occurred USIC placed on the pavement a single  
6 line of yellow locate marks (indicating a natural gas facility) and a single line of red locate marks  
7 (indicating an electrical facility). However, there were, in fact, three underground facilities in  
8 the area (two electrical facilities and one natural gas facility). Had markings on the ground  
9 indicated to Heartland Midwest personnel another underground electric facility was present, it is  
10 probable that Heartland Midwest personnel would have been able to avoid damaging the natural  
11 gas main.

**Photograph #3 – Pothole #6 is shown between the line of yellow marks (circled in yellow) and the line of red marks (circled in red) near the approximate area of the damaged main. The white dots represent the bore path. The “37” written to the left (south) of the pothole indicates a drill bit depth of approximately 37 inches, while the “3” on the right (north) side of the pothole represents a drill bit depth of approximately 3 feet. (Provided by MGE)**

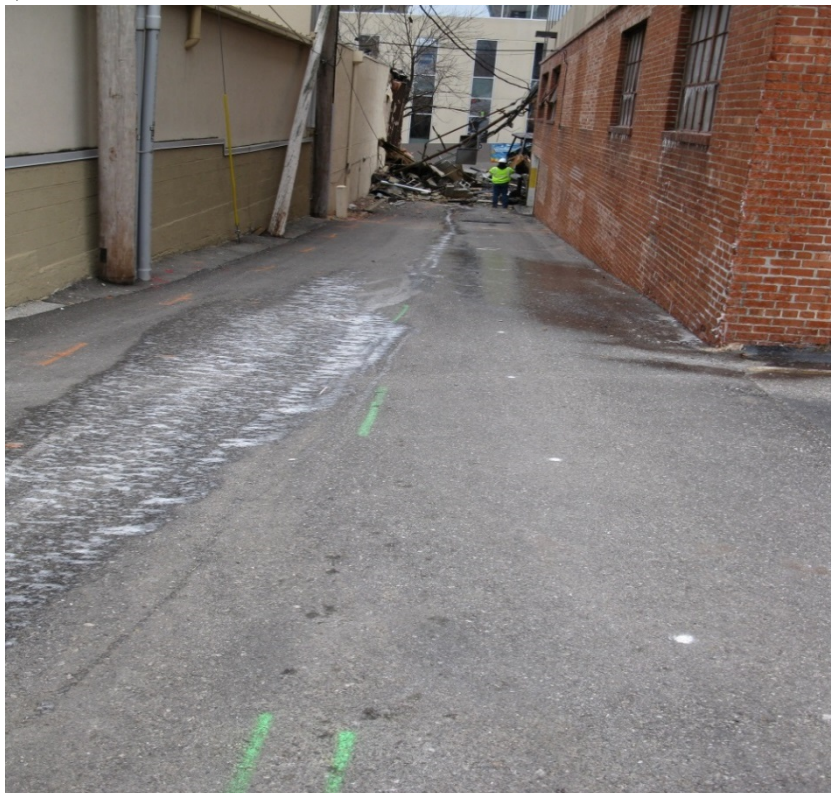
**Photograph #4 – Locate markings looking south down the alley just south of the entrance pit. The white dots show the bore path of the drilling rod. (Staff Photo)**

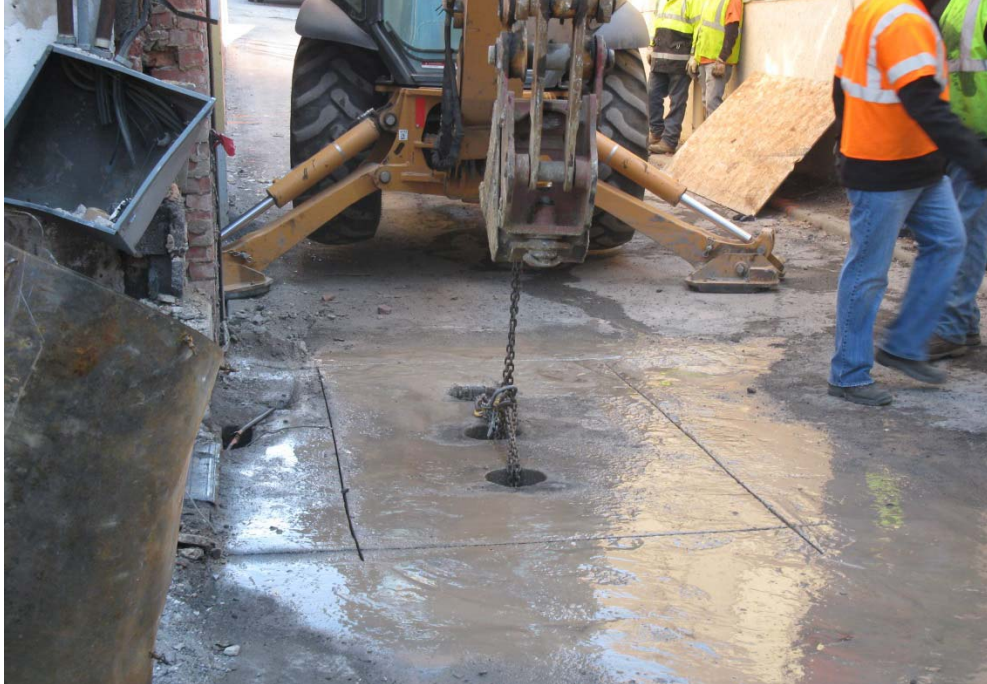
**Photograph #5 – Slab of pavement to be removed in the alley near the northeast corner of JJ's Restaurant containing potholes 3, 4 and 5 (Staff Photo)**

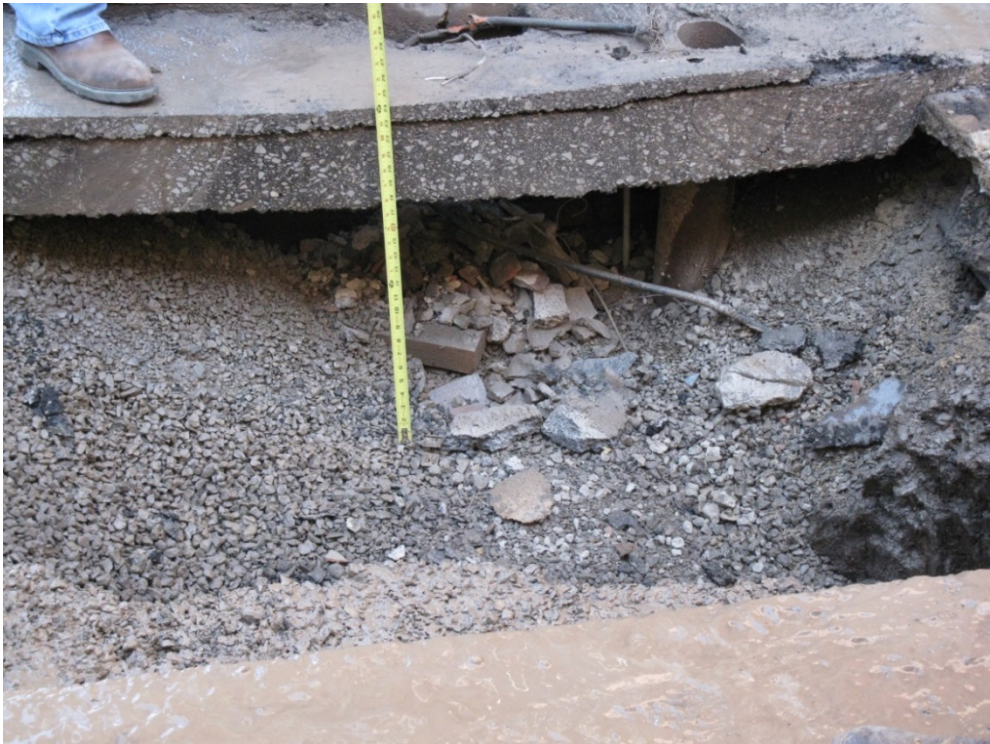
**Photograph #6 – Void Space below the floor slab at the northeast corner of JJ's Restaurant where the slab of pavement shown in Photograph 5 was removed (Staff Photo)**

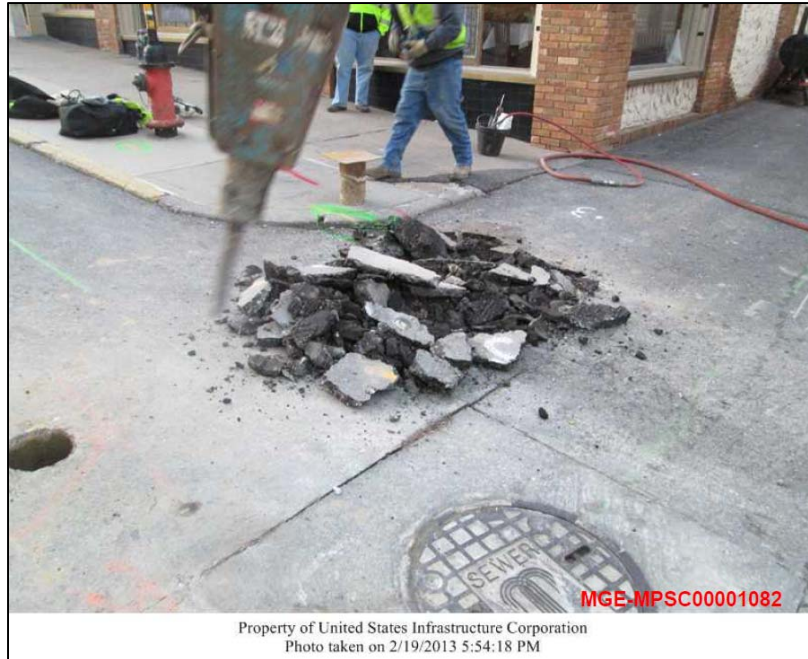
5 According to MGE's Operations and Maintenance plan regarding leak investigations,  
6 Section 3.1.3 states MGE personnel should remove vault, manhole and valve box covers as  
7 appropriate. MGE personnel did not remove the manhole cover located south of the third-party  
8 damage (See Appendix C, Photograph 7) at any point prior to the explosion.

**Photograph #7 – Broken pavement over the damaged main before the explosion across from the southeast corner of JJ's Restaurant. Also note the sanitary sewer manhole cover near the broken pavement. (Provided by MGE)**

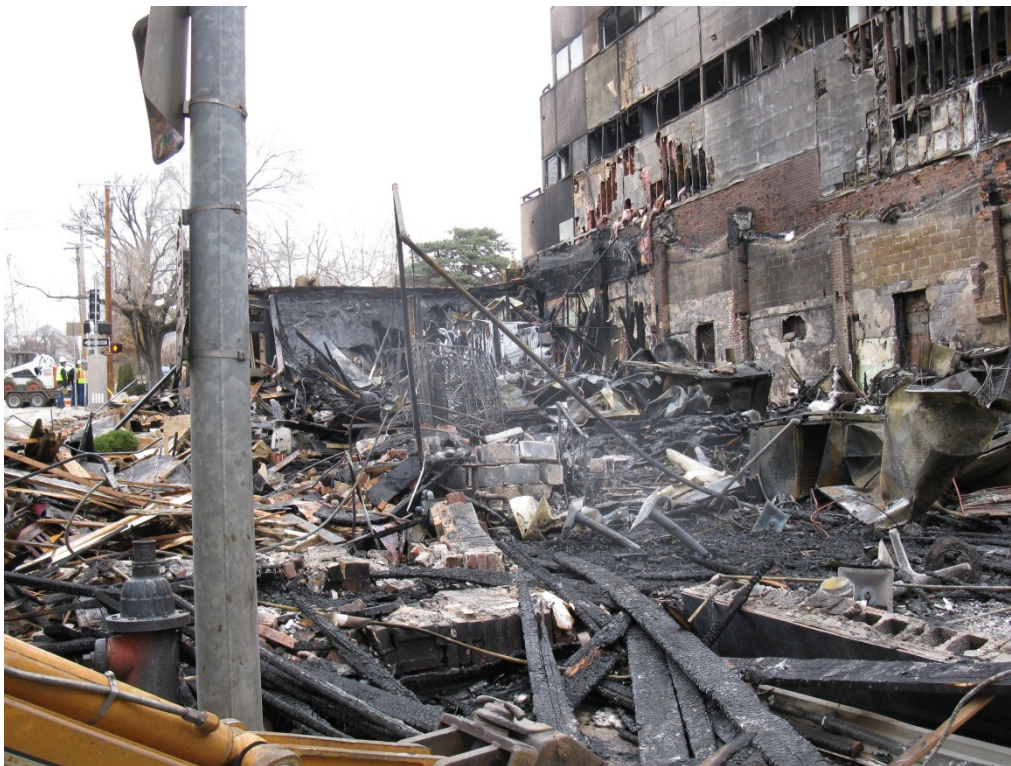
**Photograph #8 – Damage and debris from what remains of JJ's Restaurant facing west (Staff Photo)**

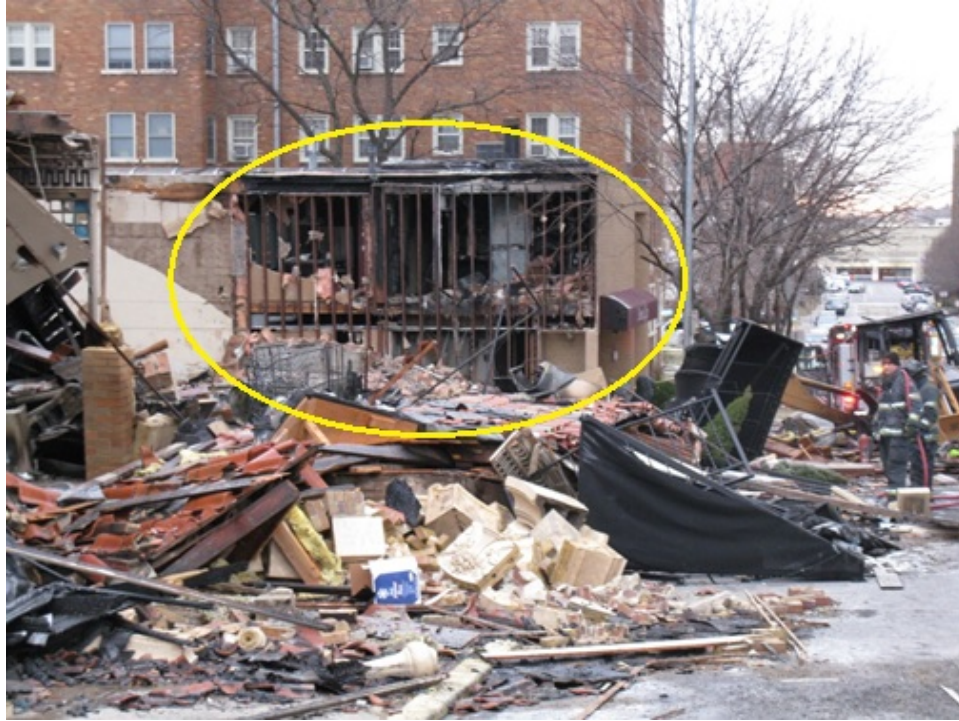
**Photograph #9 – The west side of the House of Elan sustained significant damage during the explosion and subsequent fire. Debris from JJ's Restaurant is shown in the foreground. This Photograph was taken looking east down W. 48<sup>th</sup> Street (Staff Photo).**

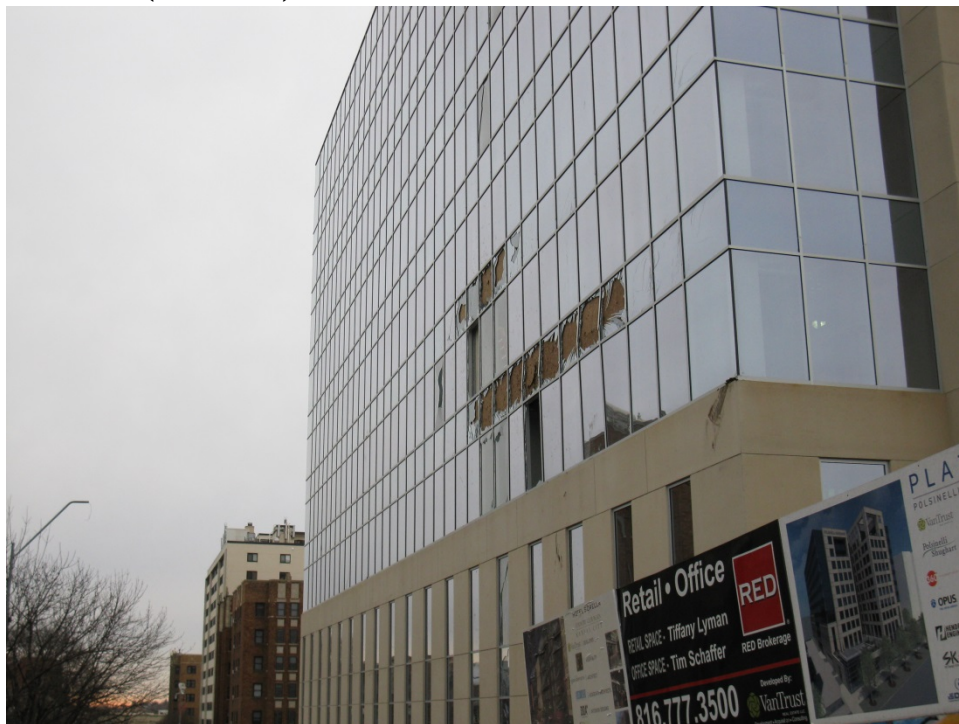
**Photograph #10 – Several windows blown out in the Plaza Vista Building south of JJ's Restaurant (Staff Photo)**

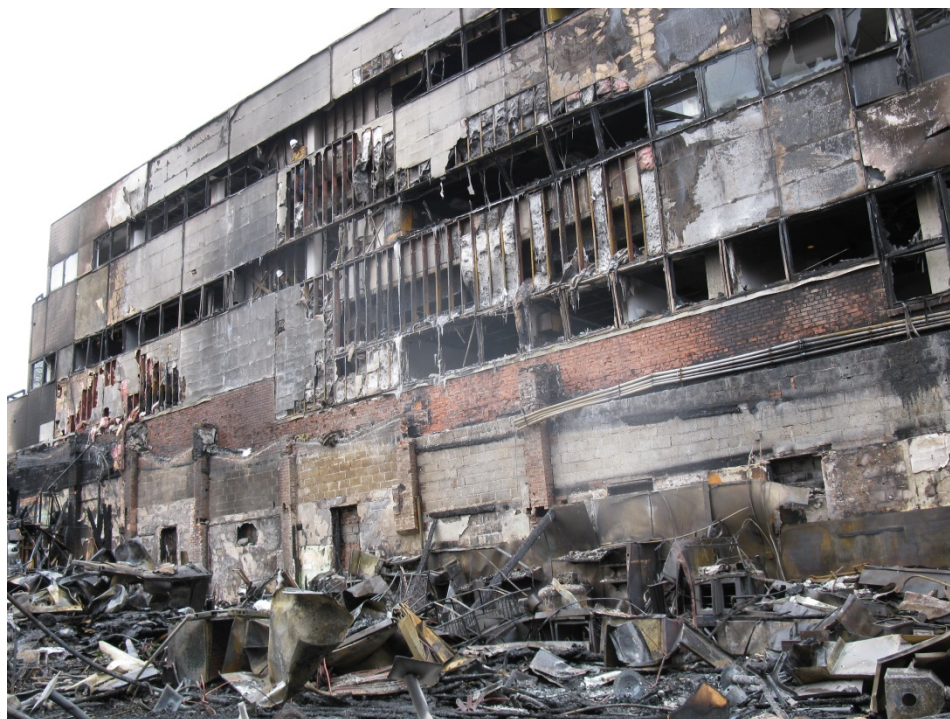
**Photograph #11 – Damage to the south side of the Plazaview Building looking northwest from W. 48<sup>th</sup> Street. Debris from JJ's Restaurant is shown in the foreground. (Staff Photo)**

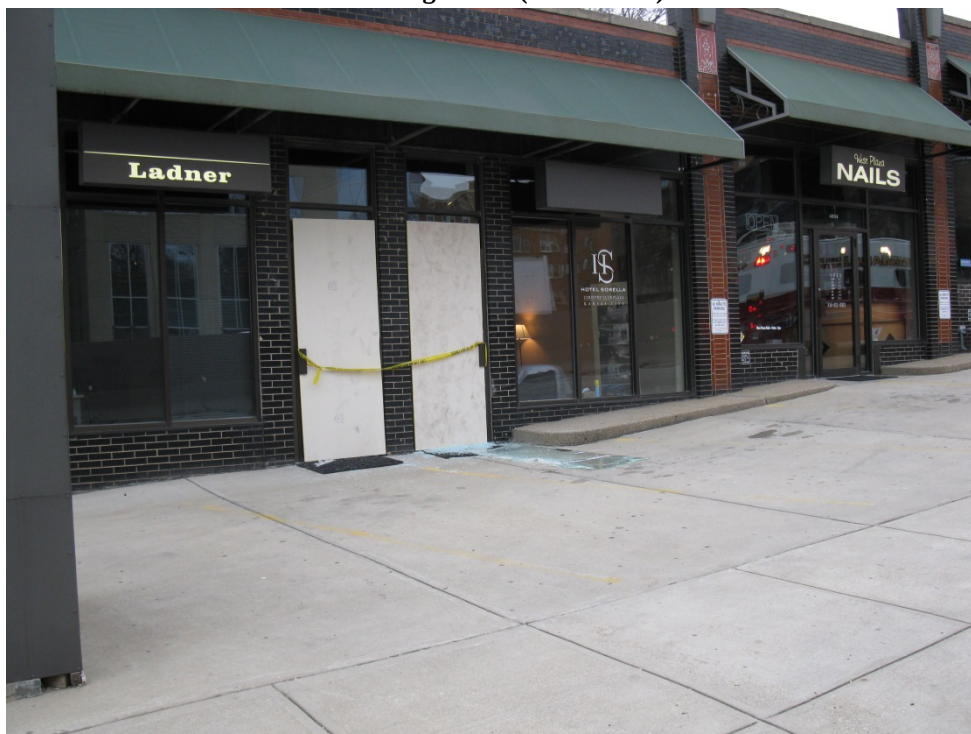
**Photograph #12 – Damage to various businesses in the strip mall located southeast of the intersection of W. 48<sup>th</sup> Street and Bellevue Avenue. (Staff Photo)**

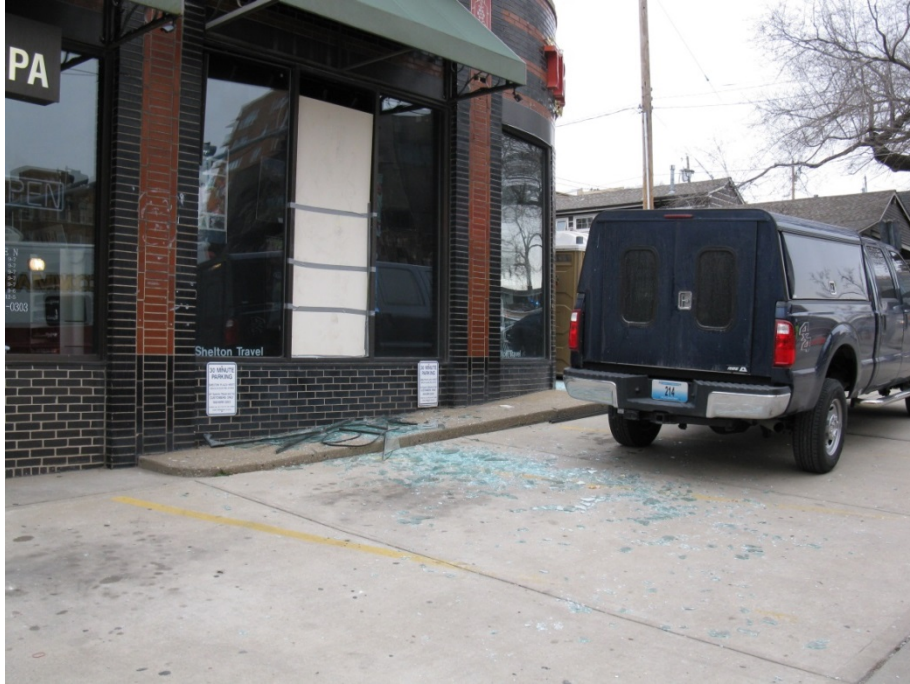
**Photograph #13 – Damage to various businesses in the strip mall located southeast of the intersection of W. 48<sup>th</sup> Street and Bellevue Avenue. (Staff Photo)**

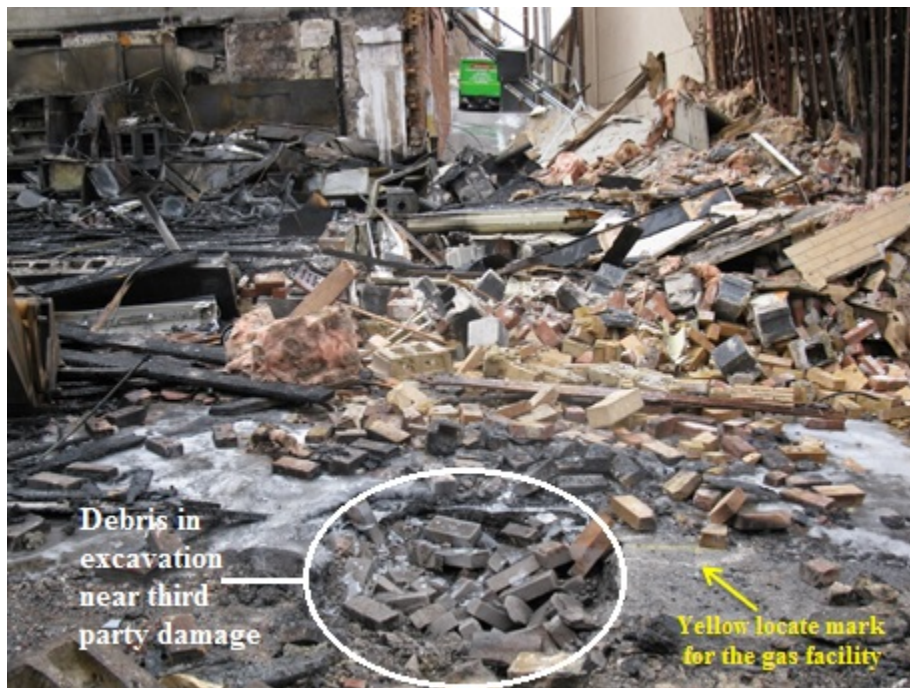
**Photograph #14 – Debris in the alley between JJ's Restaurant and the House of Elan facing north (Staff Photo)**

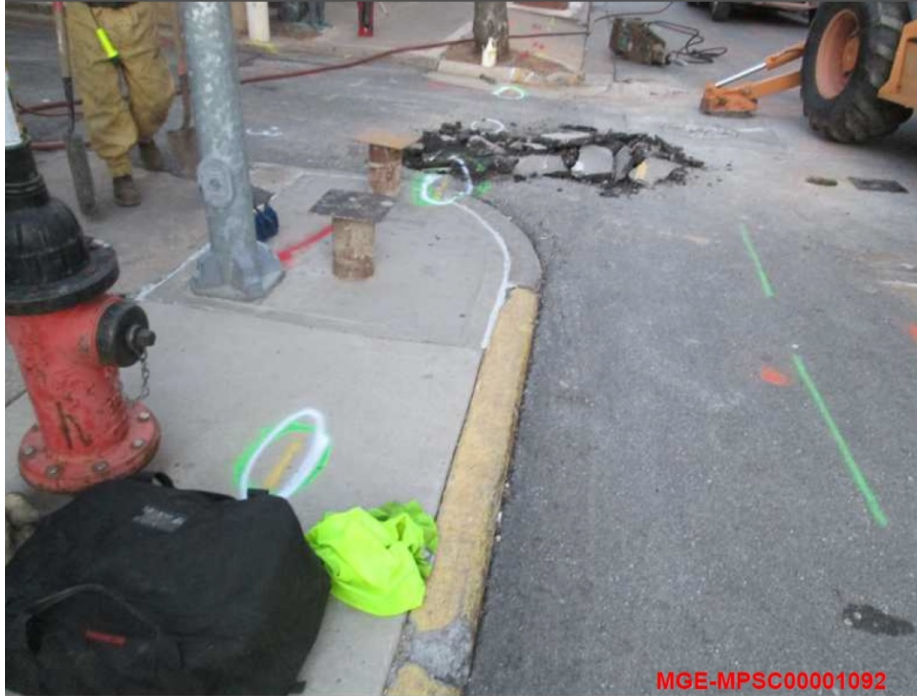
**Photograph #15 – Locate markings near the third-party damage. This Photograph was taken looking east down W. 48<sup>th</sup> Street (Provided by MGE).**

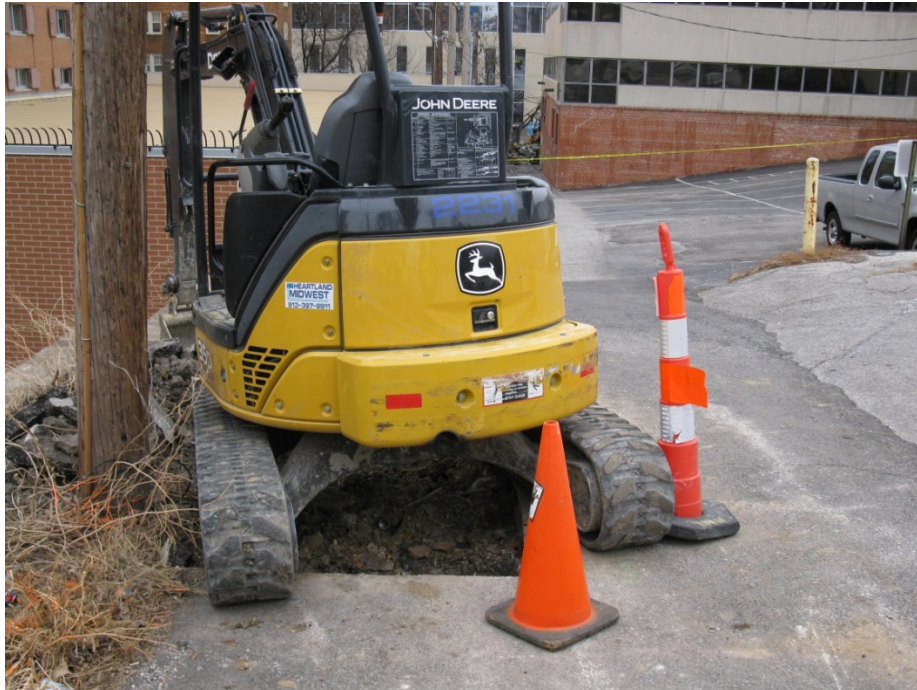
**Photograph #16 – Heartland Midwest’s mini excavator sitting on top of the entrance pit facing south down the alley. The drilling rod is located approximately under the center of the mini excavator. (Staff Photo)**

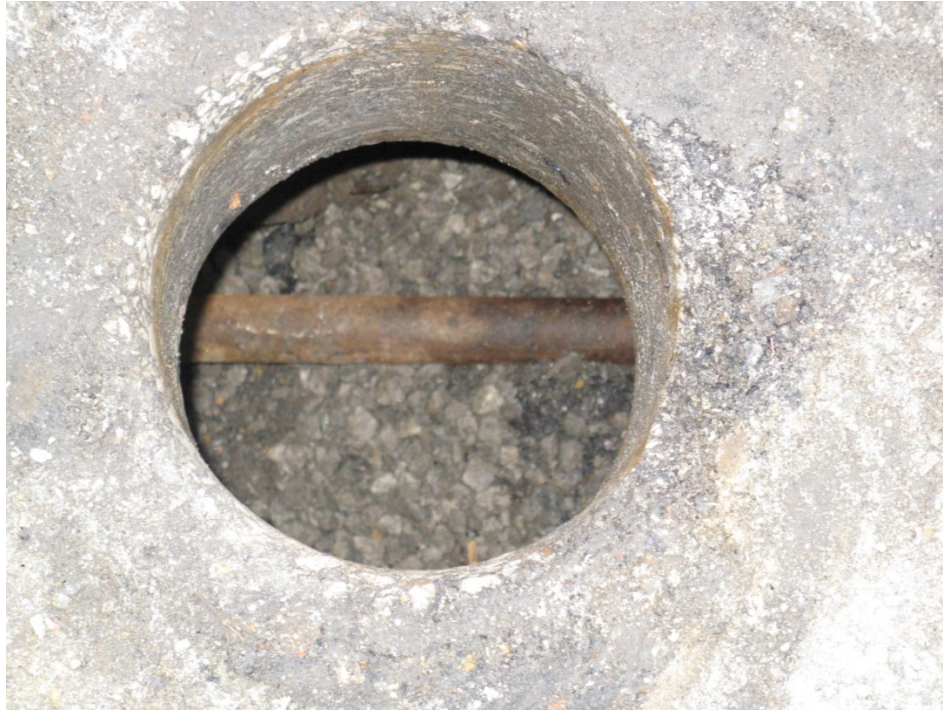
**Photograph #17 – Boring rod seen in one of potholes located near the northeast corner of JJ's Restaurant (Staff Photo).**

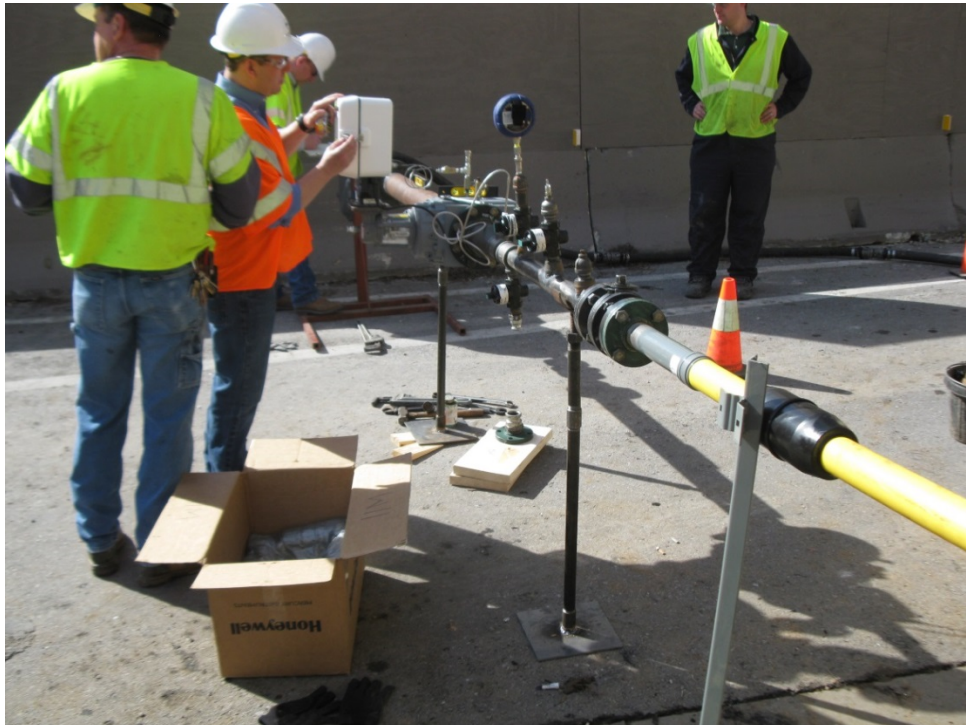
**Photograph #18 – Flow testing of the damaged section of main (Staff Photo)**

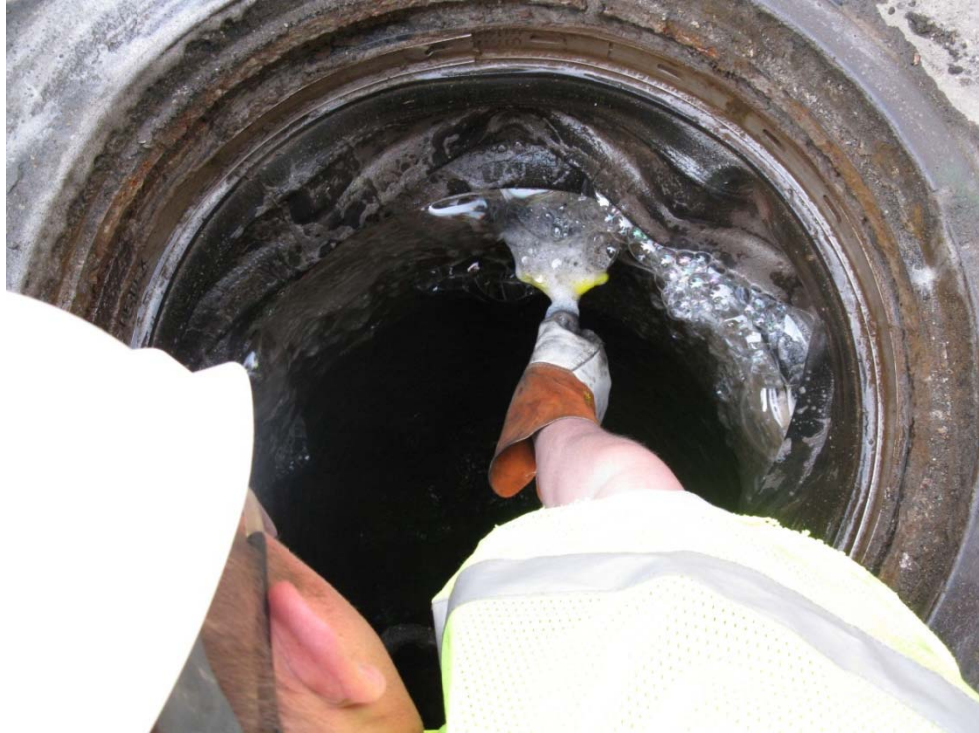
**Photograph #19 – Soap test in the sanitary sewer manhole across from the alley between JJ’s Restaurant and the House of Elan near the third-party damage (Staff Photo)**
