Missouri Public Service Commission

Staff's Gas Incident Report

910 W 48<sup>th</sup> Street  
Kansas City, Missouri  
February 19, 2013

**Missouri Gas Energy**  
**Case No. GS-2013-0400**

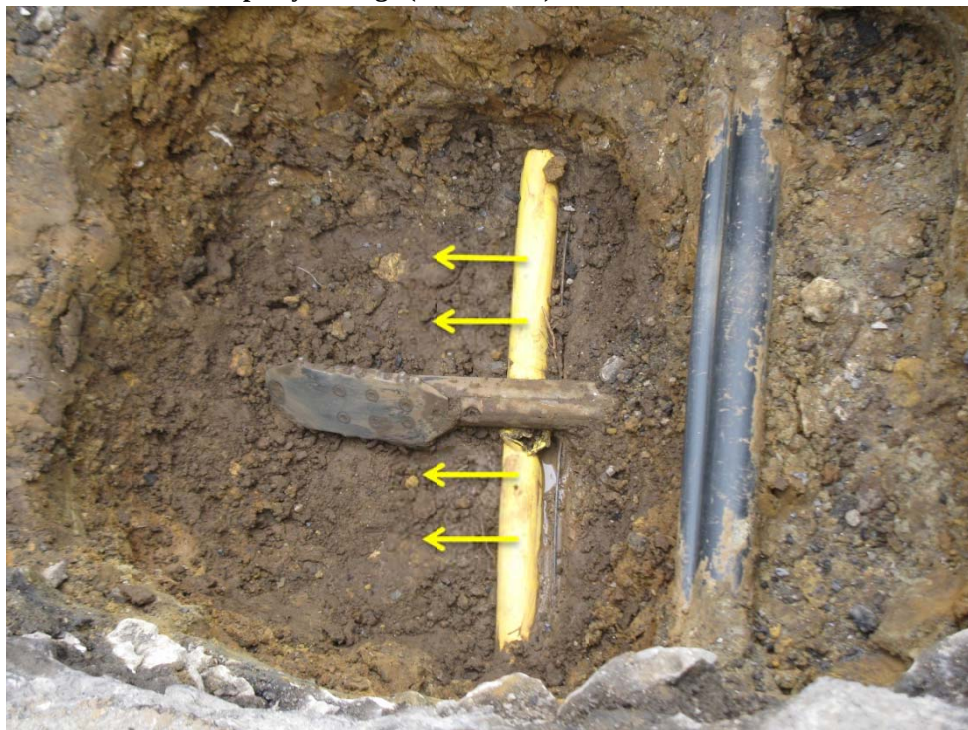
**Photograph #20 – Third-party damage exposed showing the drill bit penetrating through the gas main (yellow) in relation to the electrical conduits (2 black lines). The arrows are pointing to the tracer wire used to identify underground plastic natural gas facilities. (Staff Photo)**

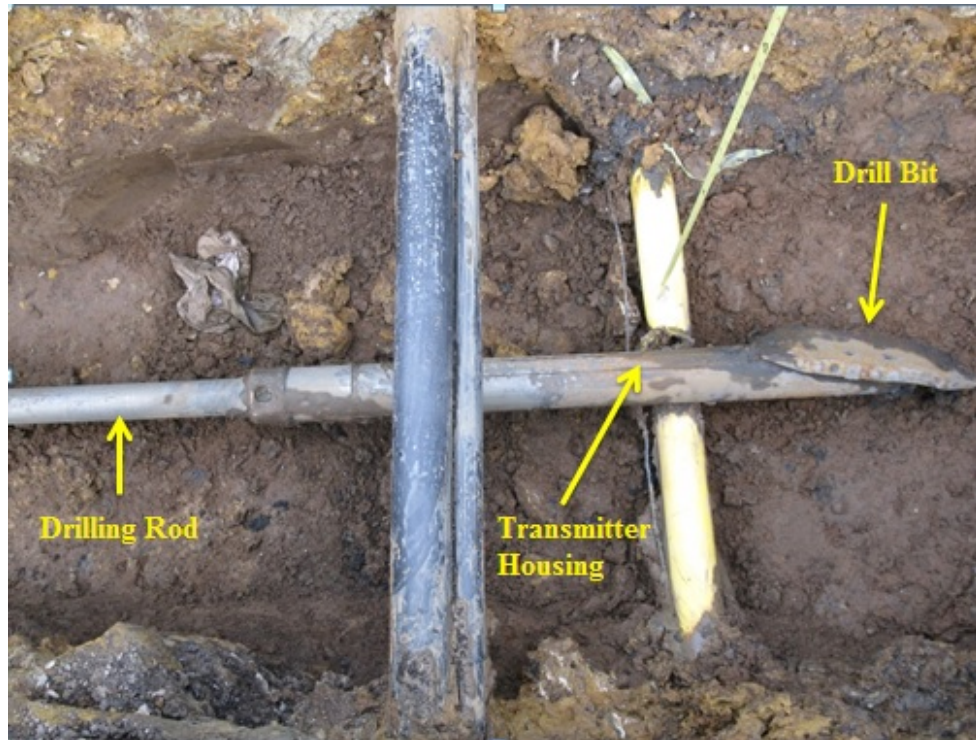
**Photograph #21 – The drill bit (facing south) penetrated through the natural gas main in relation to the two electrical facilities (Staff Photo).**

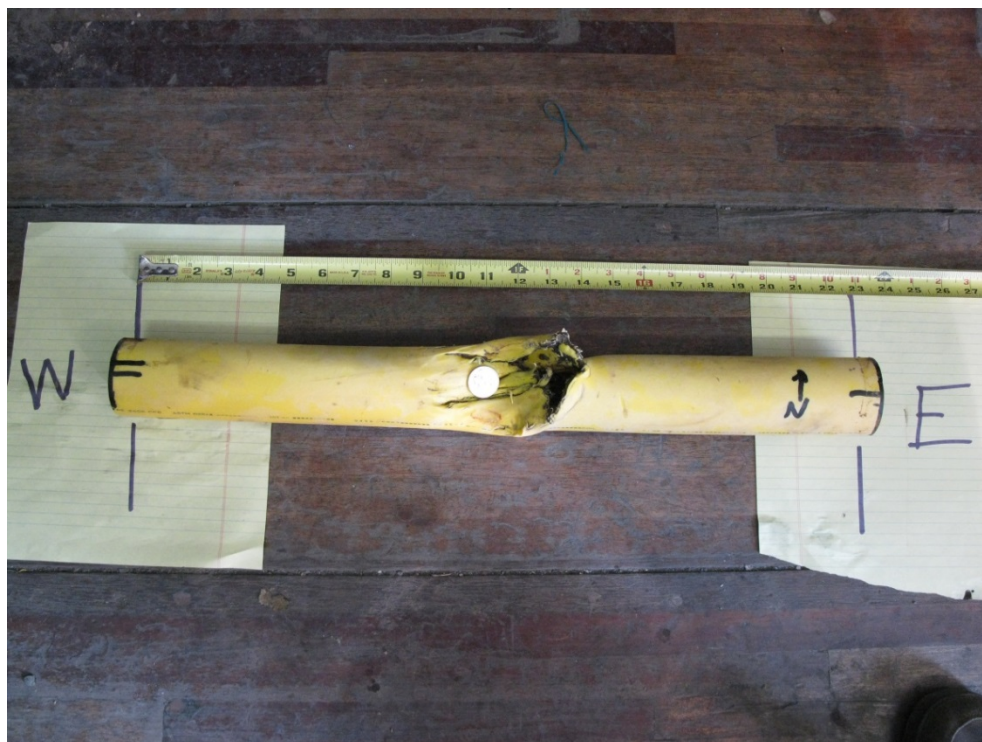
**Photograph #22 – Section of damaged main that was removed. A quarter was placed on the removed section of main as a reference to the size of the damage. (Staff Photo)**

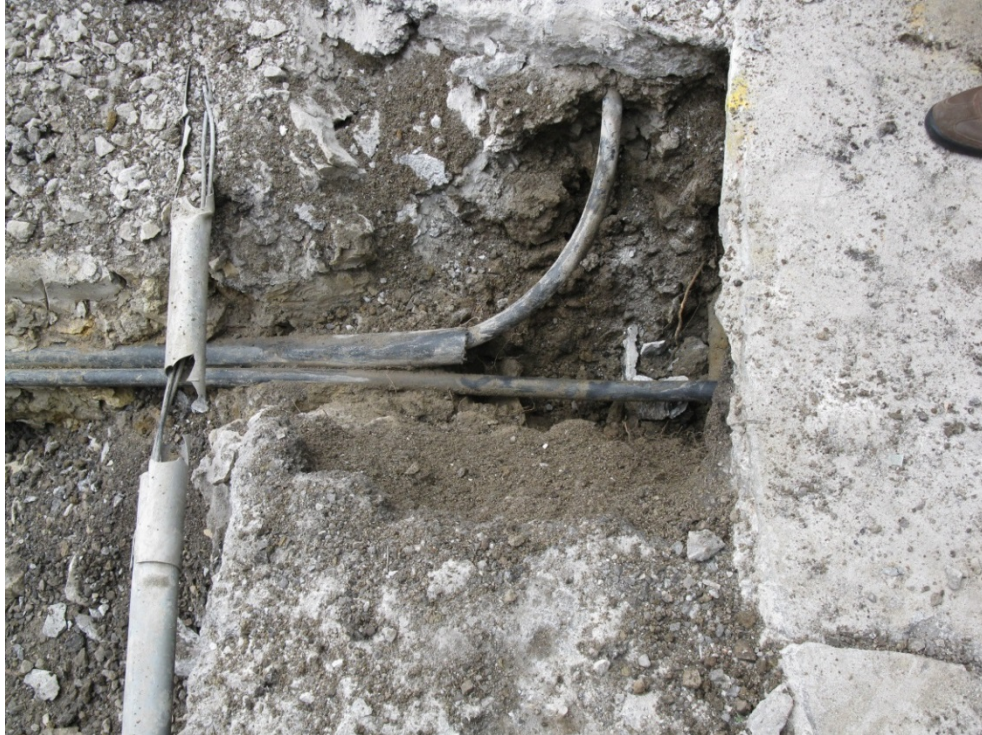
11 Staff observed only one electric line continuing to the east.

**Photograph #23 – One black conduit turning north up the alley from W. 48<sup>th</sup> Street, one black conduit continuing east down W. 48<sup>th</sup> Street, and white conduit running north and south in the alley (Staff Photo)**

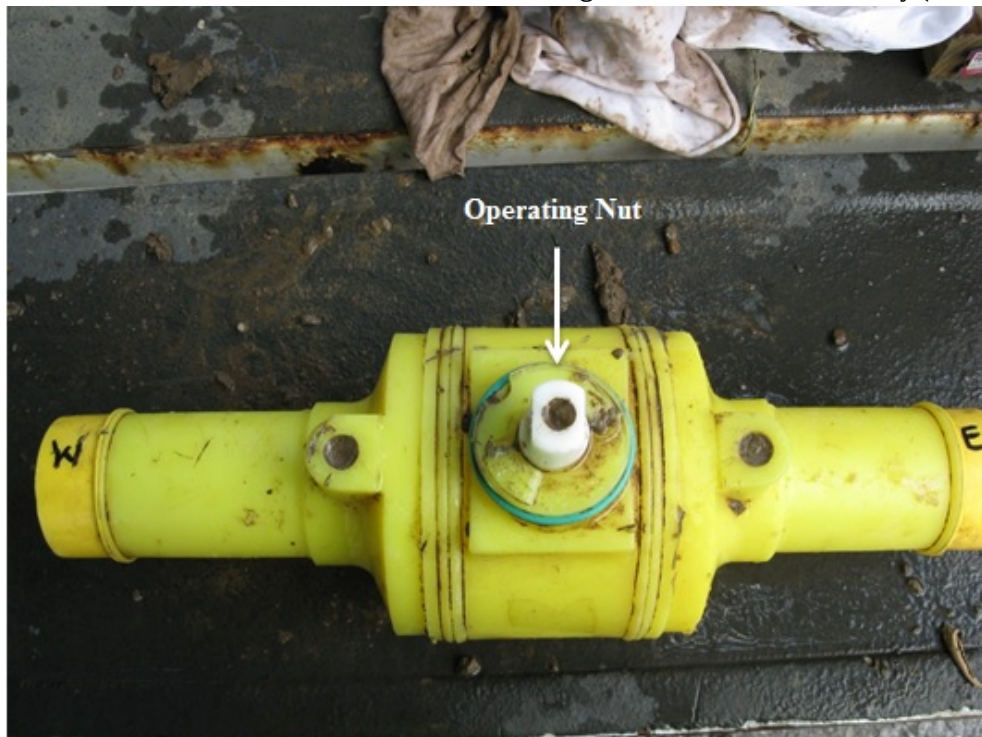
**Photograph #24 – 2-inch ball valve removed from service at W. 48<sup>th</sup> Street and Roanoke Parkway. The valve is in the closed position. (Staff Photo)**

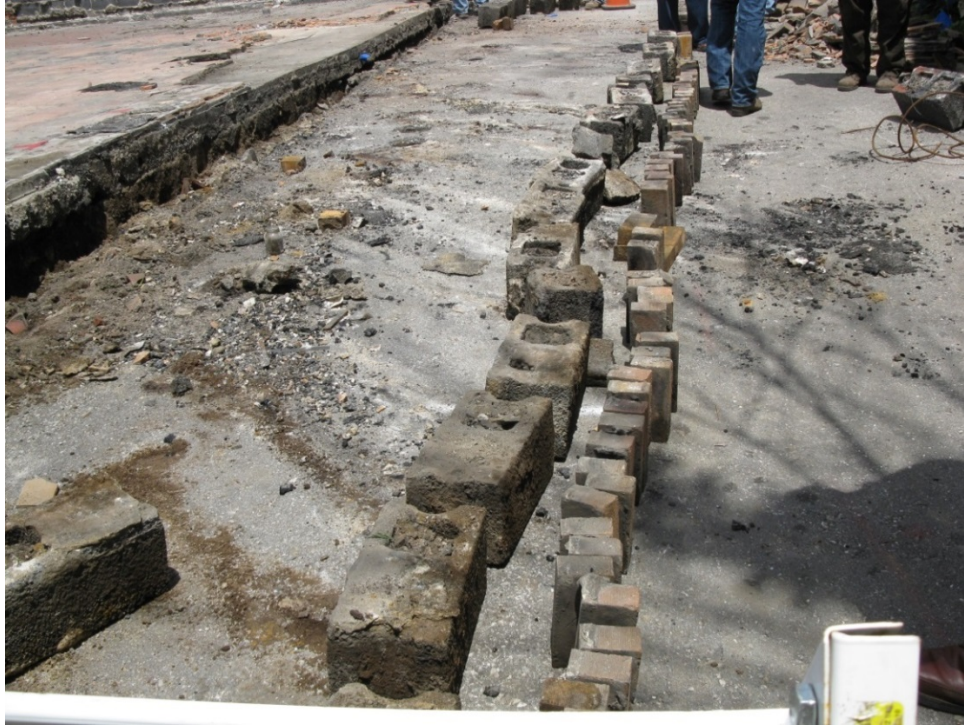
**Photograph #25 – Cinder blocks and bricks removed from the east wall of JJ's Restaurant to expose void spaces beneath the floor slab. (Staff Photo)**

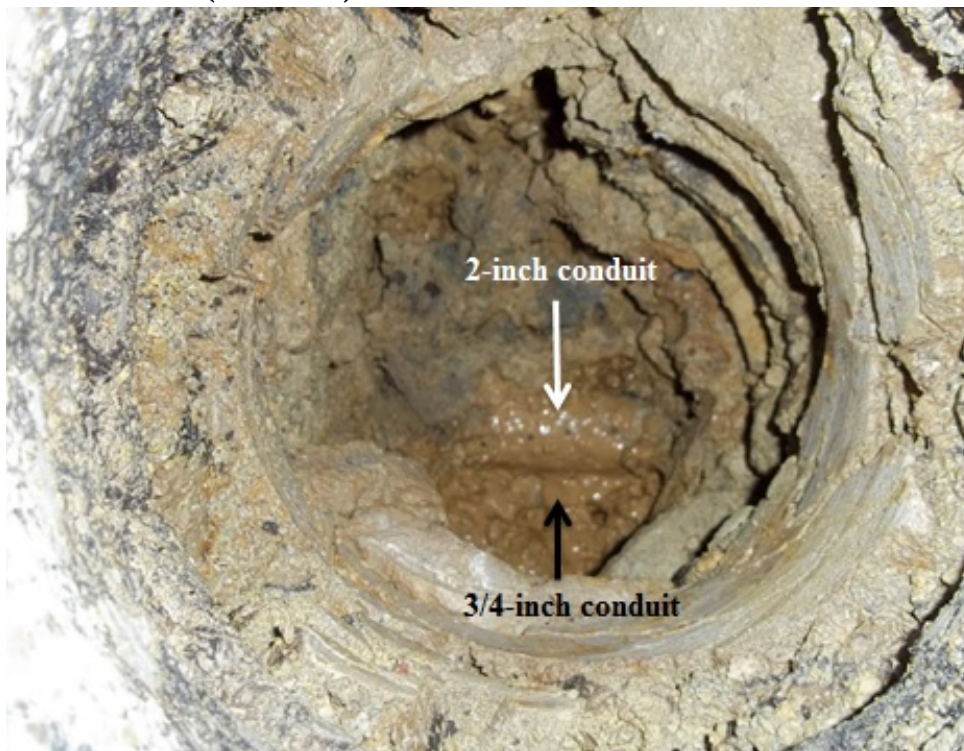
**Photograph #26 – Two facilities seen looking down into pothole #6 (Provided by MGE).**
