Appendix C: Photographs

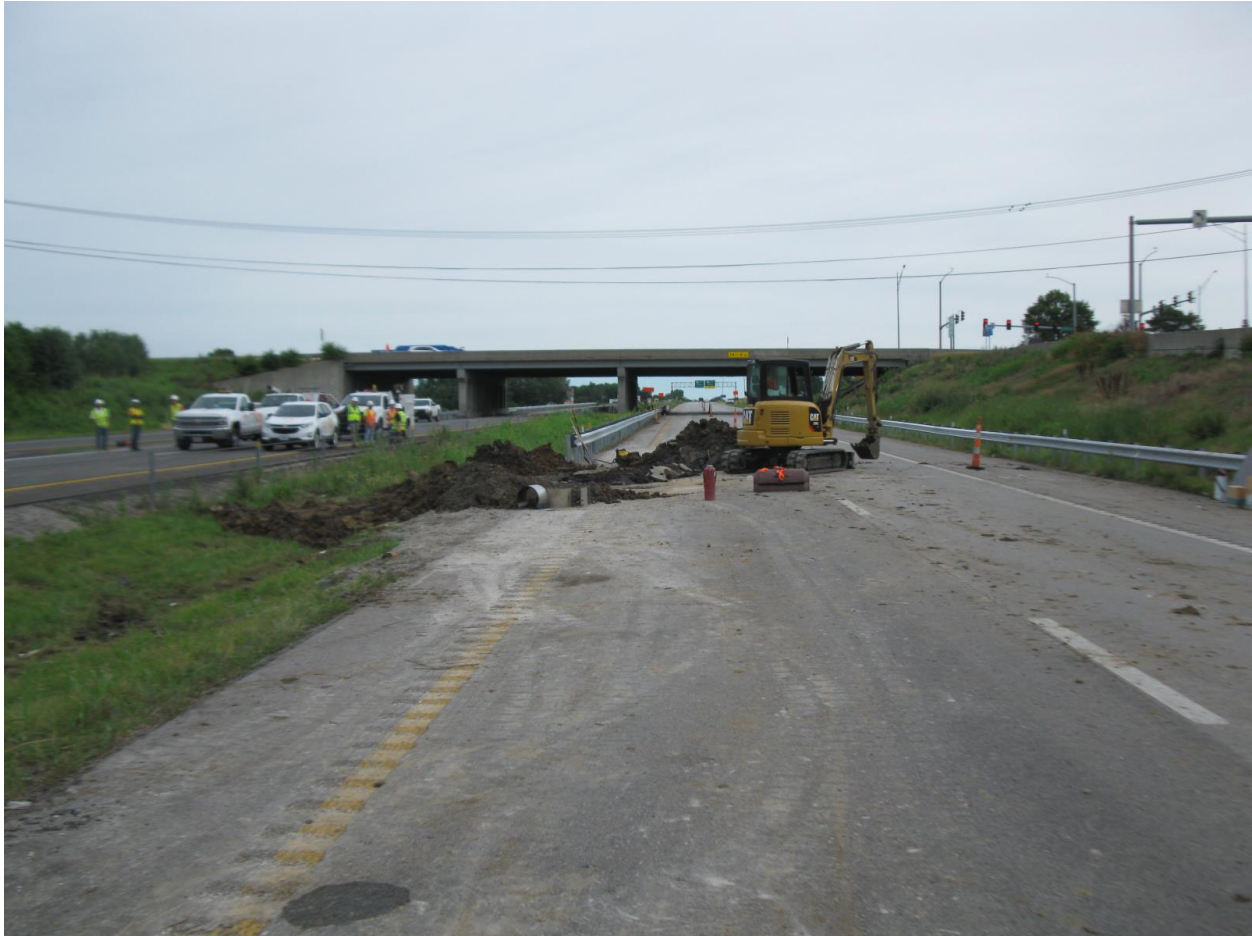
Photograph 1: Photograph looking north along the northbound lanes of U.S. Route 169 toward Northwest Barry Road overpass. The excavation in the median contains the damaged pipeline. (Source: Staff)

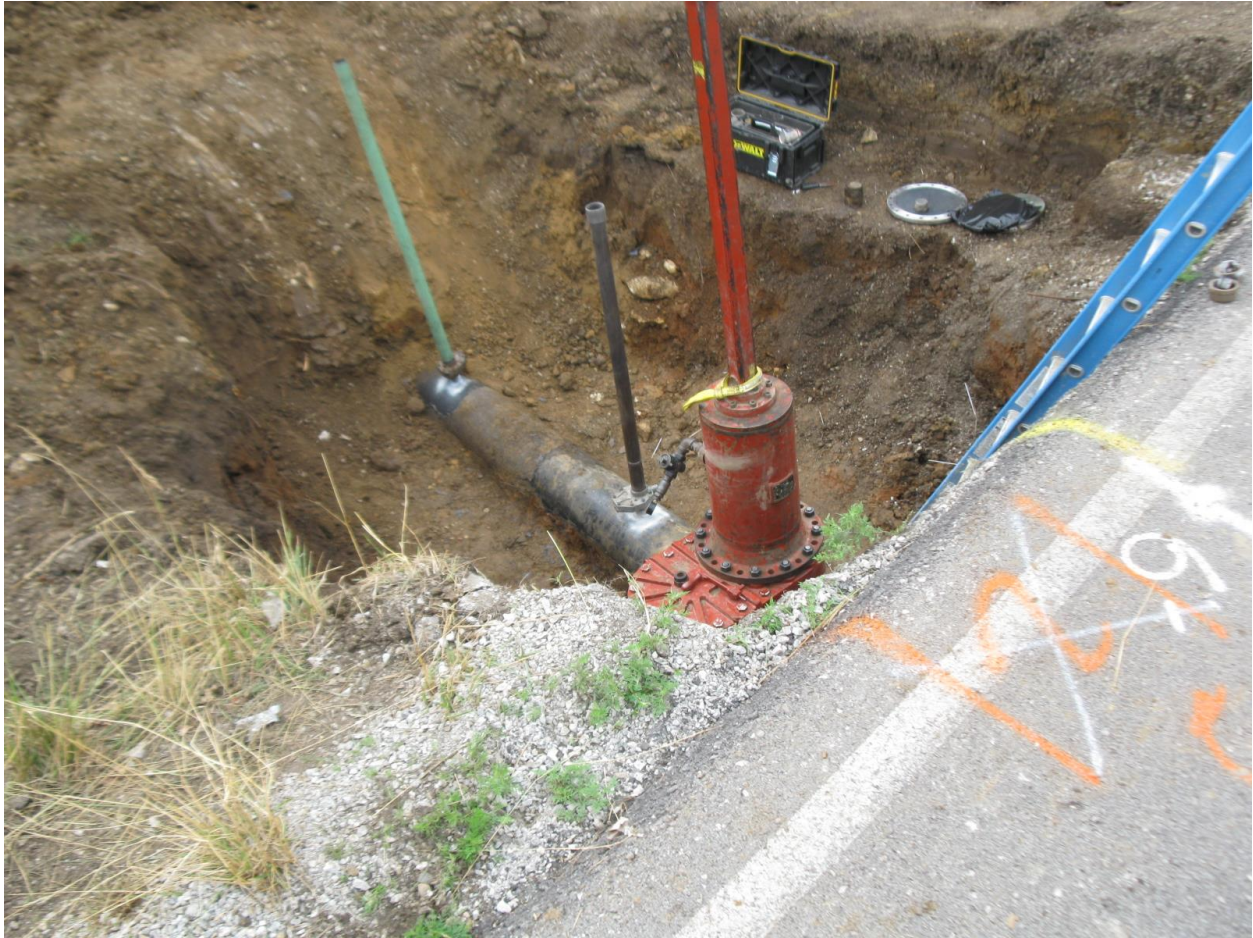
Photograph 2: Photograph of tapping and line stop fitting affixed to the pipeline on the west side of U.S. Route 169. (Source: Staff)

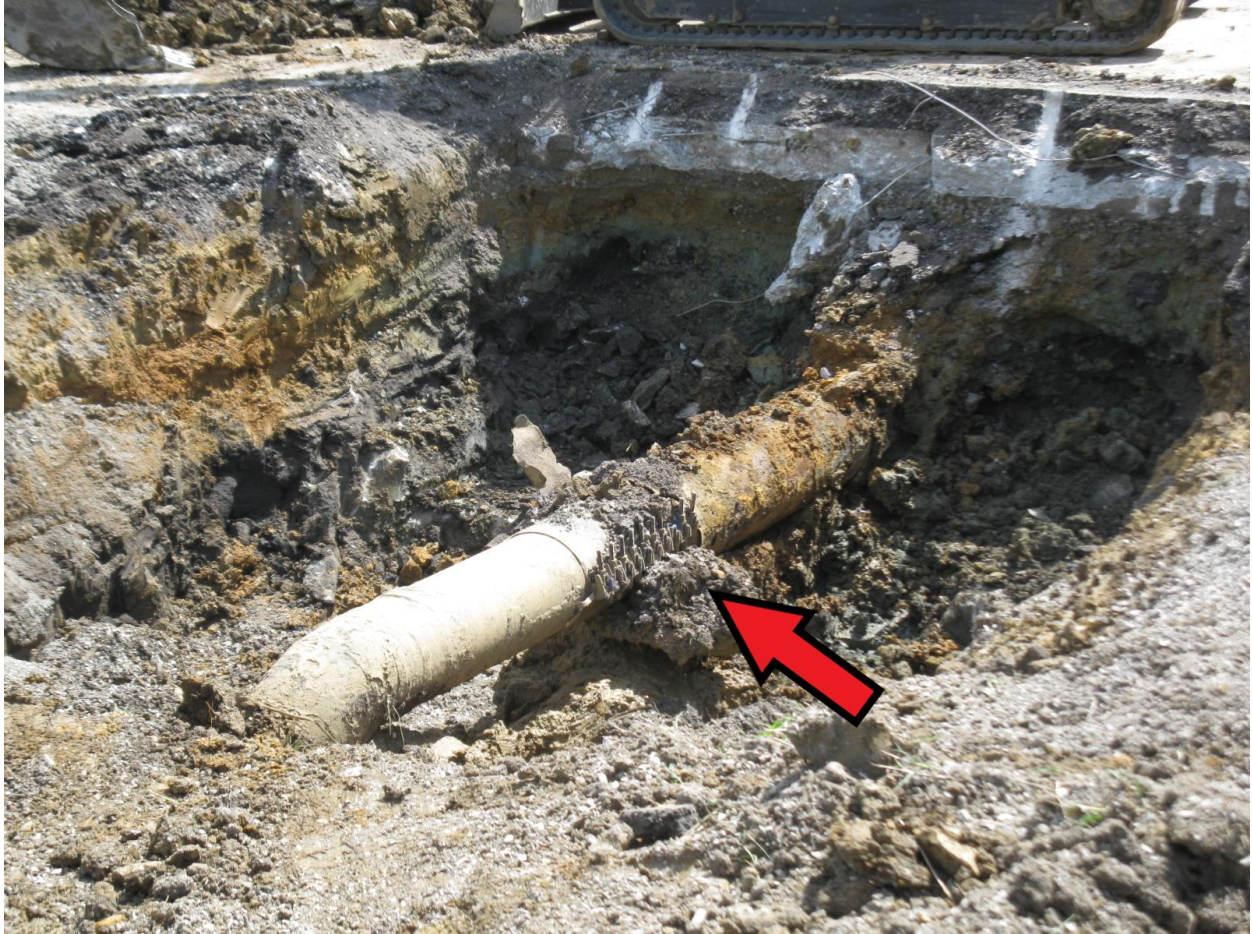
Photograph 3: Photograph of the damaged section of pipeline looking northeast. The red arrow (added by Staff) points to a repair clamp surrounding the damaged portion of the pipeline. (Source: Staff)

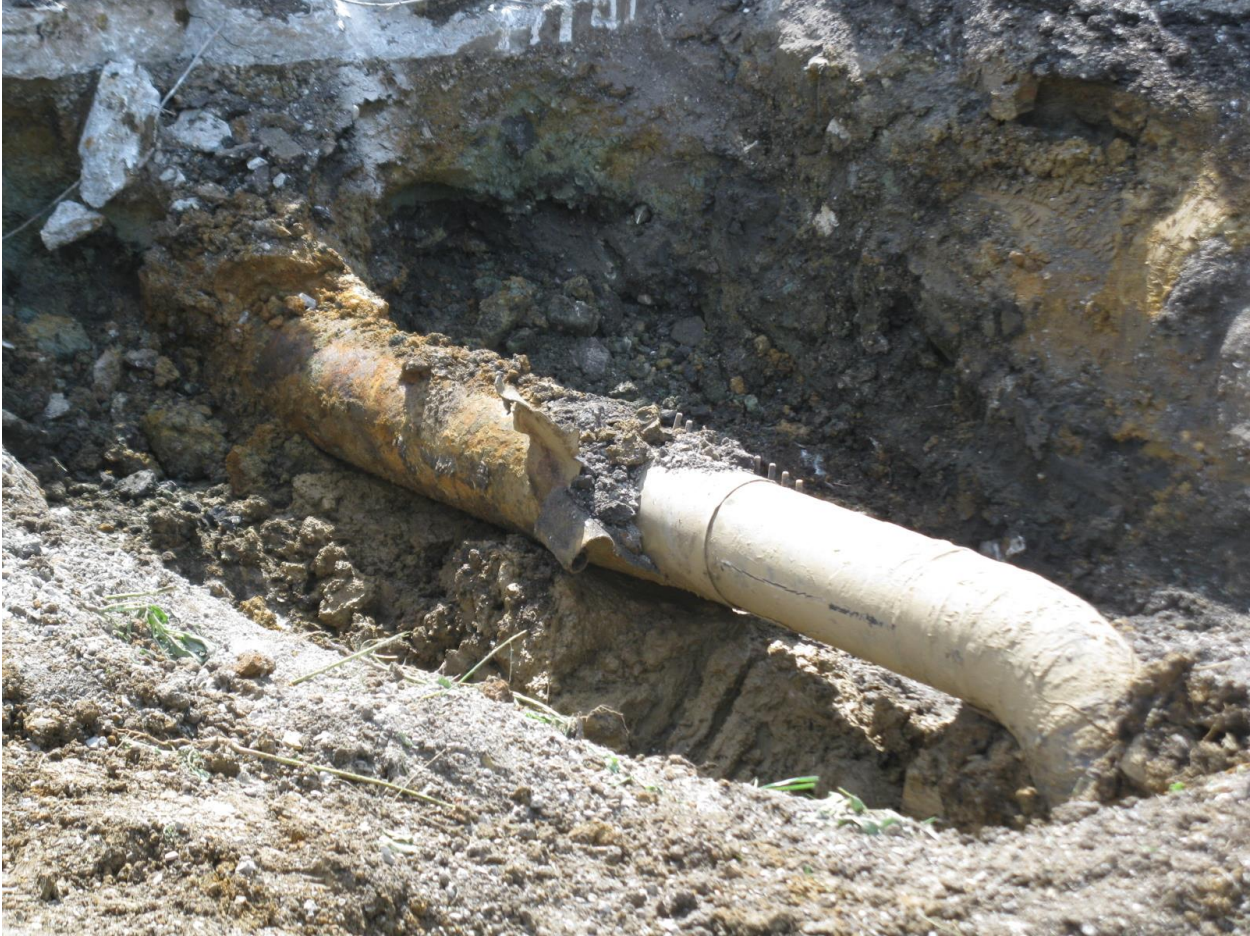
Photograph 4: Photograph of the damaged portion of the pipeline looking southeast. A repair clamp is surrounding the damaged portion of the pipeline. (Source: Staff)

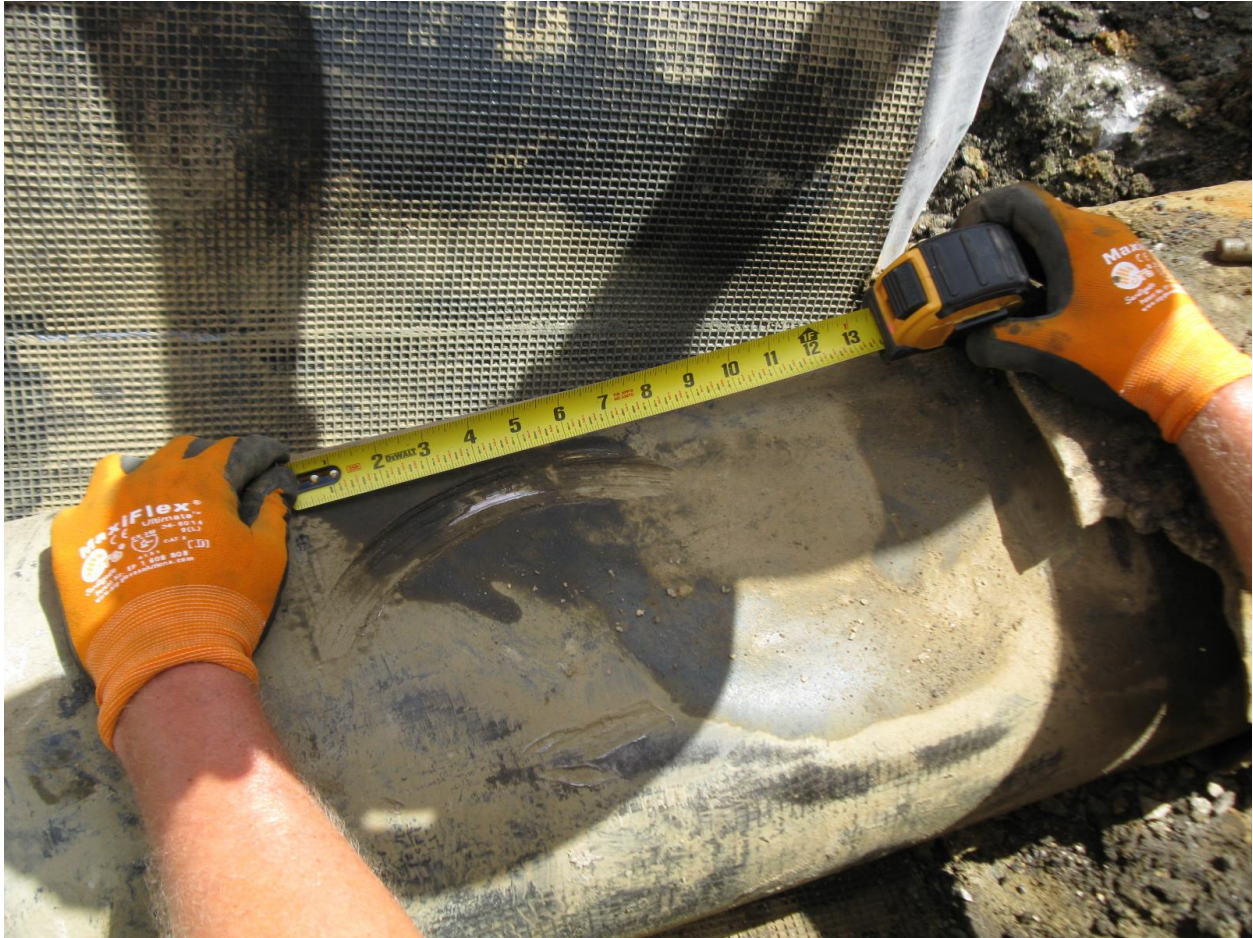
Photograph 5: Photograph of the damage to the pipeline. (Source: Staff)

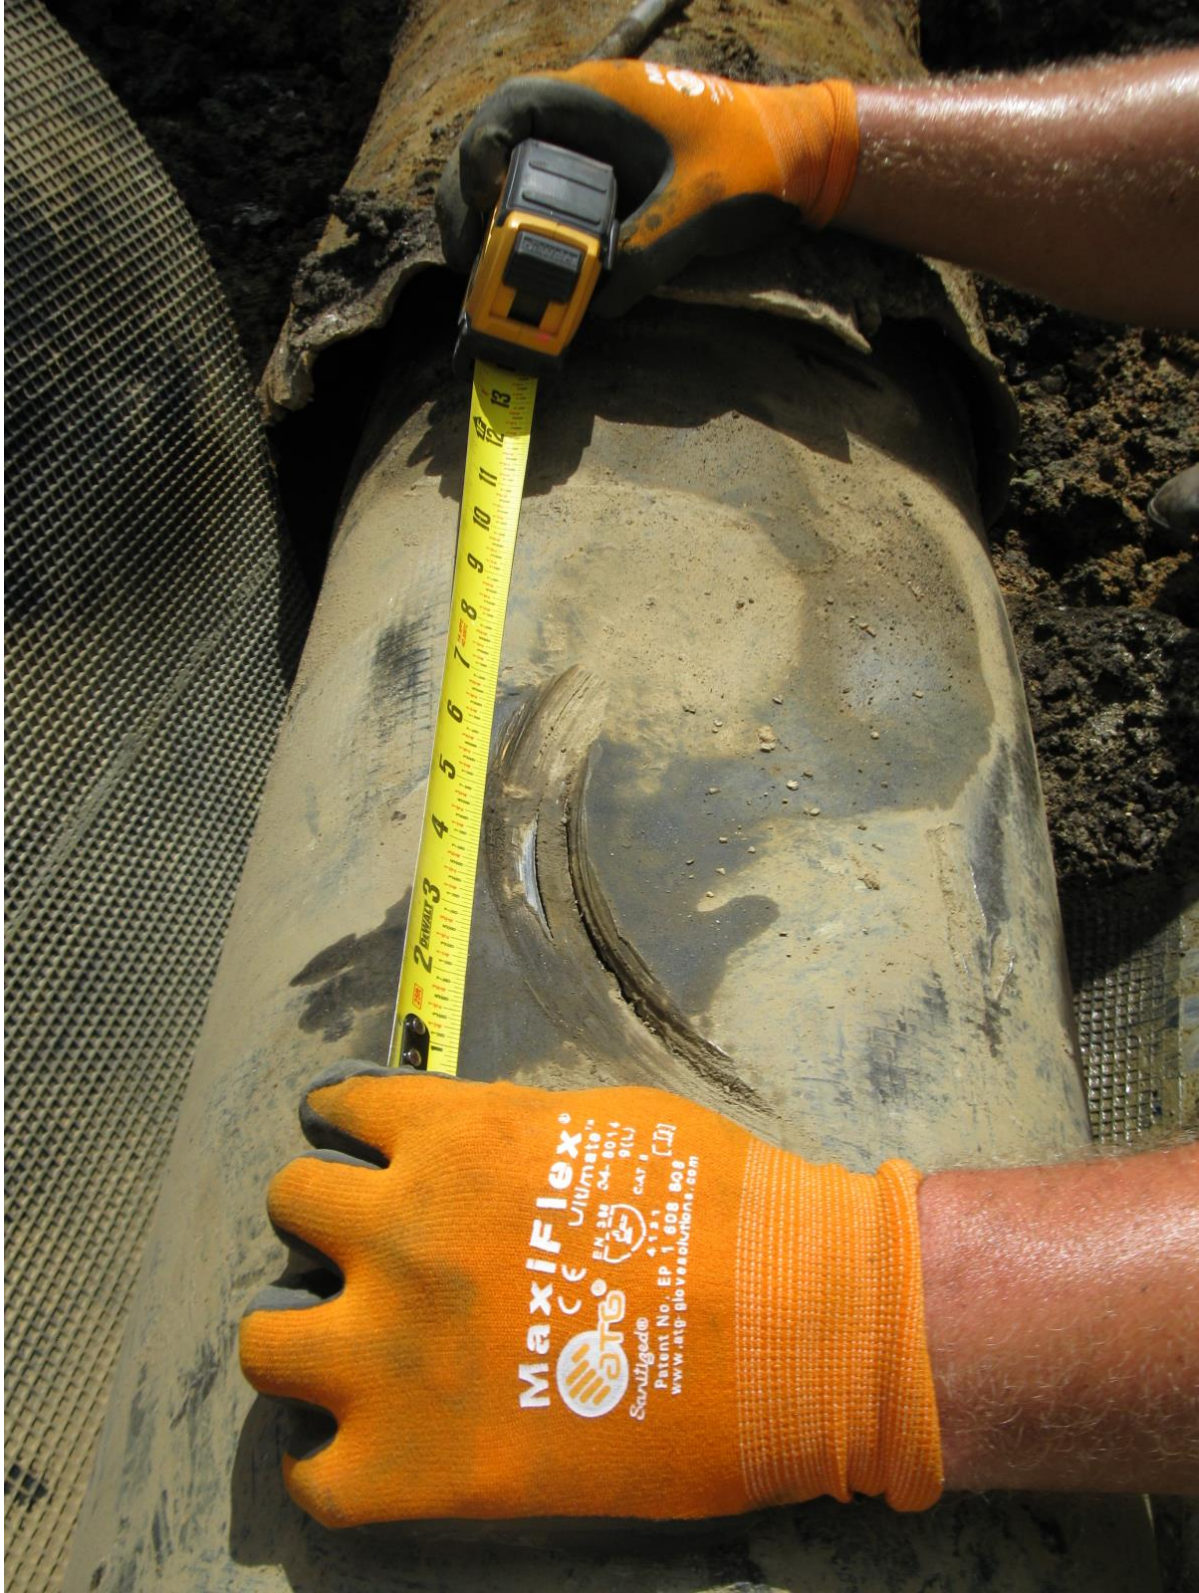
Photograph 6: Photograph of the damage to the pipeline. (Source: Staff)
