# **Missouri Public Service Commission**

# **Staff's Investigation Report**

In the Matter of an Investigation into Spire Missouri Inc., d/b/a Spire's Compliance with The Commission's Rules Regarding Natural Gas Safety Found at 20 CSR 4240-40.030

Case No. GS-2022-0047

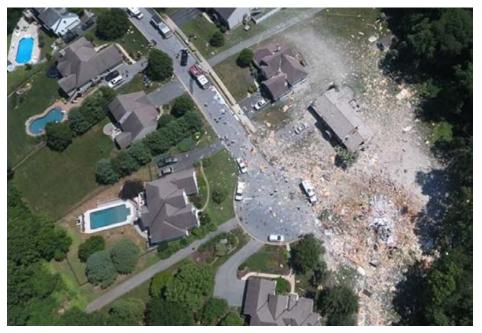
On July 2, 2017, at 12:32 p.m. eastern daylight time, a natural gas-fueled explosion occurred at a single-family residence at 206 Springdale Lane, Millersville, Pennsylvania.<sup>1</sup> The explosion killed one person and injured three others, destroyed the residence and significantly damaged six neighboring homes, one of which was subsequently condemned.<sup>2</sup> (See figure 1.)

Figure 1. Debris field at cul-de-sac area where explosion occurred.

The National Transportation Safety Board determines that the probable cause of the natural gas explosion at 206 Springdale Lane was an improperly installed mechanical tapping tee that leaked and allowed gas to migrate into the house where it ignited.

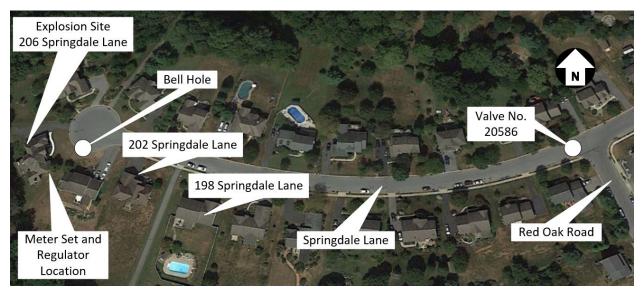
After assembling a response crew, the senior supervisor traveled to the scene. The senior supervisor told National Transportation Safety Board (NTSB) investigators that prior to arriving on-scene he reviewed the location of the closest shutoff valve to the site. On his way to the shutoff valve, he contacted the UGI engineer and informed her that he expected to shut down a main line. As the duty supervisor, the senior supervisor could exercise judgement to determine whether it was appropriate to either squeeze off the line or close a gas valve.<sup>8</sup> After the discussion with other responding UGI employees, the senior supervisor decided to squeeze off the main line rather than closing the mainline valve, because he thought this action was the fastest way of stopping the flow of gas. Figure 2 shows the location of the valve.

Figure 2. Location of gas shut-off valve in relation to accident site.

The senior supervisor told NTSB investigators that the following factors influenced his decision to squeeze off the main: he considered that given the circumstances surrounding the leak, even if the valve were turned off, the gas would continue to flow to the leak until the system lost pressure; and the line could be quickly and successfully excavated and squeezed, as compared to the time necessary to reach the valve.
