STAFF'S GAS INCIDENT REPORT

**Glen Elm Drive
Glendale, MO
January 3, 2025**

APPENDIX A

**Spire Missouri, Inc.
Case No. GS-2025-0209**

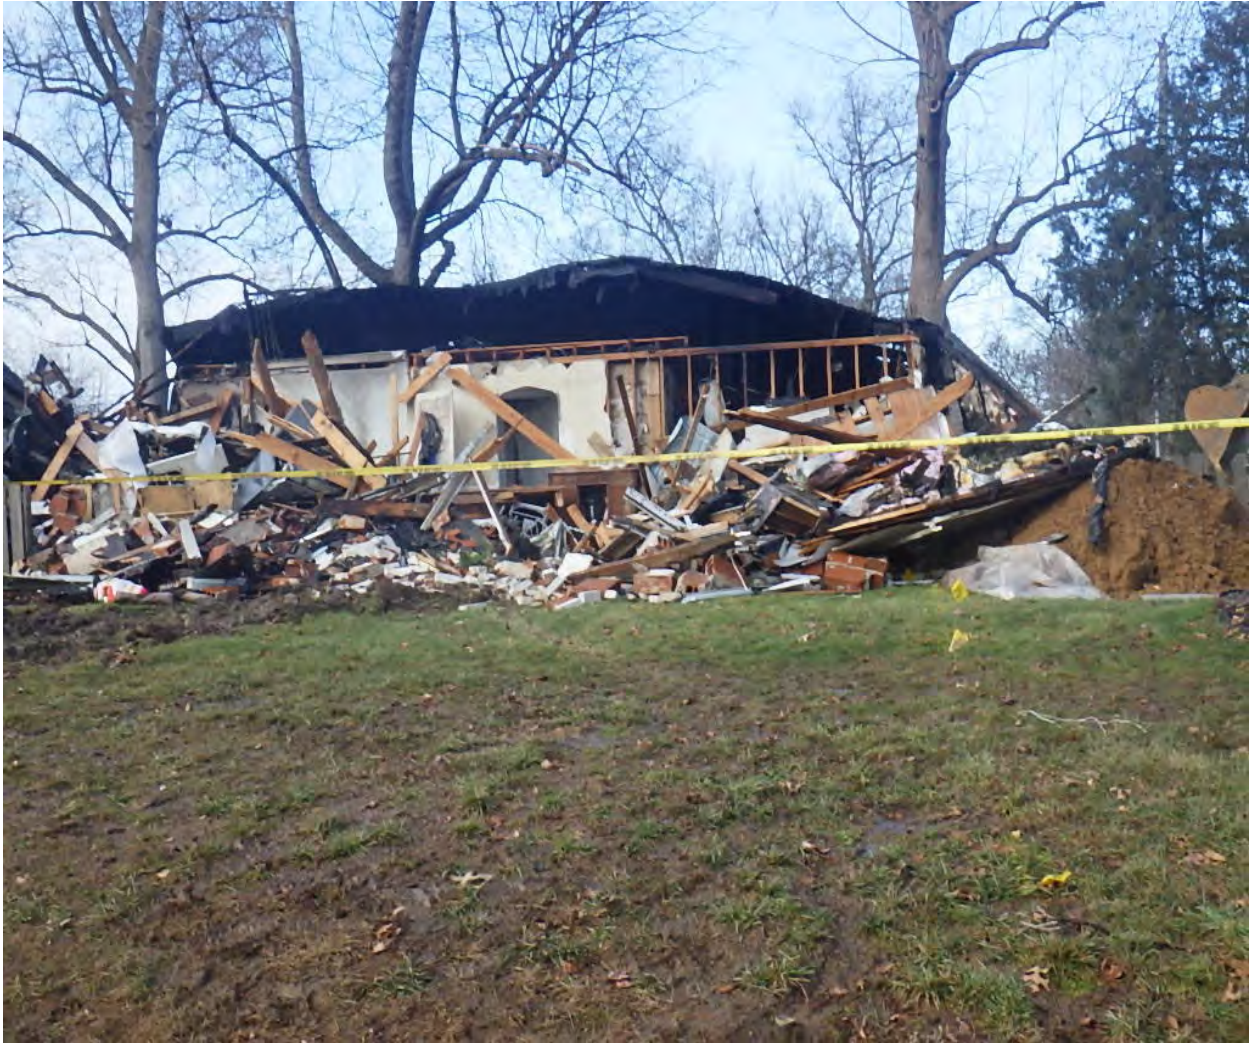
Damages			
Product/Gas Loss or Spill ⁽²⁾ 8.83 mcf Amount Recovered: 0 Estimated Amount \$47.00	Estimated Property Damage \$404,555.00 Associated Damages ⁽³⁾ \$ 404,602.00		
Description of Property Damage: Major portions of exterior walls of the residence at 895 Glen Elm Drive were blown out. It was determined to be a total loss, and was subsequently demolished. Gas service was also temporarily interrupted at 1230 N. Sappington Rd for odor level testing.			
Customers out of Service: <input checked="" type="checkbox"/> Yes <input type="checkbox"/> No Number: 2			
Suppliers out of Service: <input type="checkbox"/> Yes <input checked="" type="checkbox"/> No Number:

Figure 1 - Front of 895 Glen Elm Drive Following the Explosion.

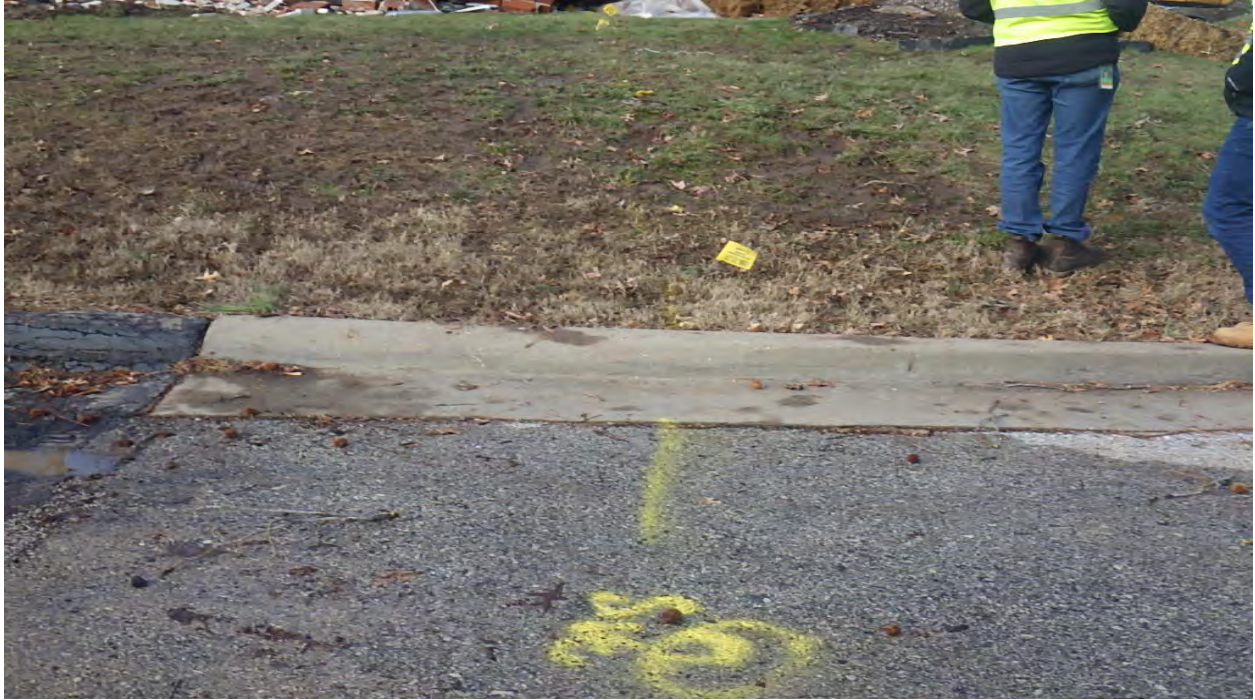
The apparent cause of the incident was ignition of gas that was released due to excavation damage to an unmarked natural gas service line. The apparent cause of the excavation damage was failure to correctly mark the location of the natural gas service line.

<i>Outside Force Damage</i>		___ N/A
Was Location Marked According to Procedures? ___ Yes <input checked="" type="checkbox"/> No		
Pipeline Marking Type: (1) Paint and flags	Location: (1) See pictures USIC service markings 1/3/2025 – the marks were placed from residence south to Glen Elm Dr., as opposed the actual location of the service line that ran from N. Sappington Rd. to the residence from the east.	
State Law Damage Prevention Program Followed? <input checked="" type="checkbox"/> Yes ___ No ___ No State Law		
Notice Required: <input checked="" type="checkbox"/> Yes ___ No	Response Required: <input checked="" type="checkbox"/> Yes ___ No	
Was Operator Member of State One Call? <input checked="" type="checkbox"/> Yes ___ No	Was Operator on Site? ___ Yes <input checked="" type="checkbox"/> No	
Did a deficiency in the Public Awareness Program contribute to the accident? ___ Yes <input checked="" type="checkbox"/> No

Figure 2 – USIC Natural Gas Locate Made Prior to Incident.

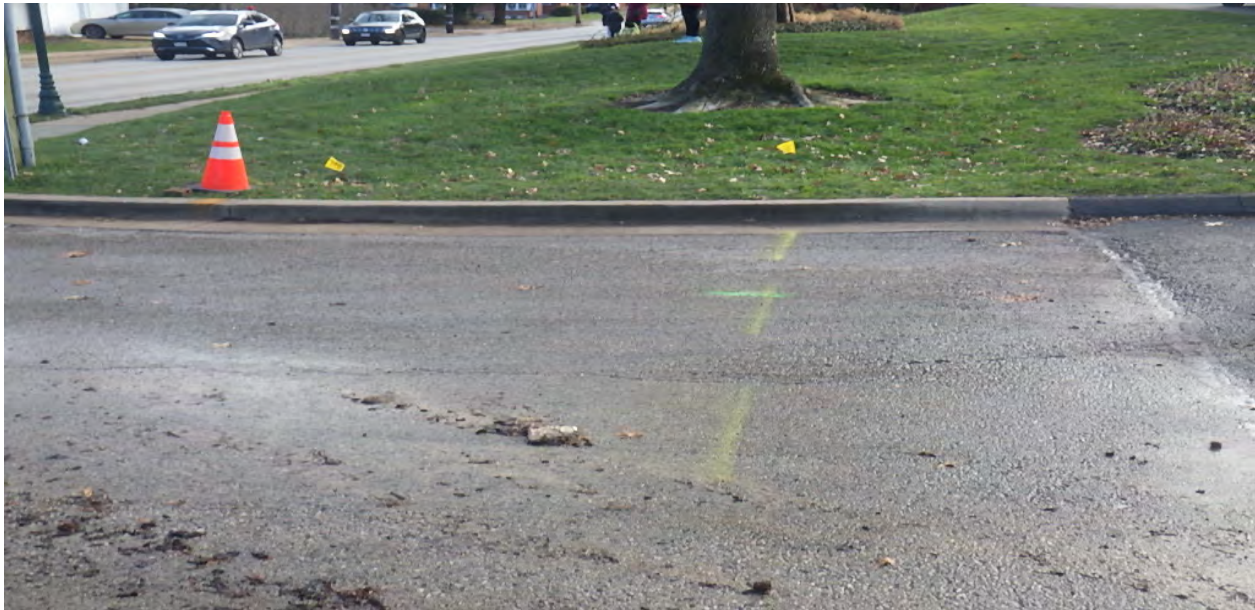
Figure 3 – USIC Natural gas service locate

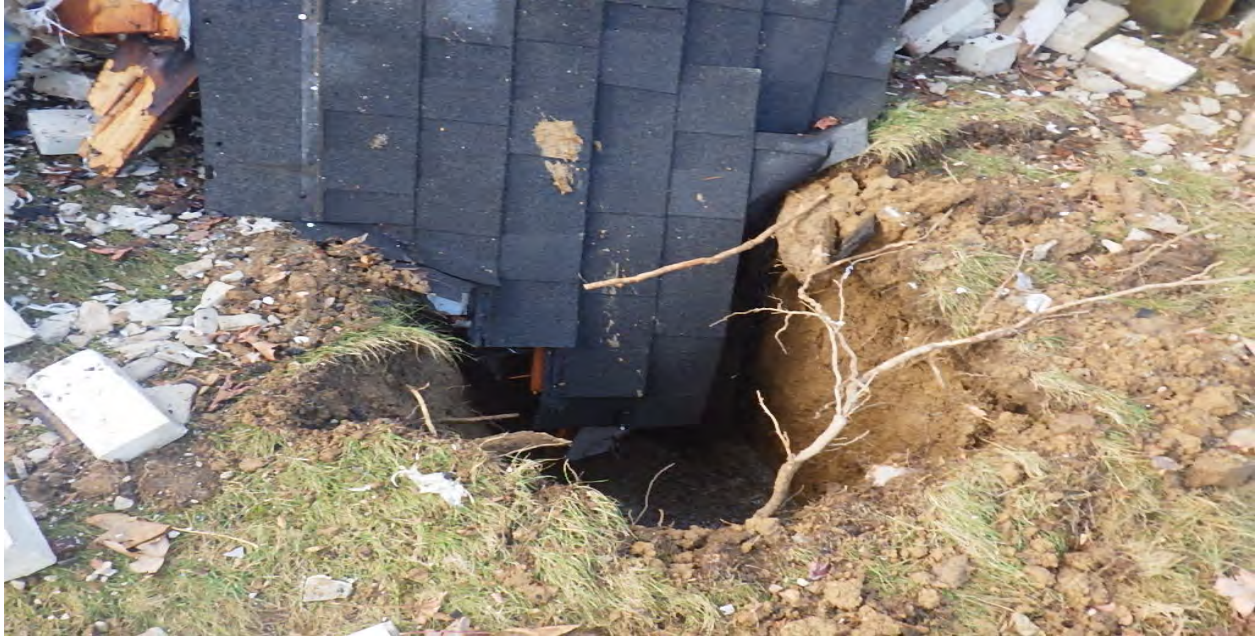
Figure 4 – Excavation Made Prior to Incident

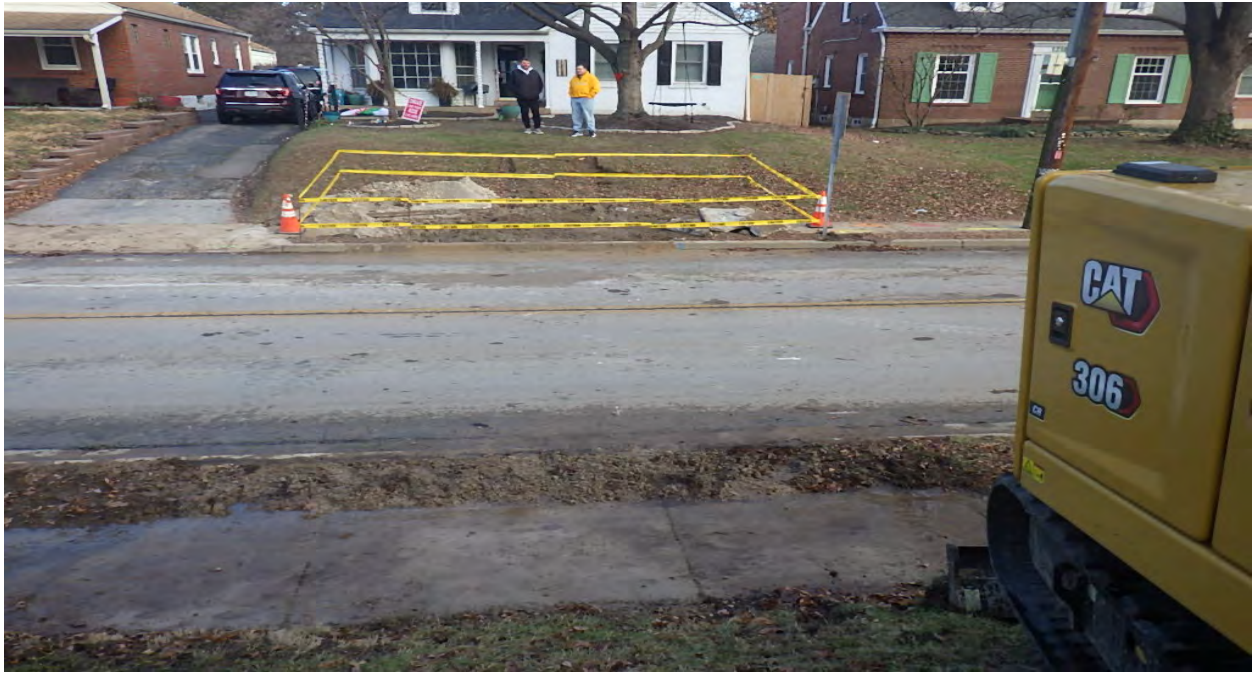
Figure 5 – Location of Spire Excavation Made in Attempt to Find Gas Curb Valve

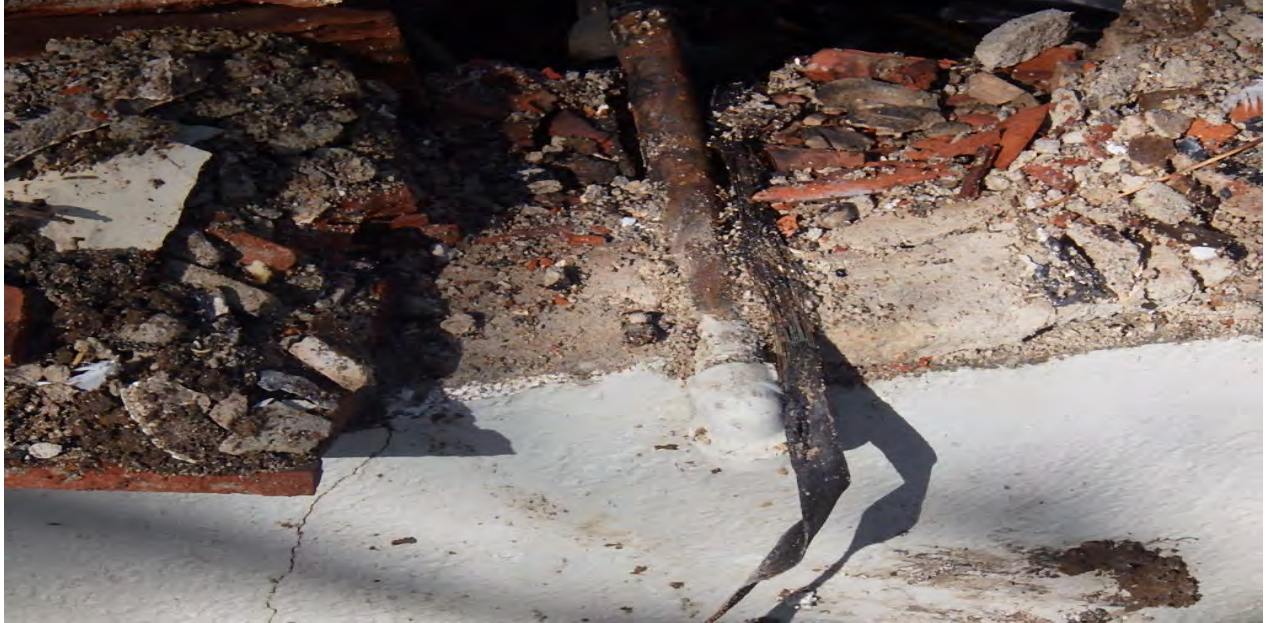
Figure 7 – Inside Meter Vent

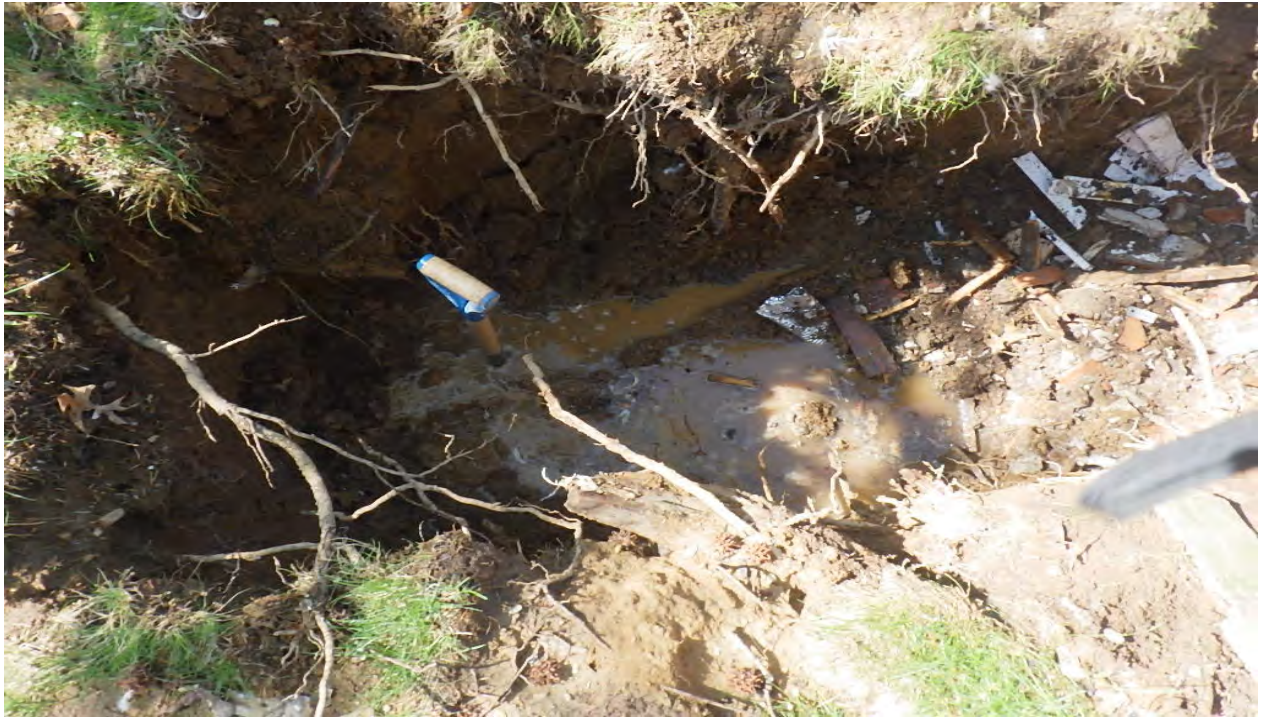
Examination of the service line following the incident by Staff revealed that the copper service line appeared to have been pulled and bent by the excavator bucket and was damaged at the outside of and near the foundation wall where the service line entered the residence. The distance from the point of the damaged service line to the wall of the house was estimated following the incident to be approximately 11 feet. The source of ignition is unknown.

Pipe Failure Description ___ N/A	
Length of Failure (inches, feet, miles): 1 inch on a 9-foot section of pipe. (1)	
Position (Top, Bottom, include position on pipe, 6 O'clock): Side of pipe in the 3 O'clock position.	Description of Failure (Corrosion Gouge, Seam Split): Puncture from mini excavator bucket.
Laboratory Analysis: ___ Yes ___X_ No	
Performed by:	
Preservation of Failed Section or Component: ___X_Yes ___No	
If Yes - Method: Spire Missouri Inc East Secure evidence locker	
In Custody of: Spire Missouri Inc East	
Develop a sketch of the area including distances from roads, houses, stress inducing factors, pipe configurations, direction of flow, etc. Bar Hole Test Survey Plot, if included, should be outlined with concentrations at test points.	
See Confidential Figure 6 of Exhibit 1 to Appendix A, Exhibit 5 to Appendix A and end of this checklist.

Figure 8 – Service Line

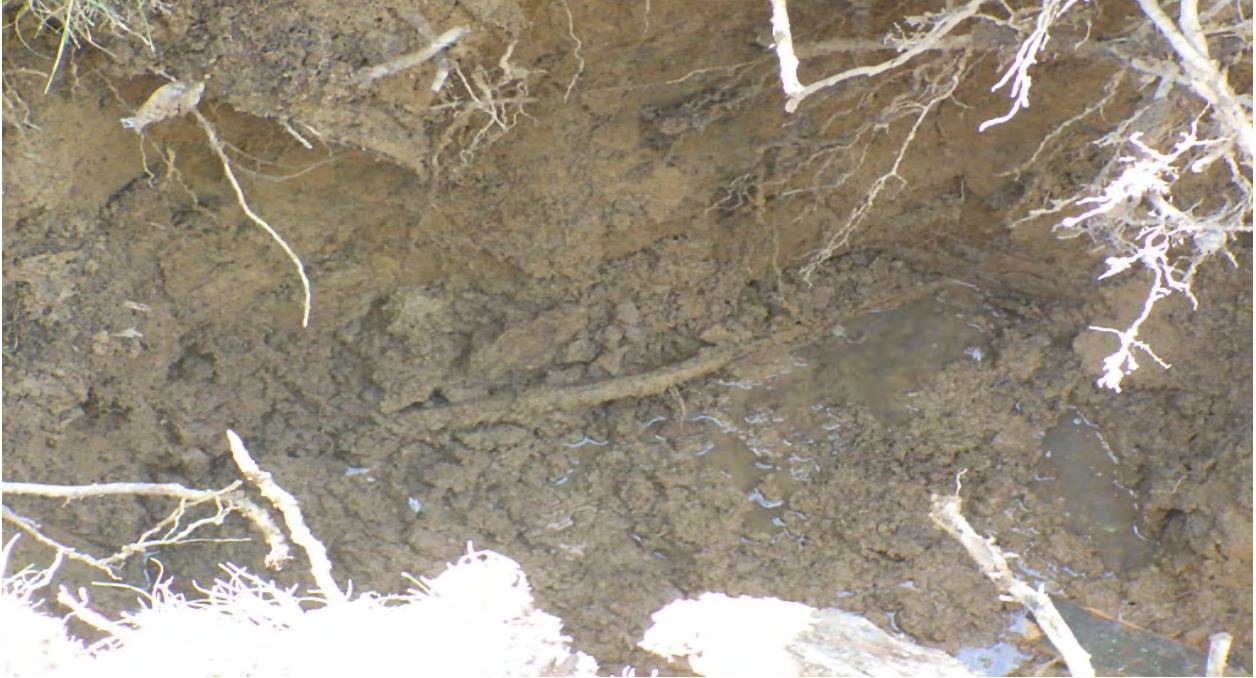
Figure 9 – Service line

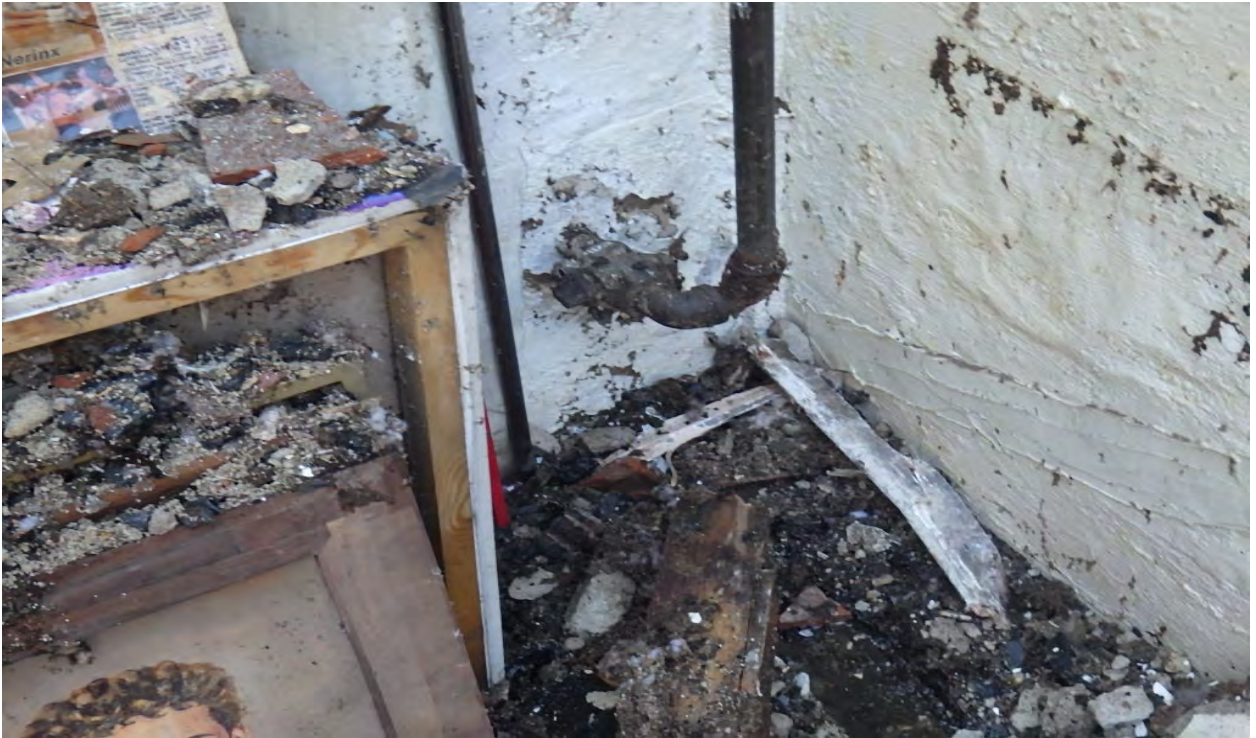
Component Failure Description ___ N/A	
Component Failed:	½-inch Copper service line and the service head adapter at the basement wall. (1)
Manufacturer: unknown – 1960s	Model: unknown
Pressure Rating: unknown	Size: ½-inch
Other (Breakout Tank, Underground Storage):

Figure 10 – Service Line In Basement

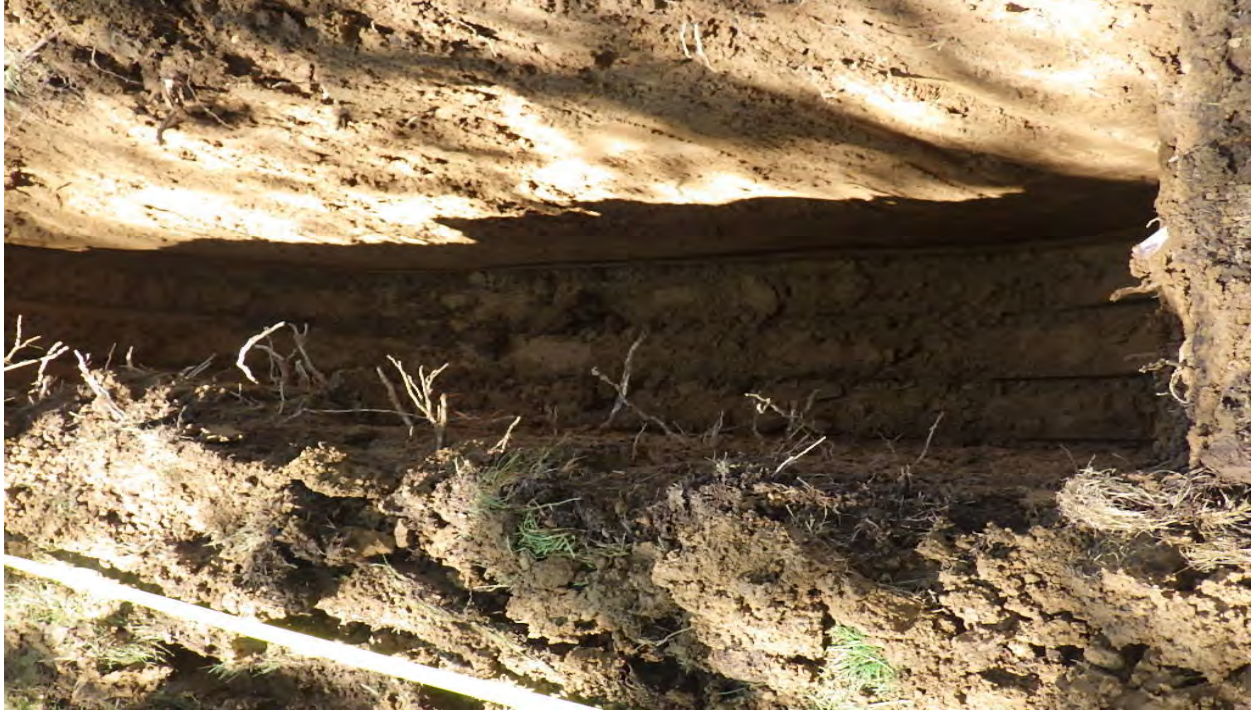
Figure 11 – Excavation overUSIC Locate

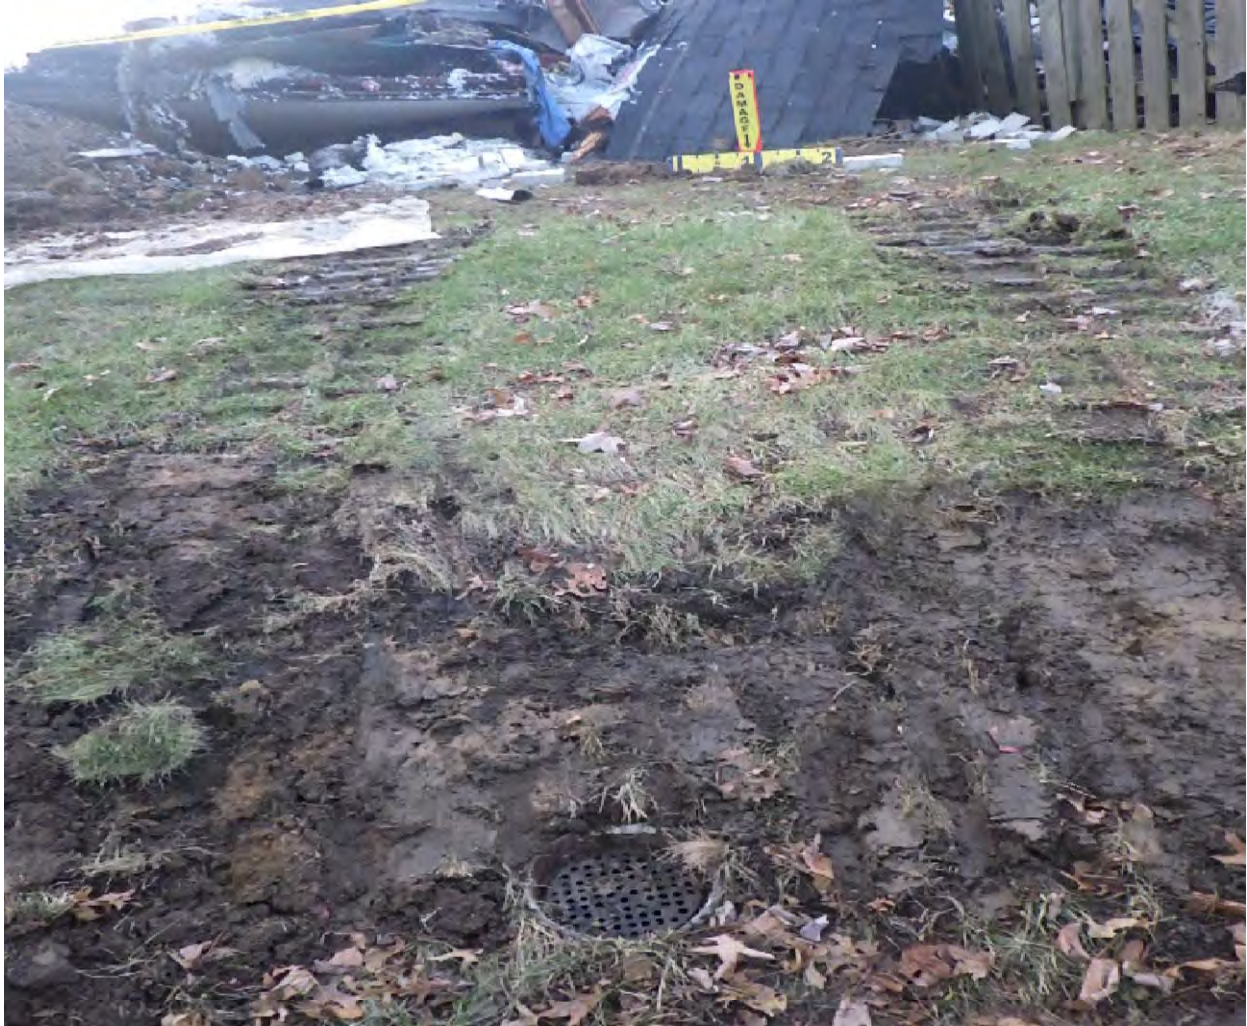
Figure 12 – Excavator’s work site
