STAFF'S GAS INCIDENT REPORT

**Glen Elm Drive
Glendale, MO
January 3, 2025**

Failure Investigation Report (FIR)

Case No. GS-2025-0209

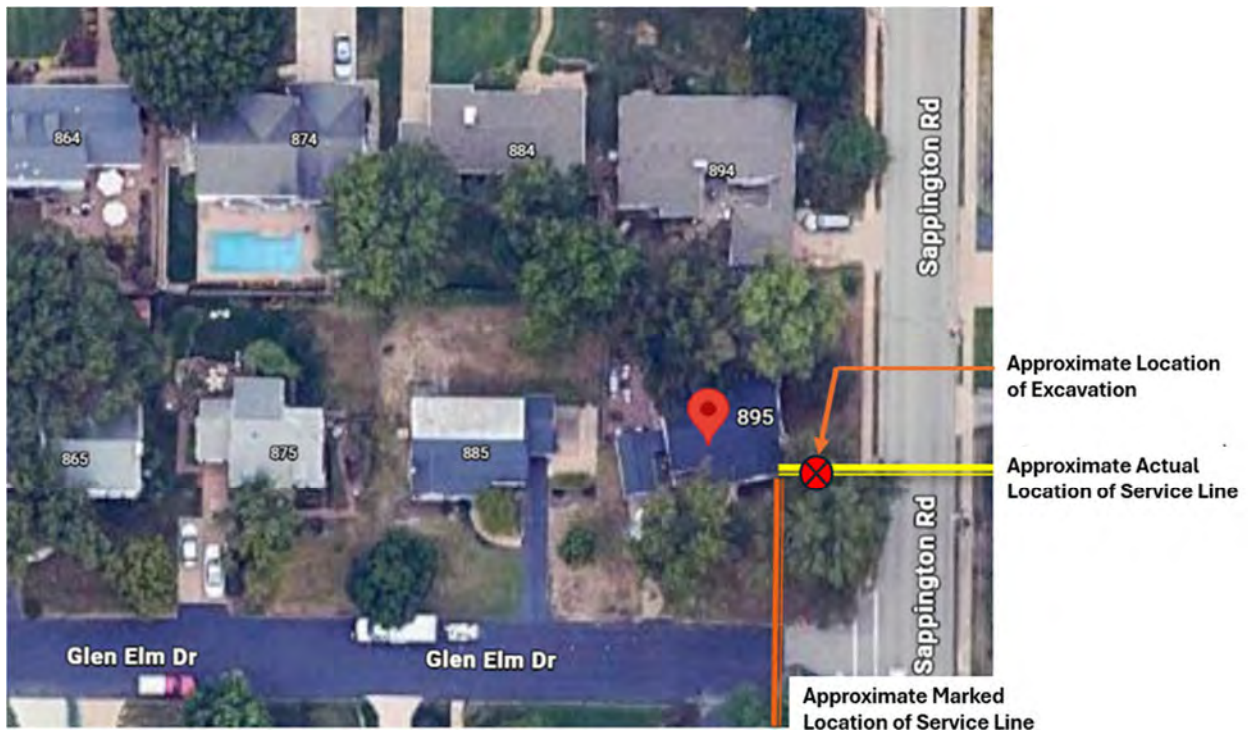
Figure 2: Approximate Locations of Actual Gas Service Line to 895 Glen Elm Dr., Excavation Location and Marked Location of Service Line on January 3, 2025 (Source: Google Maps, Staff added approximate locations of service line and text boxes).

Staff's initial on-site investigation on January 3, 2025, at 3:15 pm was to observe the accuracy of Spire's location of its service line. Staff observed that Spire had marked the location of its service line as entering the property from the South side of Glen Elm Drive crossing Glen Elm Drive going North to the South side of the residence at 895 Glen Elm Drive. However, the actual location of the Spire Natural gas service line is on the East side of North Sappington Road. There is a curb valve in the sidewalk directly across from 895 Glen Elm Drive that runs under North Sappington Road to the East side of 895 Glen Elm Drive to the inside meter. The third-party damage to the service line was caused by the locator not correctly marking the Spire natural gas service line. Staff interviewed Spire compliance personnel, the owner of PLS Plumbing and responding members of the St. Louis Police Bomb and Arson investigator on site.

The apparent cause of the incident was ignition of gas that was released due to excavation damage to a natural gas service line. The apparent cause of the excavation damage was Spire's Contract Locator's failure to correctly mark the location of the natural gas service line.

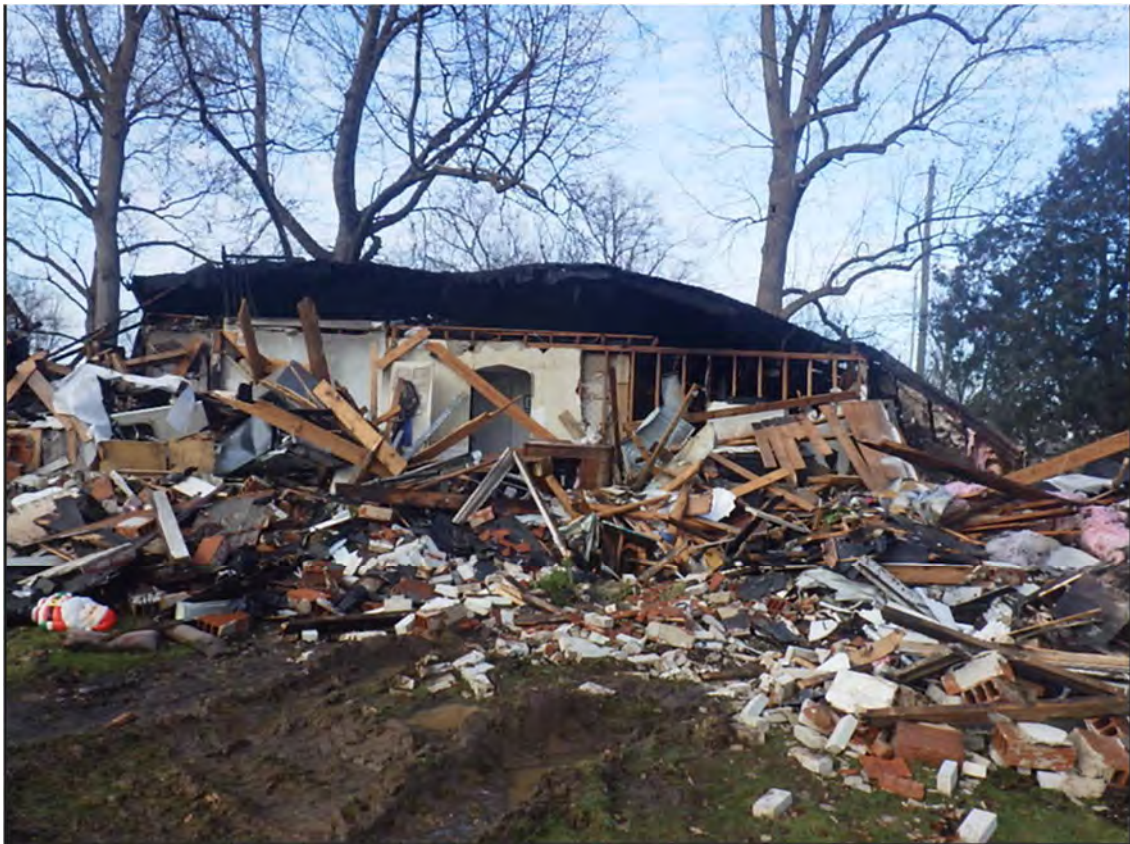
There were four people inside the residence at 895 Glen Elm Dr. when it exploded. All occupants were transported to Mercy Medical Center. One of the occupants sustained minor injuries and was treated and released that day. Initial estimates of property damages are \$404,555, including an estimated cost of \$401,755 cost of public and non-operator private property damage, \$2,300 damage and repair to Spire property and \$500 emergency response costs. Following the explosion, the residence was demolished. Figure 3 shows the home following the explosion.

Figure 3: Residence at 895 Glen Elm Dr. on January 3, 2025, following explosion. Photograph was taken from Glen Elm Dr. looking North. (Source: Staff Photograph)
