# MISSOURI PUBLIC SERVICE COMMISSION

## STAFF'S GAS INCIDENT REPORT

Glen Elm Drive  
Glendale, Missouri  
January 3, 2025

**Case No. GS-2025-0209**

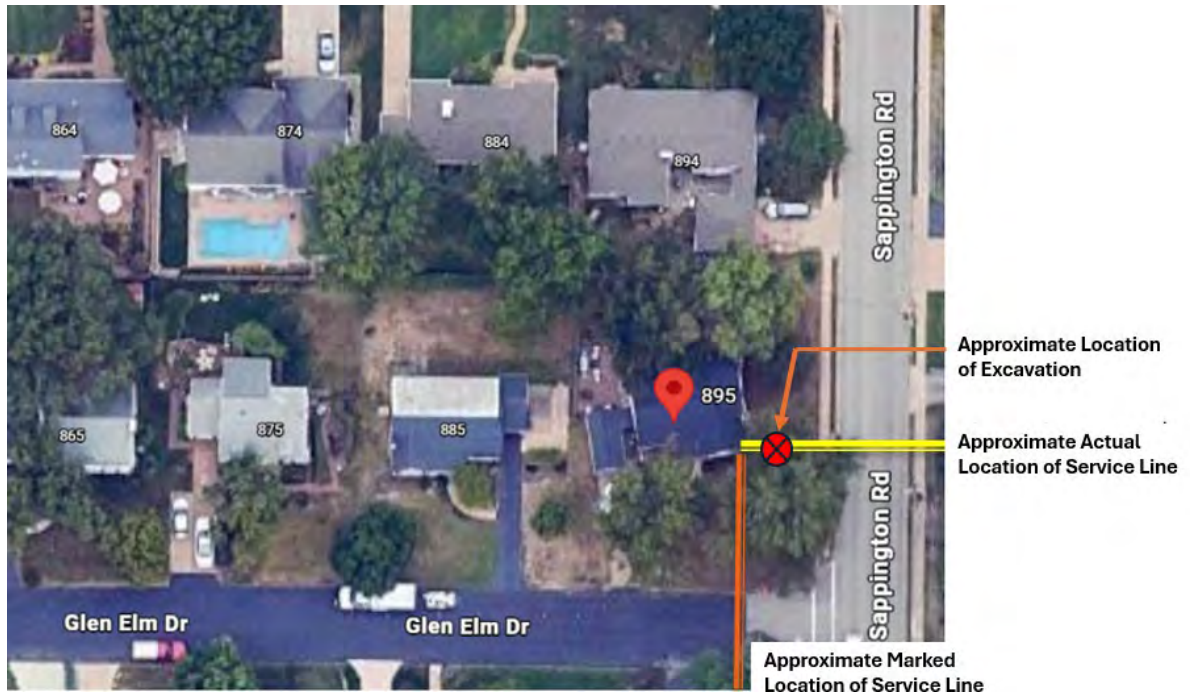
At 7:21 a.m. on January 3, 2025, the Excavator requested an Emergency locate of buried utilities in the vicinity of 895 Glen Elm Dr. for work associated with a repair of the sewer service. The location of work on the Missouri 811 ticket requests utility locations on “front and right facing front side and including Glen Elm Dr. curb to curb and N. Sappington Rd. curb to curb”, with a start date and time of January 3, 2025, at 9:30 a.m. Spire’s Contract Locator responded “Marked” on Spire’s behalf by updating the ticket status at 8:09 a.m. Although Spire’s Contract Locator did place marks indicating the presence of a natural gas service line, the marks were not in the correct location. The marks showed that the service line ran to the residence from Glen Elm Dr. to the south of the property, whereas the actual location of the service line ran from N. Sappington Rd. to the residence from the east. Figure 1 shows the approximate actual location of the service line as well as the approximate location that was marked by Spire on January 3, 2025.

**Figure 1: Approximate Locations of Actual Gas Service Line to 895 Glen Elm Dr., Excavation Location and Marked Location of Service Line on January 3, 2025 (Source: Google Maps, Staff added approximate locations of service line and text boxes).**

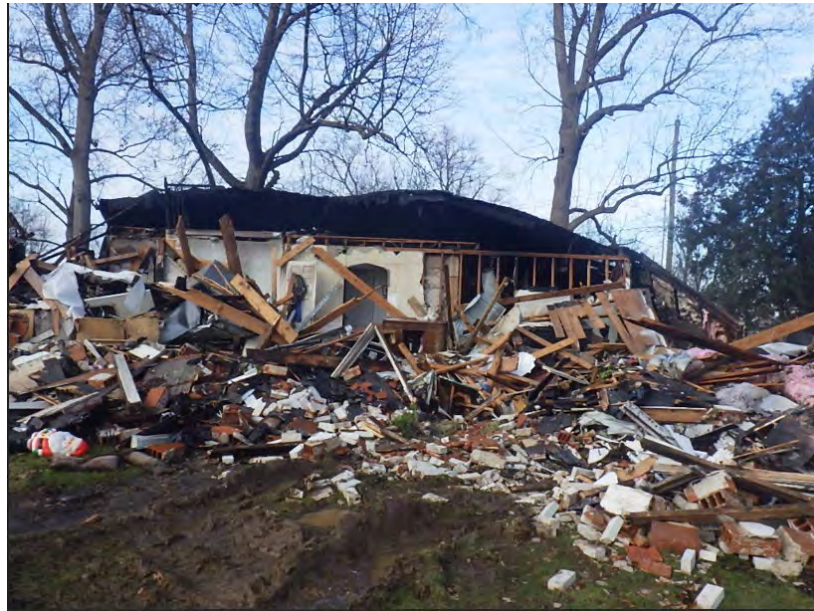
**Figure 2: Residence at 895 Glen Elm Dr. on January 3, 2025, following explosion. Photograph was taken from Glen Elm Dr. looking North. (Source: Staff Photograph)**

Staff's examination of the service line following the incident indicated that the copper service line appeared to have been pulled and bent by the excavator bucket and was damaged at the outside of and near the foundation wall where the service line entered the residence. Staff believes that either the abandoned steel service line or active copper service line may have acted as a conduit to transport gas to the break in the copper service line near the foundation wall as a pathway for migration of released natural gas into the residence. Another potential migration pathway could have been the blowing gas from the damaged service line through an open basement window. The distance from the point of the damaged service line to the wall of the house was estimated following the incident to be approximately 10 feet.<sup>7</sup> The source of ignition is unknown. The home was demolished following the explosion.
