Staff Final Electric Incident Report

**Kansas City Power & Light Company
Case No. ES-99-581**

**Hawthorn Station
Boiler No. 5 Explosion
Kansas City, Missouri
February 17, 1999**

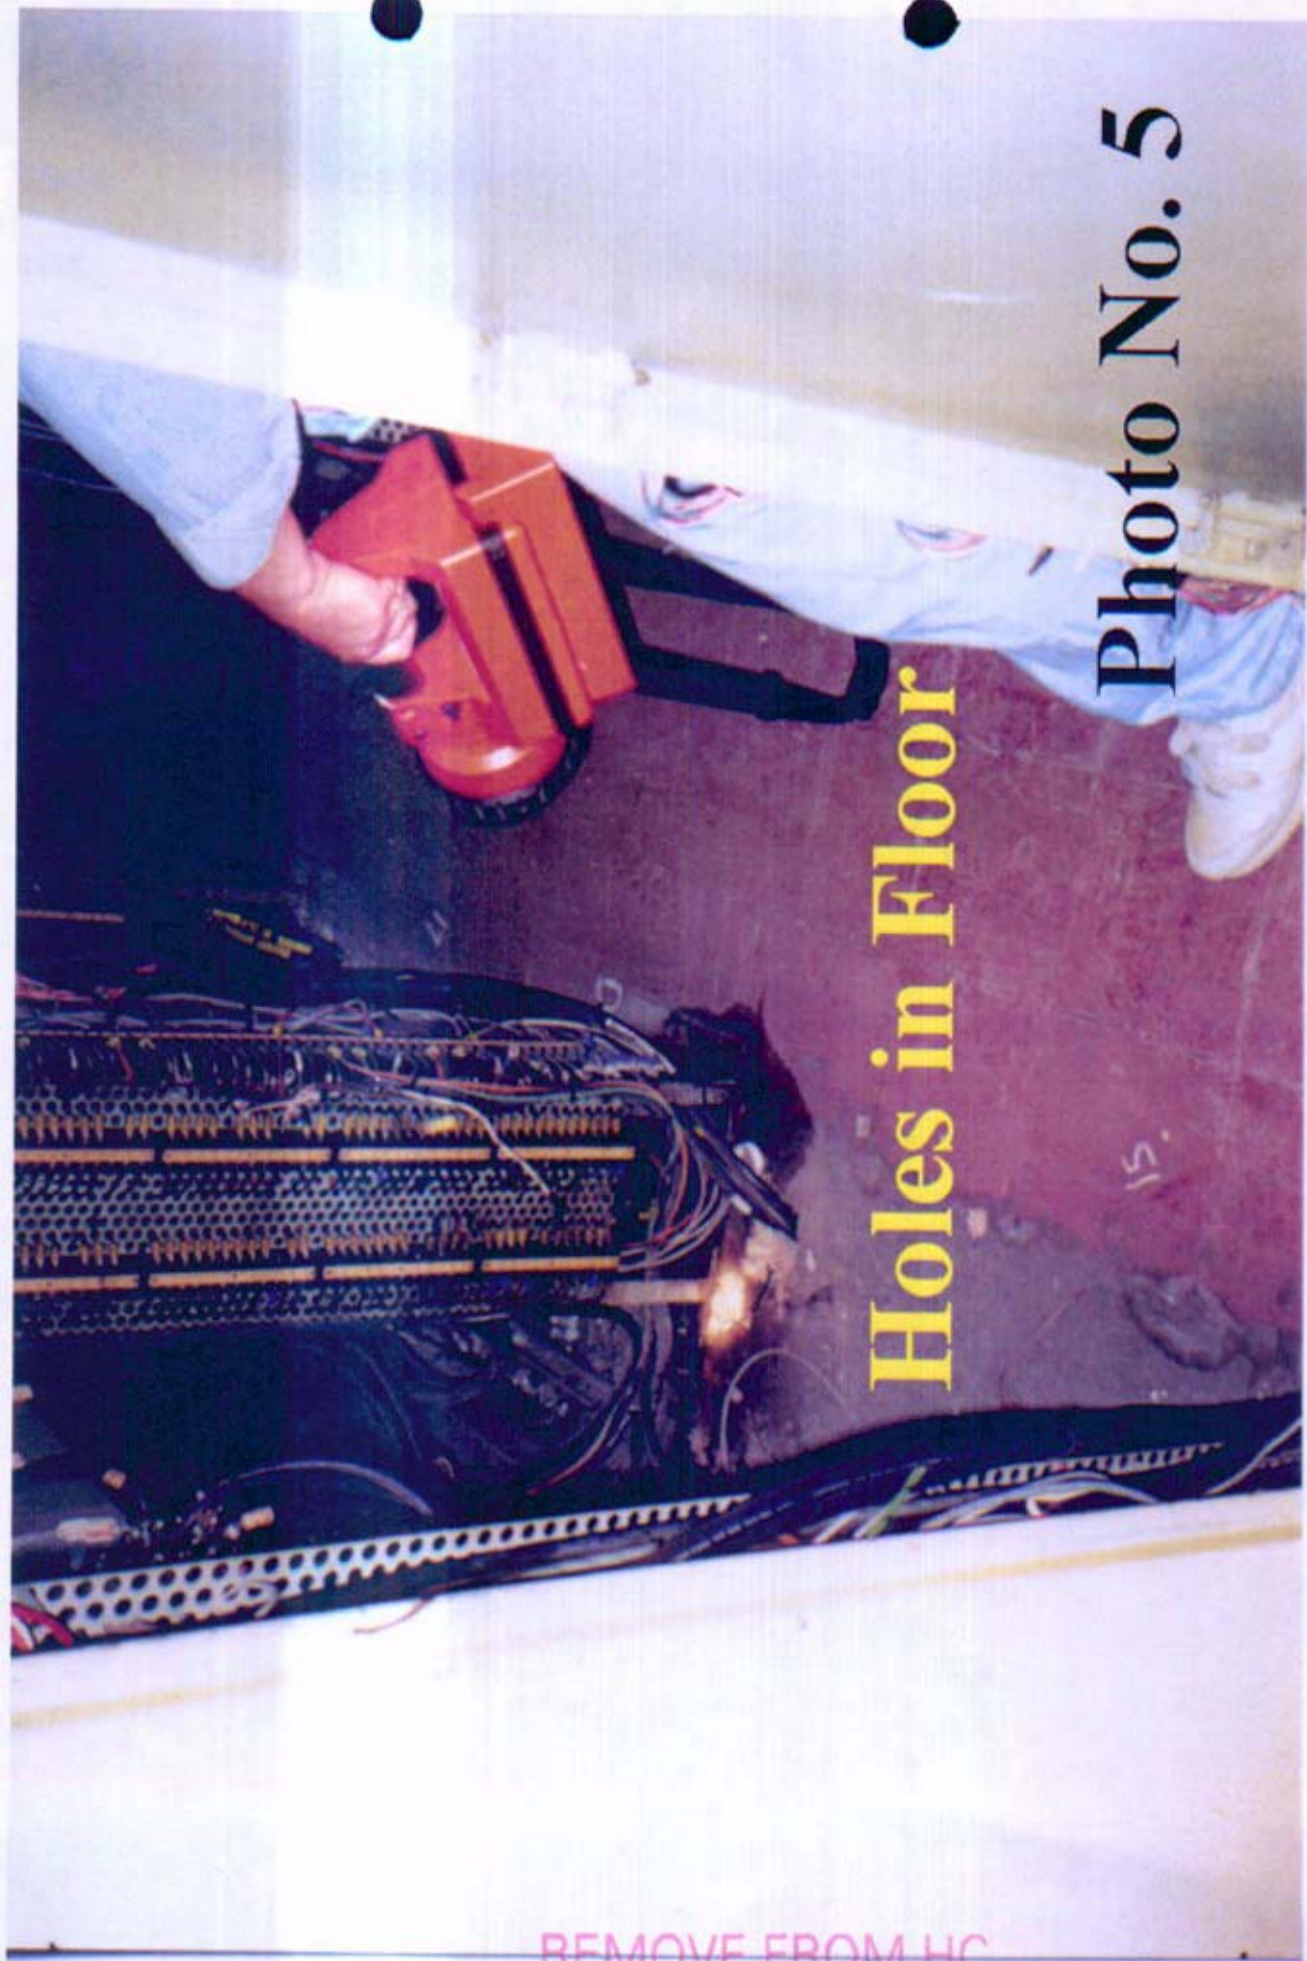
Photo No. 5

Holes in Floor

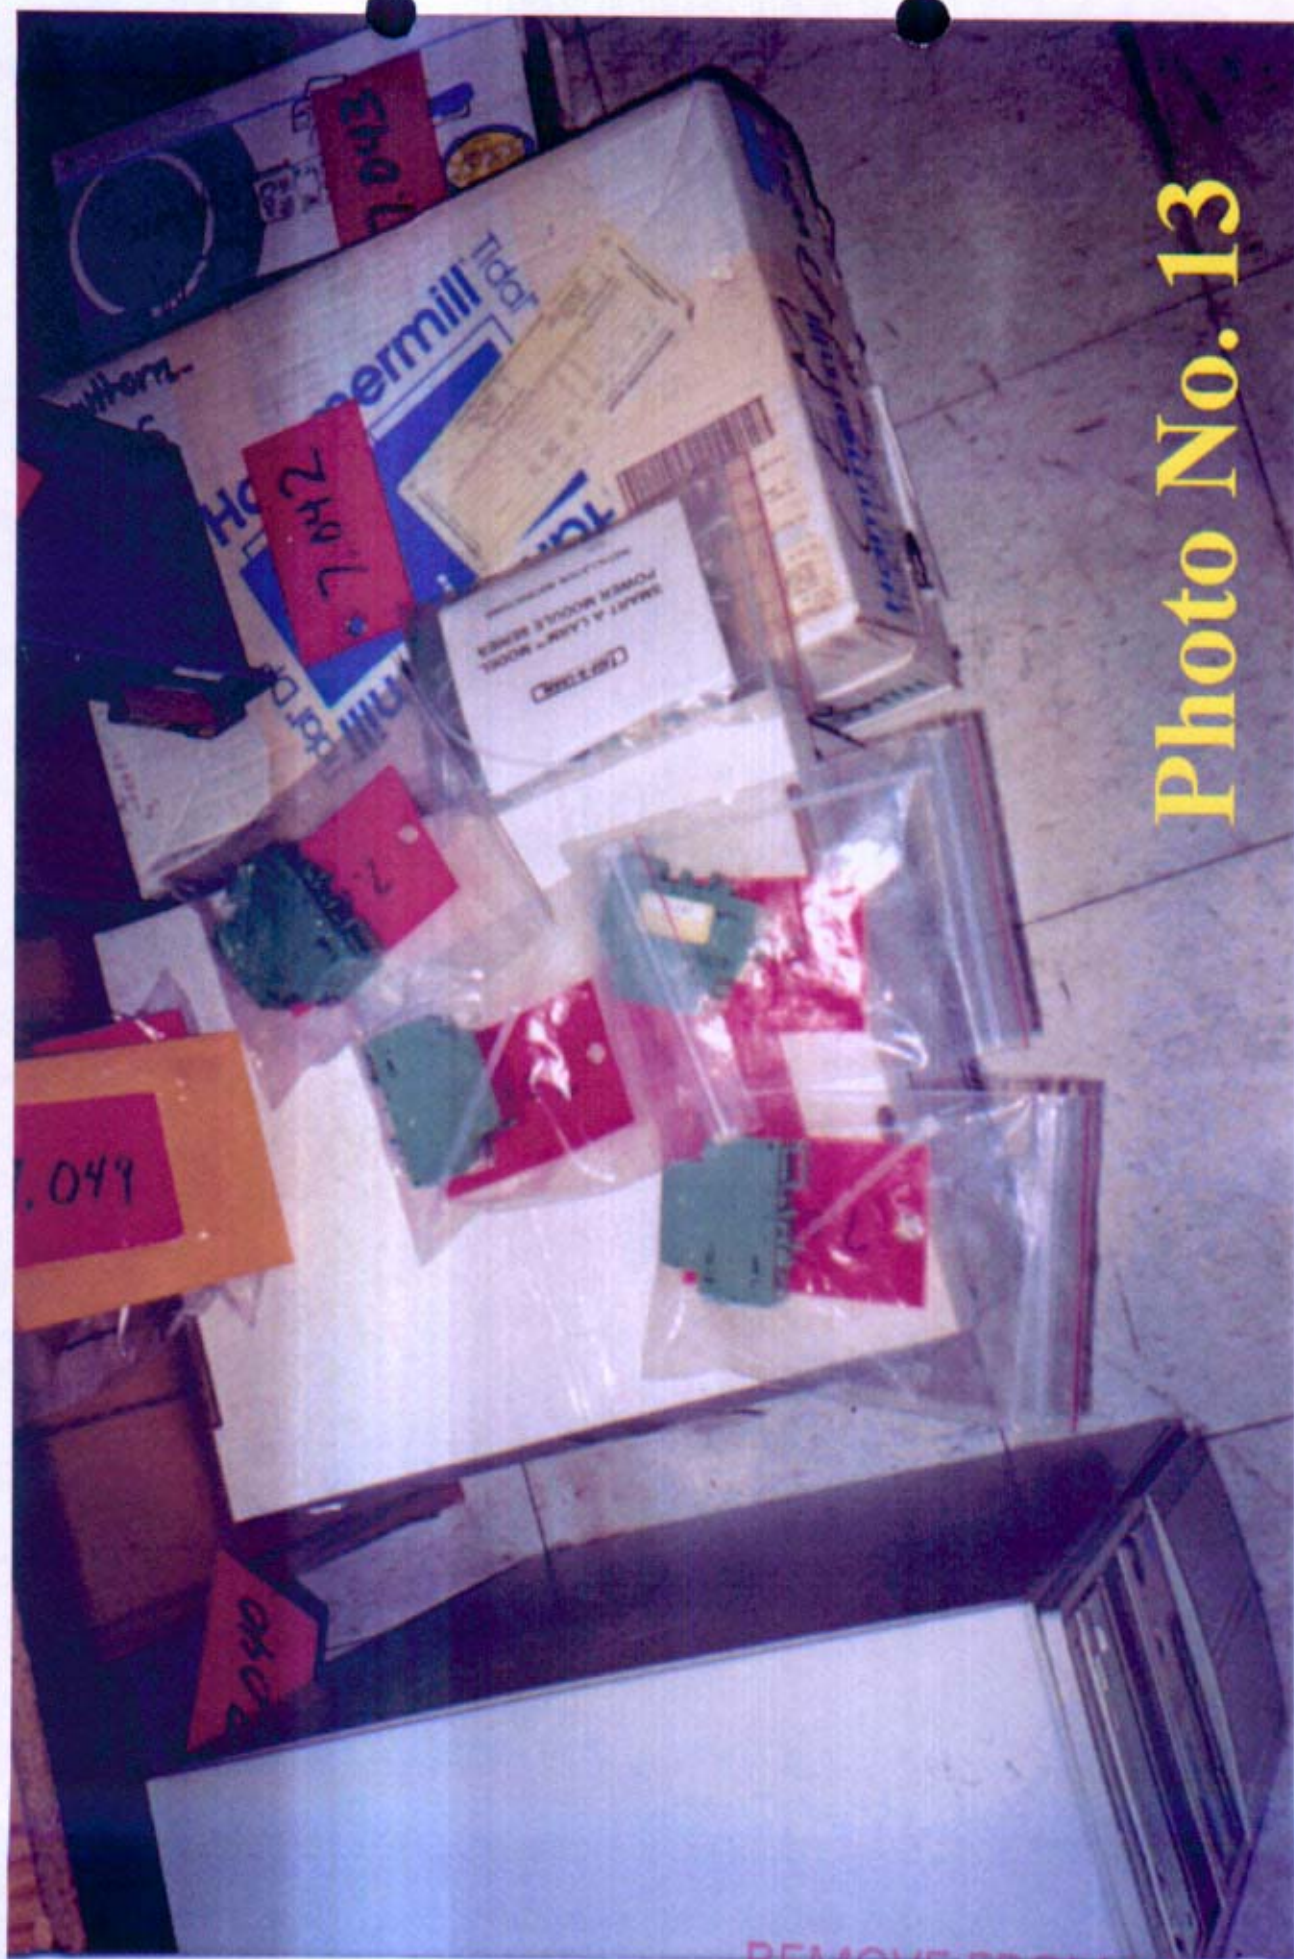
Photo No. 13

13. **SCM devices in plastic bags, which have been removed from the BMS control cabinet for examination.**
14. A view of the damaged boiler from the north side looking southward.

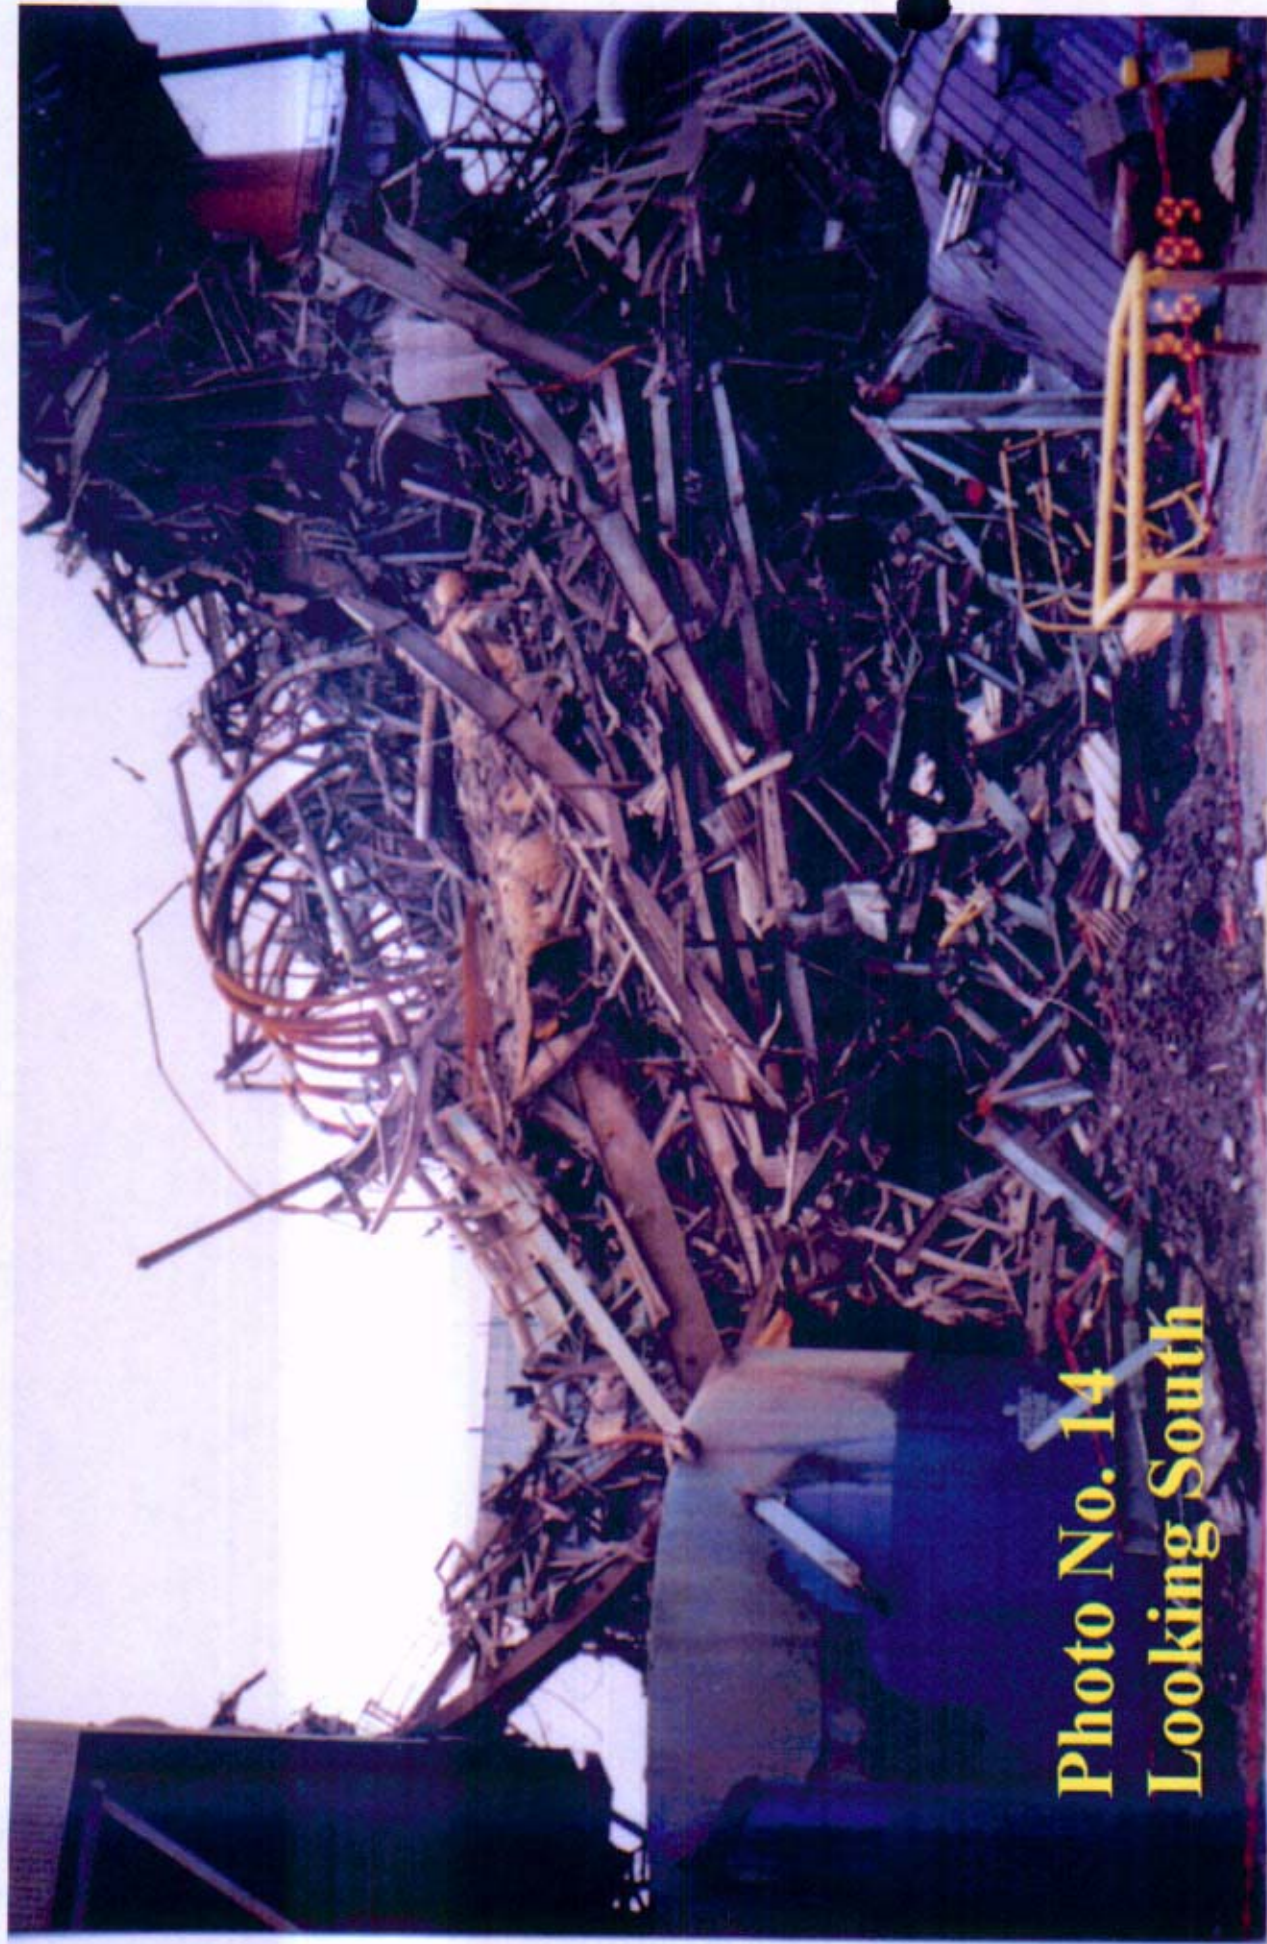
Photo No. 14
Looking South

The boiler and the boiler related equipment located in the boiler building, as well as the boiler building itself, were destroyed by the explosion (see photographs 14 and 15 in Appendix A; **see tab 7 of KCPL's report in Appendix E**). The structural steel supporting the boiler and the building walls close to the boiler were damaged beyond repair. The ductwork from the boiler to the precipitators was damaged (see photograph 16 in Appendix A). The coal bunkers and the supporting structural steel were damaged (see photographs 17 and 18 in Appendix A).

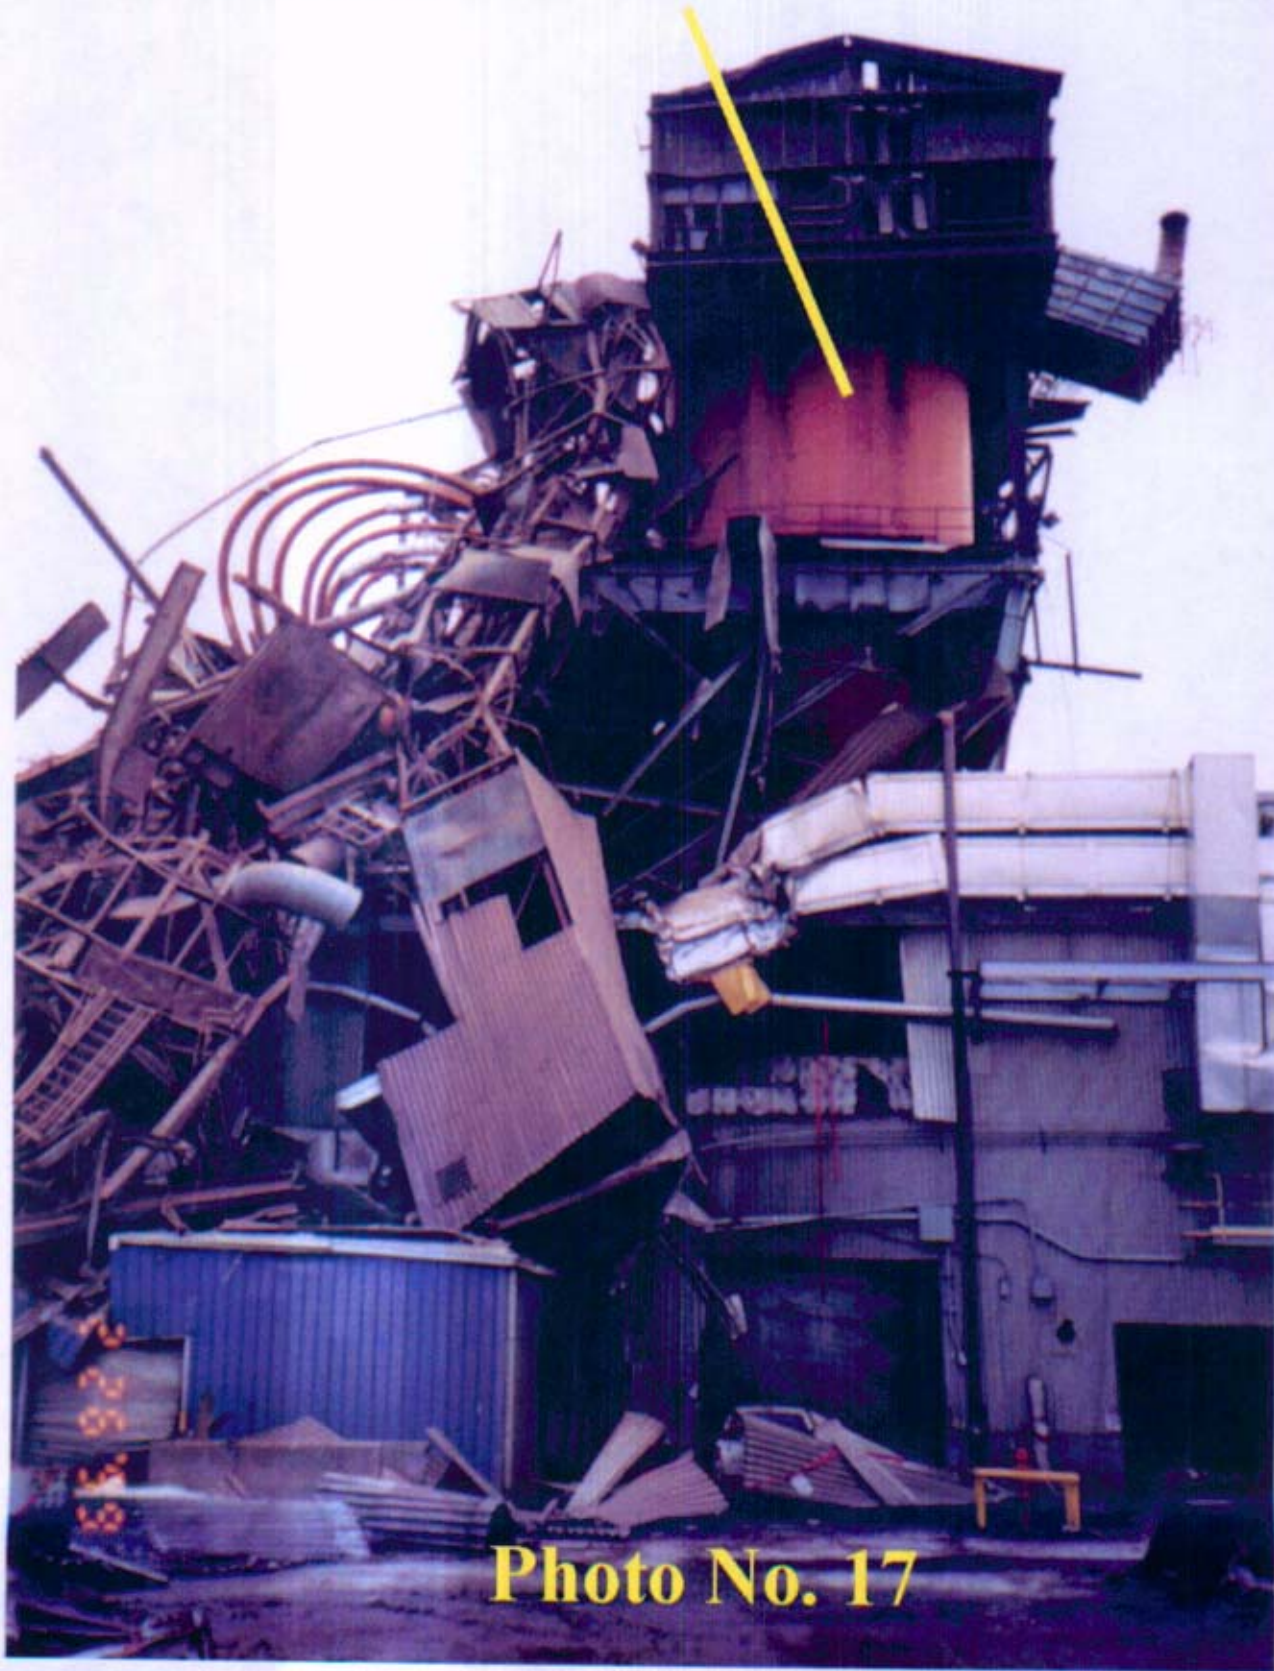
Photo No. 17

15. A view from the east looking westward. An area is indicated where Boiler #5 would have been.
16. A view of the precipitator ductwork damage.
17. A view from the north, looking southward at the coal bunkers leaning toward the turbine room elevation. The coal bunkers were located on the west side of the boiler.

**Coal Bunkers leaning toward
turbine elevation**

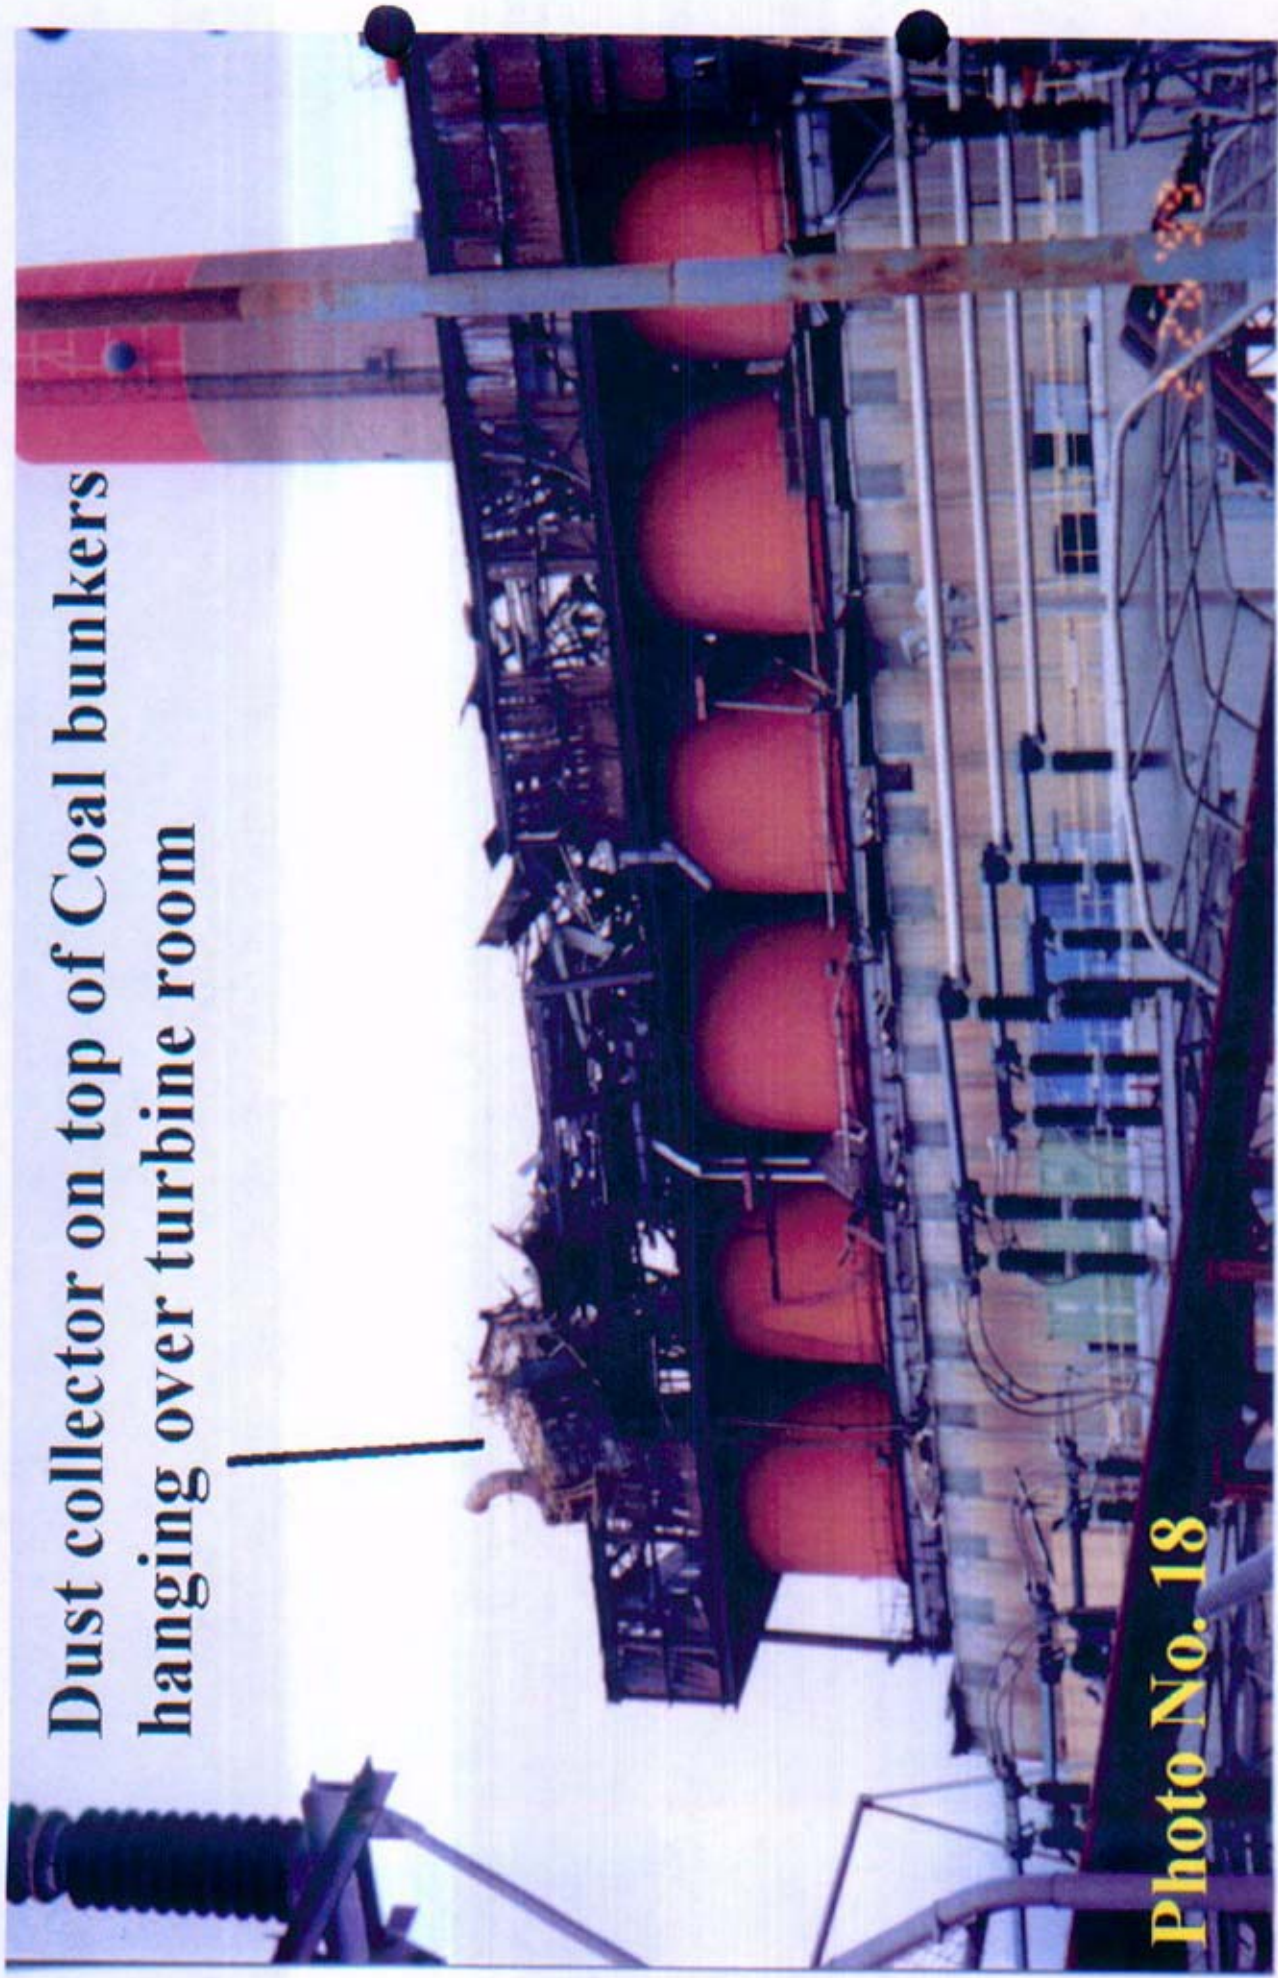
Photo No. 18

18. A view from the west, looking eastward at the coal bunkers.
19. A view from the north, looking southward at the damaged boiler. Contractor's crane is removing pieces of the boiler debris. The steam drum can be seen in the center of the debris with the piping still attached and bent.

**Dust collector on top of Coal bunkers
hanging over turbine room**

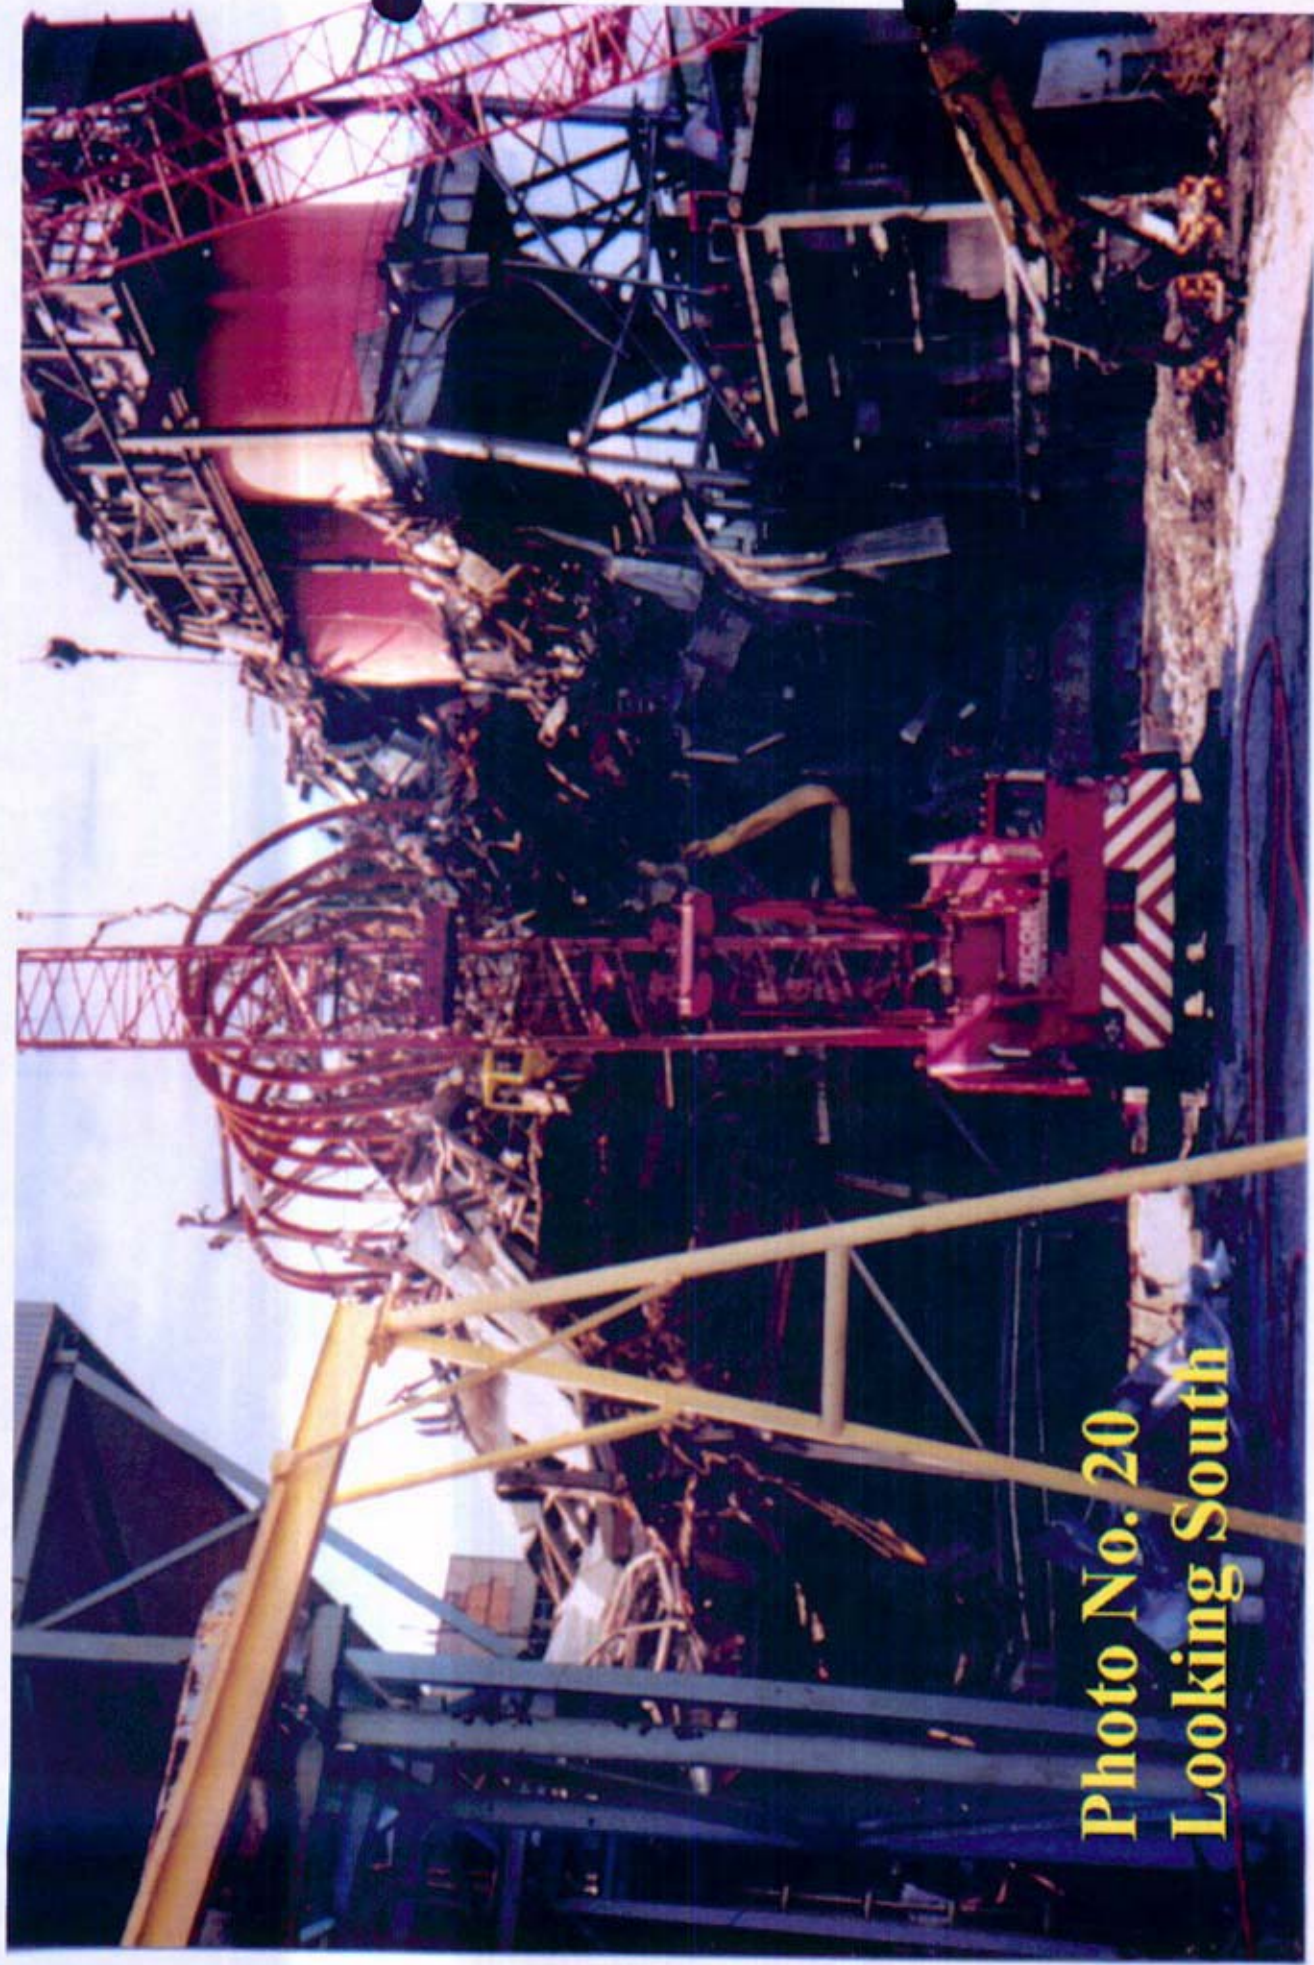
Photo No. 20
Looking South

20. A view from the north, looking southward at the damaged boiler. Contractor's crane is removing pieces of the boiler debris.
21. A view of the natural gas piping and valves recovered from the debris.

In the immediate days after the incident, KCPL's first priority was to secure the plant area and identify any unstable structures that might fall. A preliminary investigation indicated that the boiler was beyond repair. A contractor was hired to remove the large pile of debris left by the explosion, and to remove the unstable coal bunker, dust collector, and precipitator ductwork (see photographs 19, 20, 21, 22, 23, 24, 25, 26 in Appendix A).

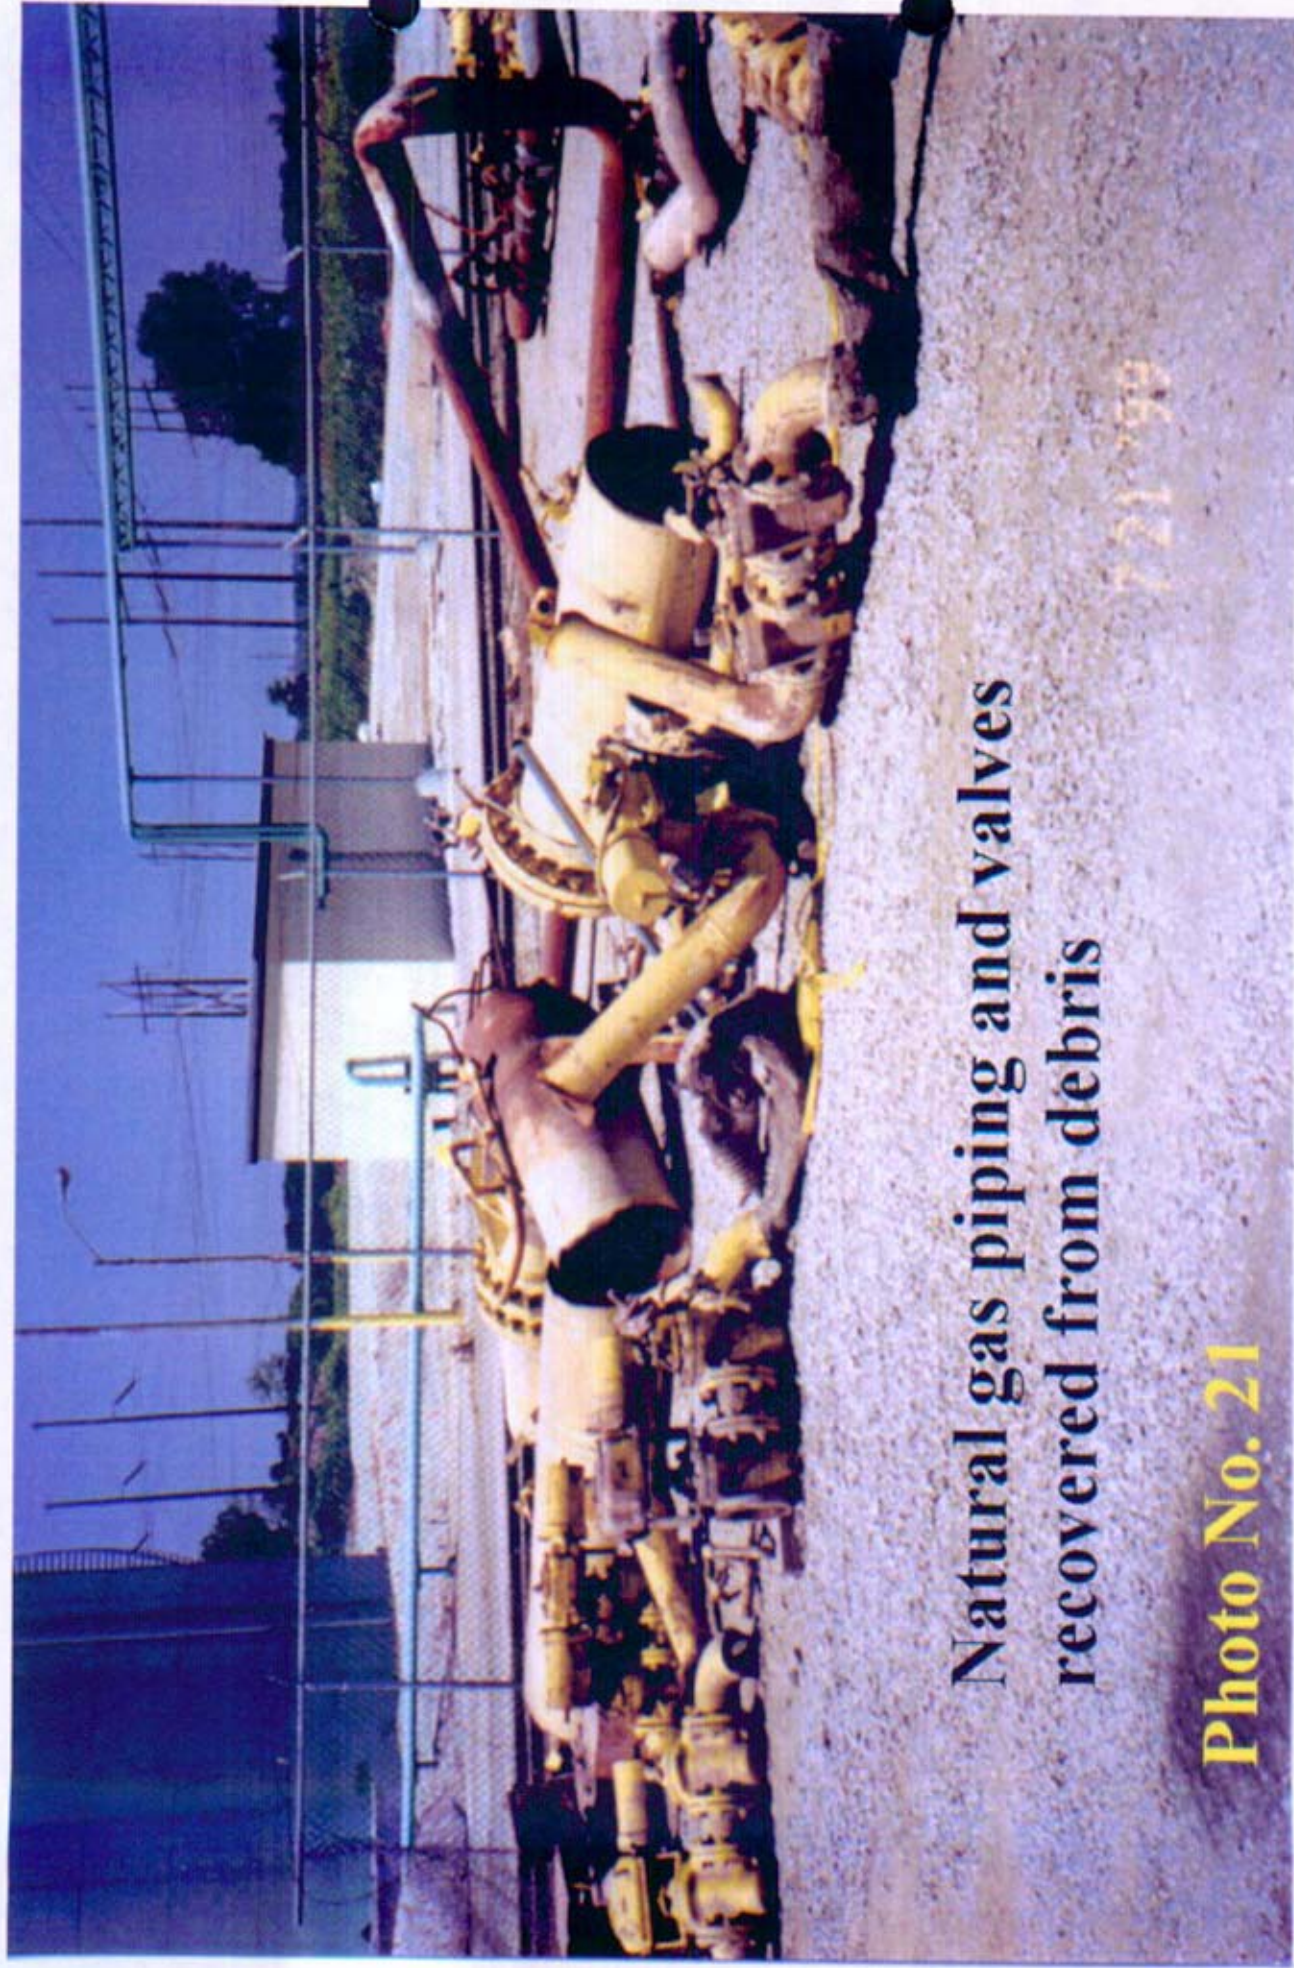
Photo No. 21

**Natural gas piping and valves
recovered from debris**

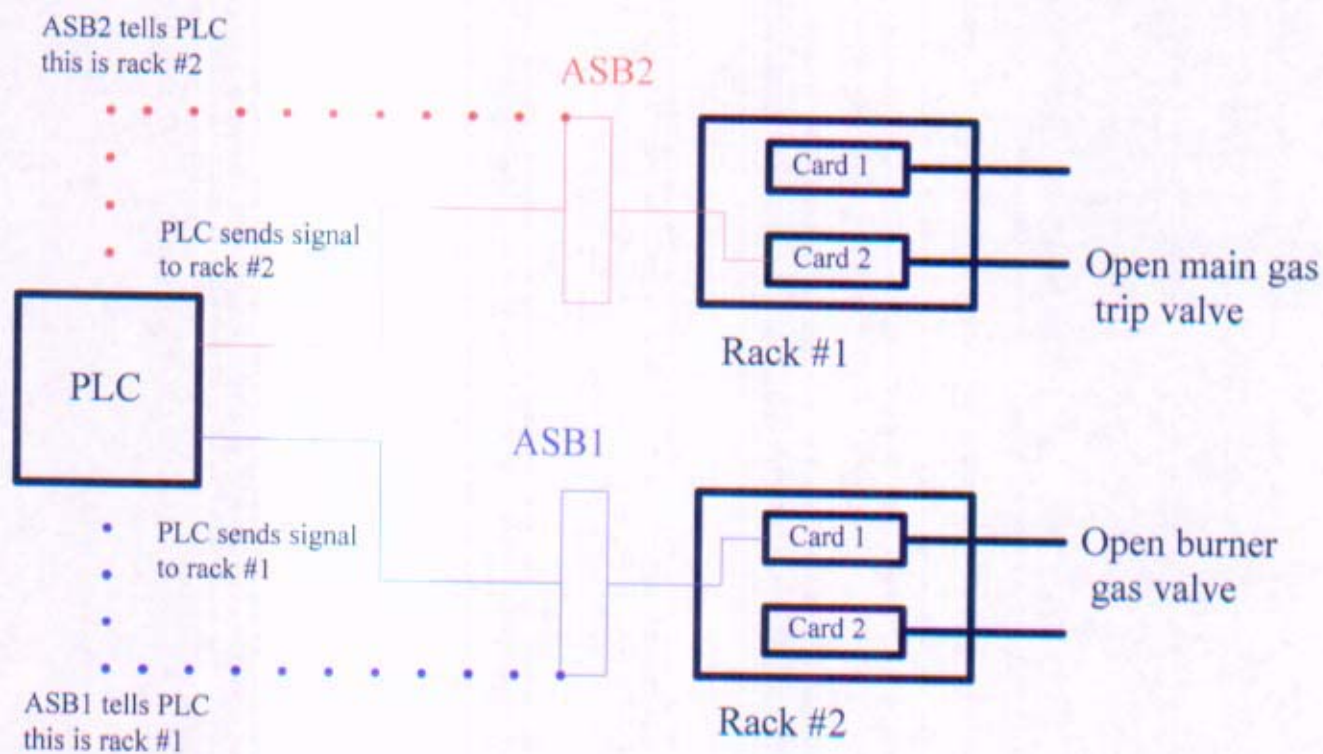
Figure 1-4

Repairs were initiated by KCPL personnel to clean and dry out the electronic control cards in the burner management system (BMS). While completing this process, the position of two electronic addressing cards were switched in the burner management system. Switching the addressing cards without configuring them properly caused one main gas burner valve to open, and two ignitors to operate. In addition, switching the cards without reconfiguring sent a signal to the main gas trip valve to open.

Because of the fault indication on the ASB card, KCPL personnel apparently believed there was a bad communication addressing card in rack #2, and following the vendor's trouble shooting guide, replaced the existing communication addressing card with a new card. When this failed to clear the fault indication on rack #2, they removed the new card from rack #2 and placed it in rack #1 in an attempt to determine if the new card was functioning properly. Getting no fault indication on rack #1 they left the new card in rack #1, and put the communication addressing card from rack #1 into rack #2, and continued to clean and dry the other cards in rack #2.

ASB Cards in wrong locations

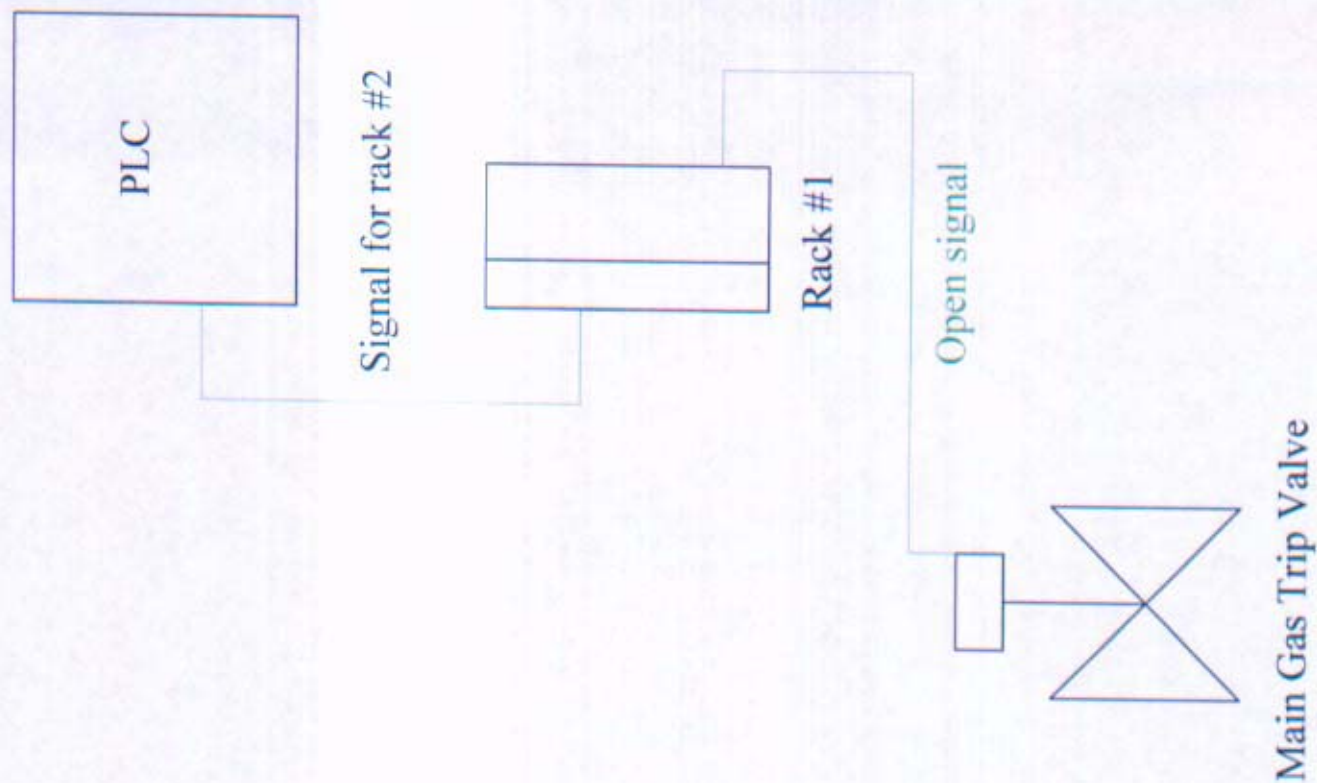
Figure 1-6

KCPL's investigation team has concluded that the design of the BMS with no redundancy for the SCM devices was a poor design. The failure of the SCM3 device prevented a latching relay from functioning properly, which was required to trip the main gas trip valve.

With the main gas trip valve and the corner burner gas valve open, a path was created allowing natural gas into the boiler. KCPL's investigation team believes that the natural gas entering the boiler mixed with the available air and reached the proper proportional mixture of air and natural gas needed for combustion, and was then ignited causing the explosion. Due to the total destruction of the boiler, KCPL's investigation team could not determine the exact source of ignition or spark, however, because the ignitors were operating, KCPL's investigation team presumed that this was the source of ignition. **

Signal path at the time of boiler explosion

1. **Kansas City Power & Light Company review and test the fuel trip control logic on all its non-nuclear units and make a determination whether or not there is a possibility that a failure of one device of the control system could put the unit in a hazardous condition. KCPL should produce a report of its findings, including a description of the trip logic for each unit reviewed, and file it in this case.

2. KCPL make the modifications necessary to the control systems of all its non-nuclear units to ensure a safe trip condition of those units. KCPL should produce a report on what modifications were made, and file it in this case.
