Missouri Public Service Commission

Staff's Gas Incident Report

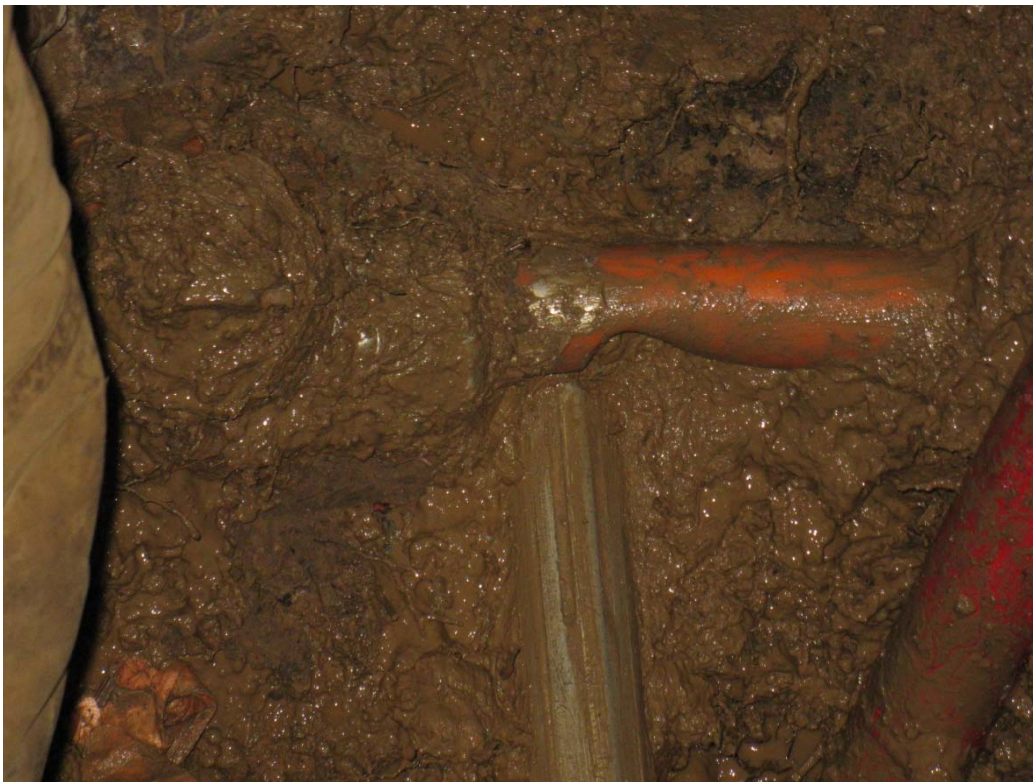
**Photograph #4 –The position of damaged service line and directional boring drill head. The service line valve is covered in mud on the left side of the photograph. This photograph was taken facing south. (Staff Photo)**

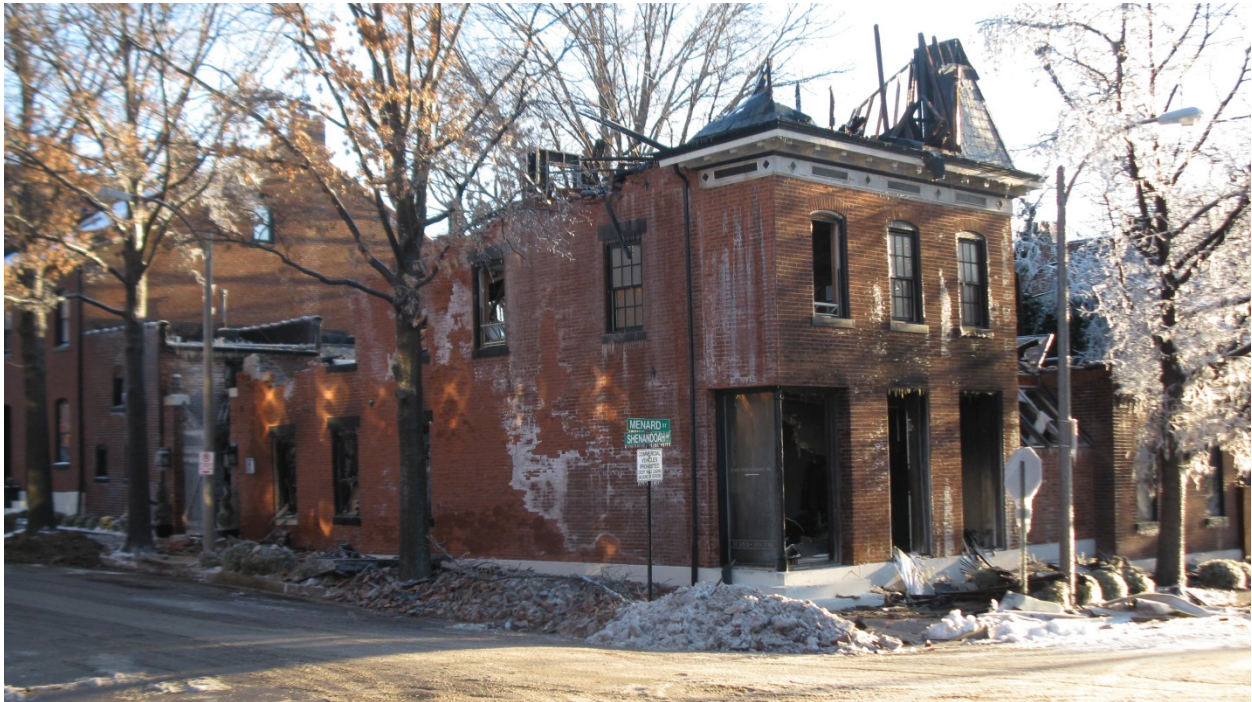
**Photograph #5 – 2222 Menard Street following incident, looking northeast from the intersection of Menard Street and Shenandoah Avenue. (Staff Photo)**

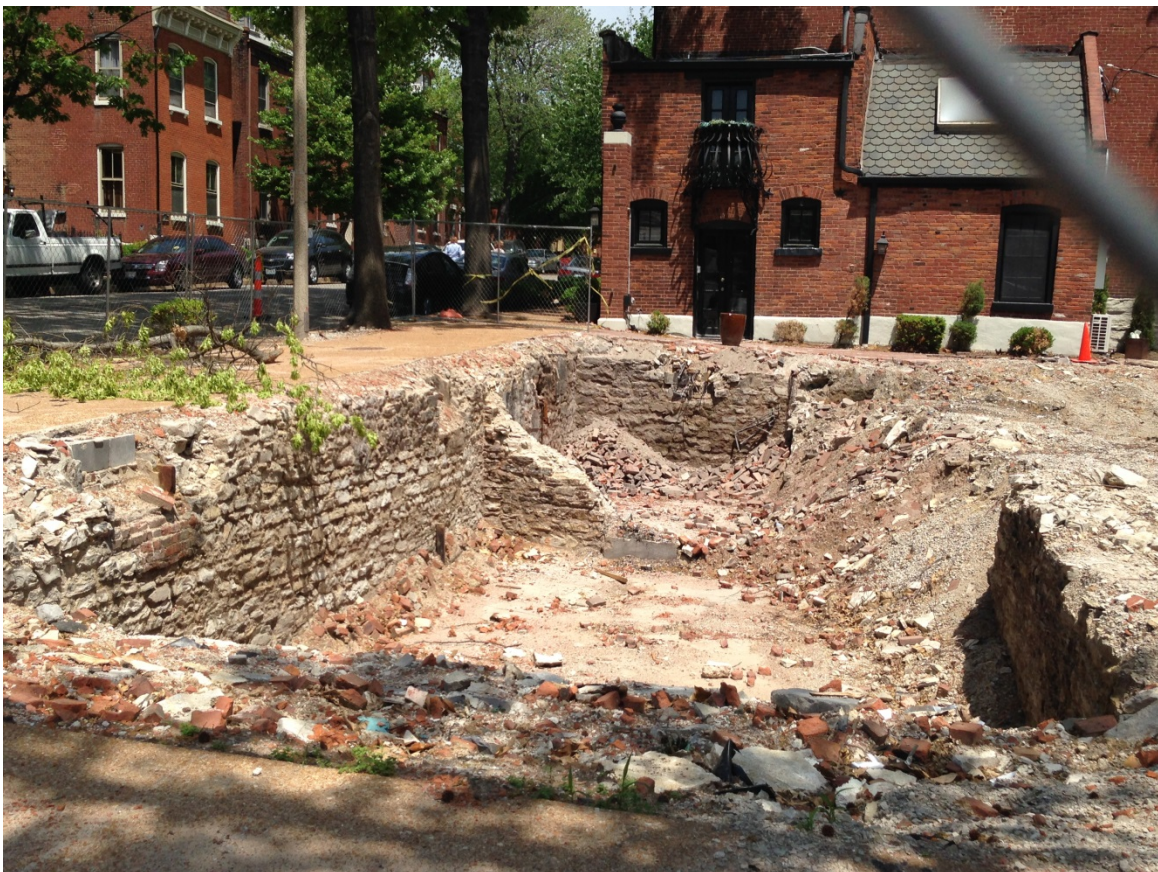
**Photograph #6 – Foundation at 2222 Menard Street on May 8, 2014 following demolition. (Staff Photo)**

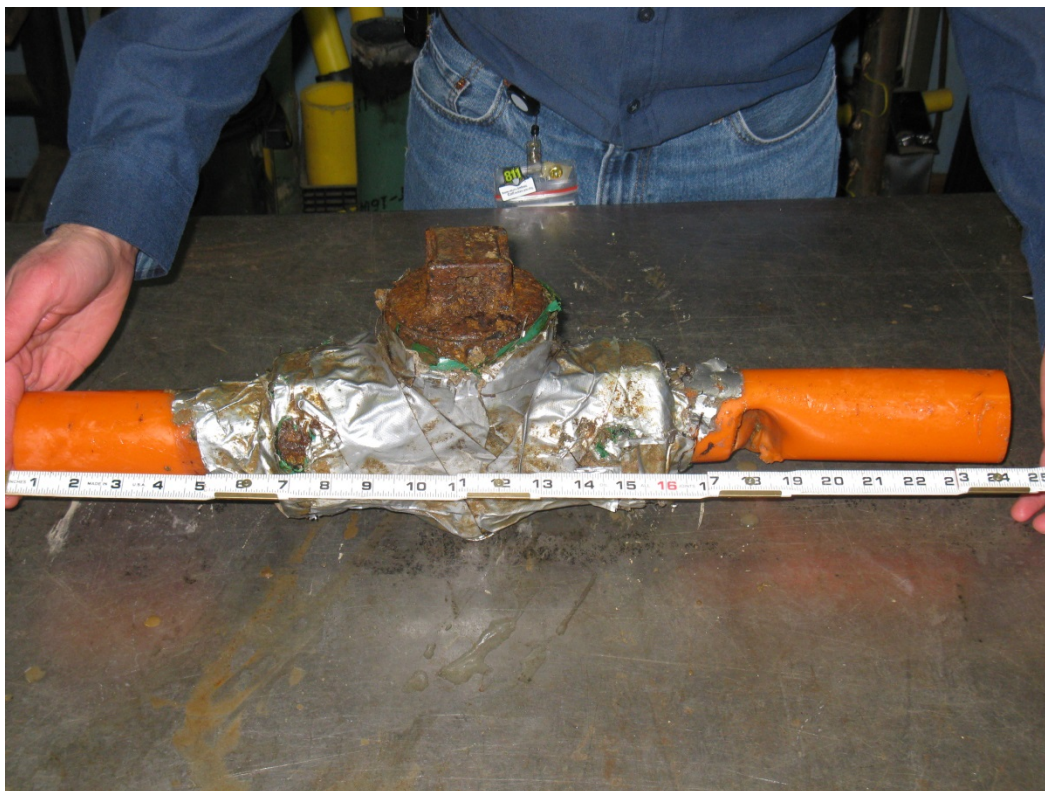
**Photograph #7 – Service line valve and damaged 2-inch diameter PE service line oriented east (left side) to west (right side). (Staff Photo)**

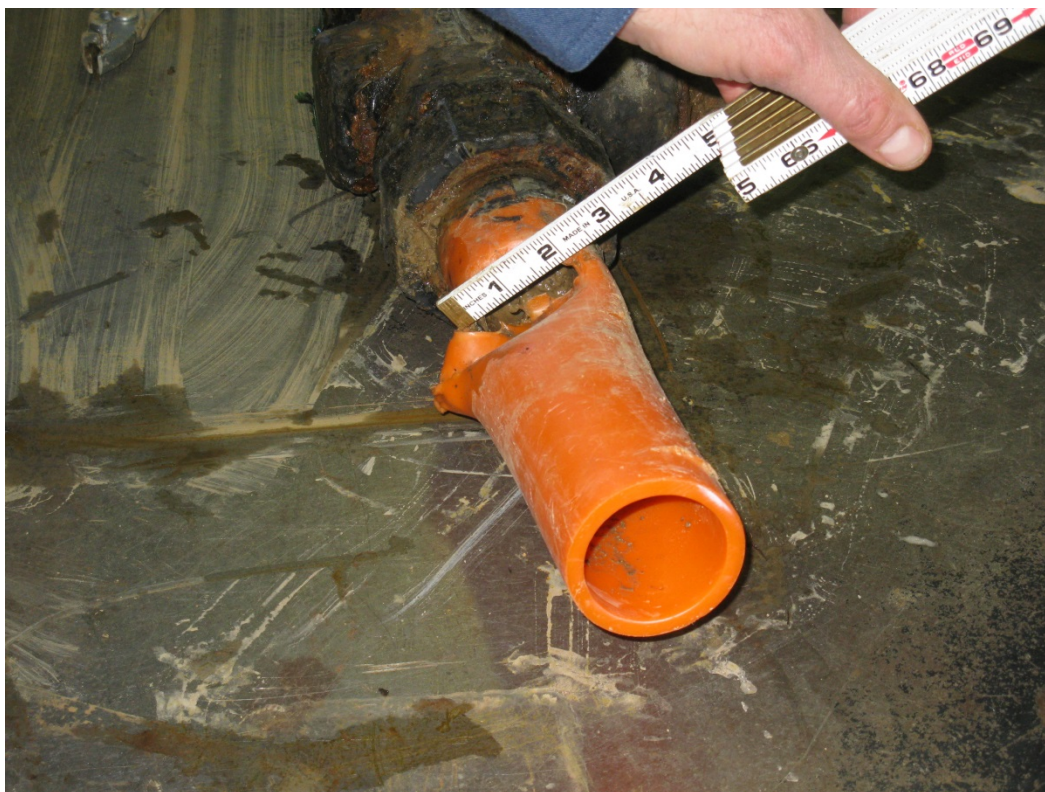
**Photograph #8 – The circumferential dimension of the hole is approximately 2 inches. (Staff Photo)**
