In the Matter of Union Electric Company, d/b/a AmerenUE's Tariffs to Increase Its Annual Revenues for Electric Service

) <u>Case No. ER-2010-0036</u>

Unresolved hazardous conditions at Spring Lake in Jefferson County, Missouri

## The Case of Stray Voltage in a Lake

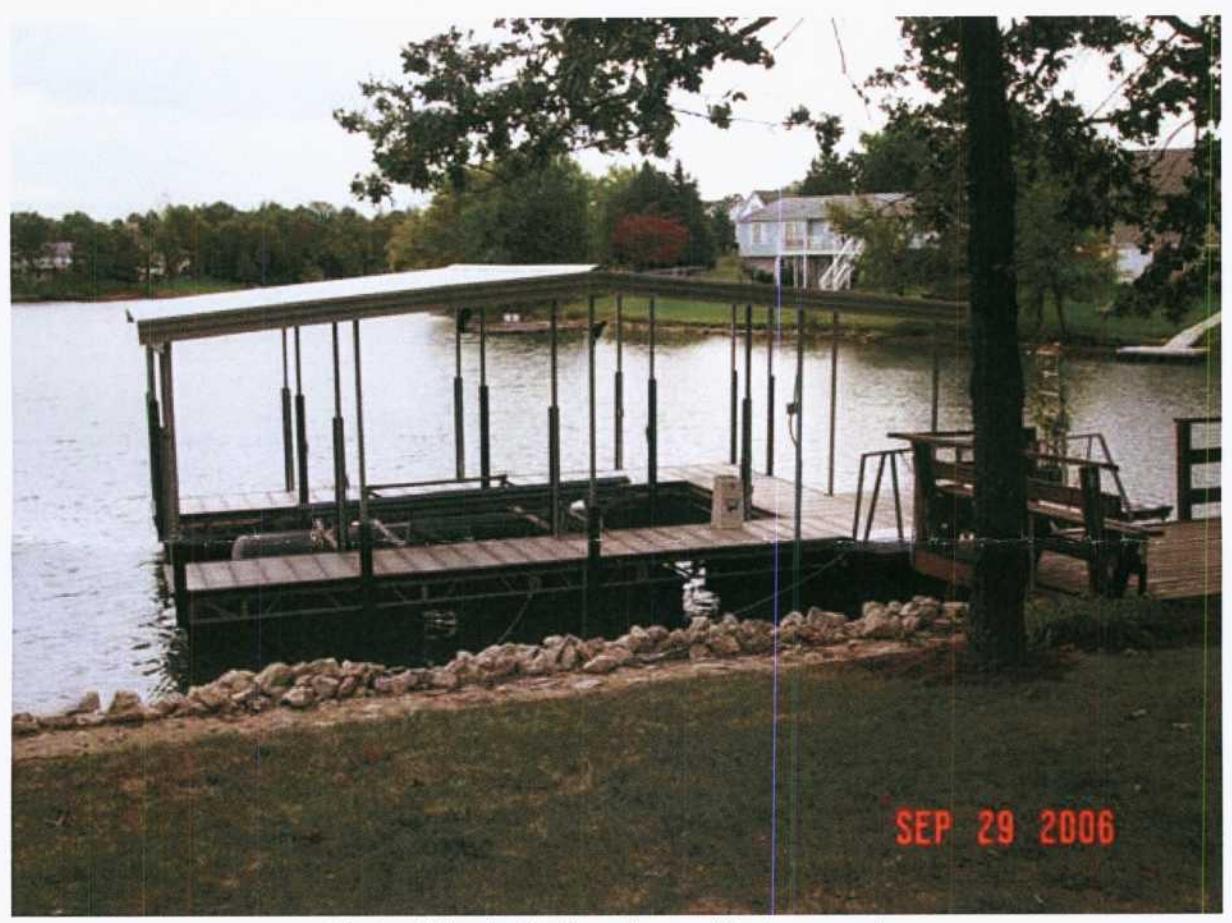
Photo of the dock where the accident occurred.
