**INCIDENT INVESTIGATION
INTERIM REPORT**

**Boiler No. 5 Damage
Hawthorn Plant
Kansas City, Missouri
February 17, 1999**

Prepared by the Staff of the
Missouri Public Service Commission

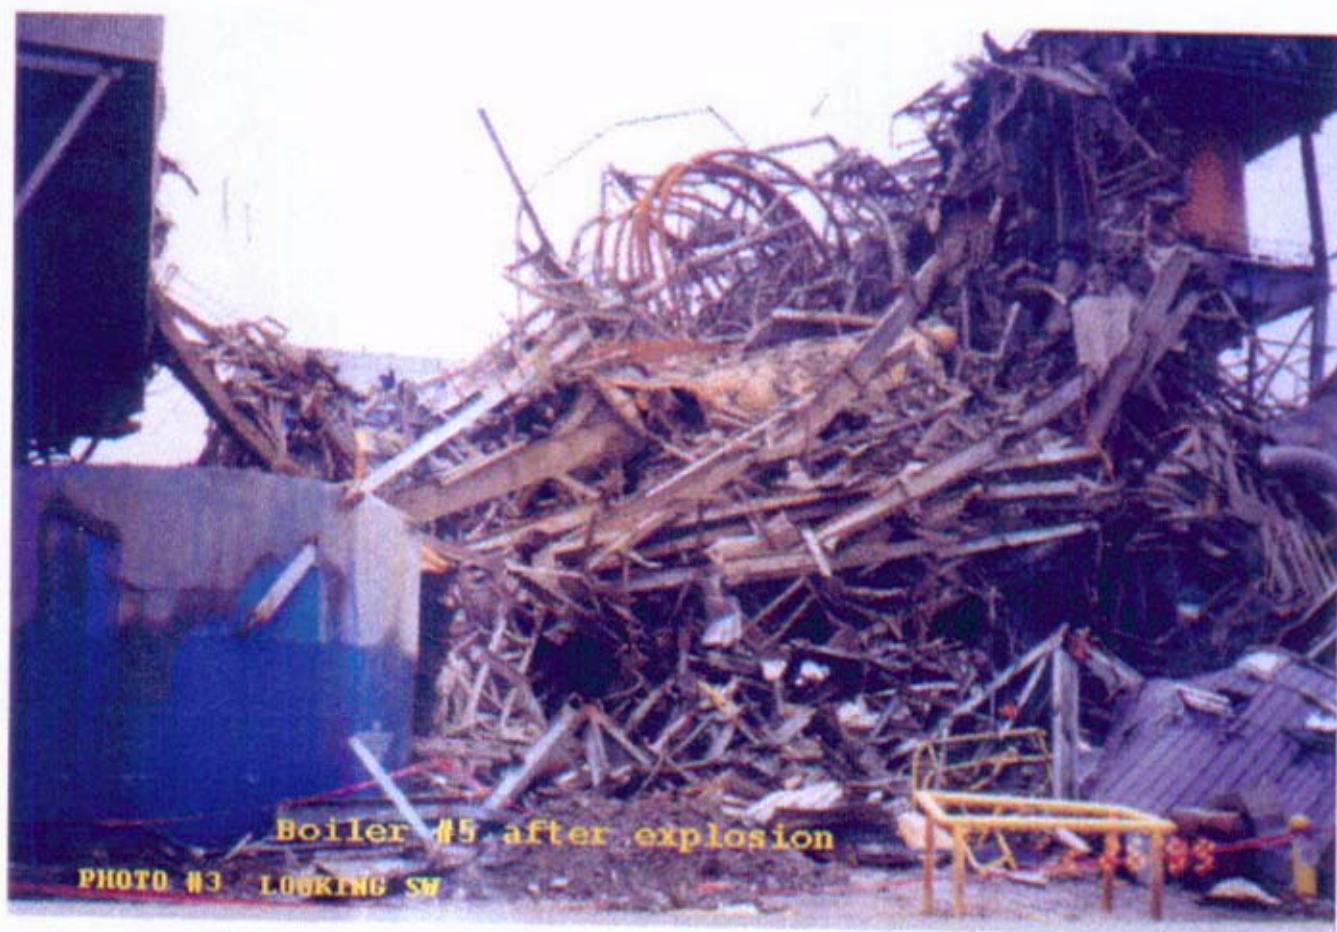
PHOTO #3 LOOKING SW

Boiler #5 after explosion

An explosion occurred at approximately 12:30 a.m. on February 17, 1999, which destroyed Boiler No. 5 at the KCPL Hawthorn Power Plant. (See photographs 1 and 2, Appendix A). The explosion also destroyed the structural steel supporting the boiler, as well as all equipment located in the boiler building. (See photographs 3, 4, 5 and 6, Appendix A). In addition to the boiler, the explosion damaged the coal bunkers and the supporting structural steel, the two precipitators and the associated ductwork, and miscellaneous structures located outside of the boiler building. (See photographs 7, 8 and

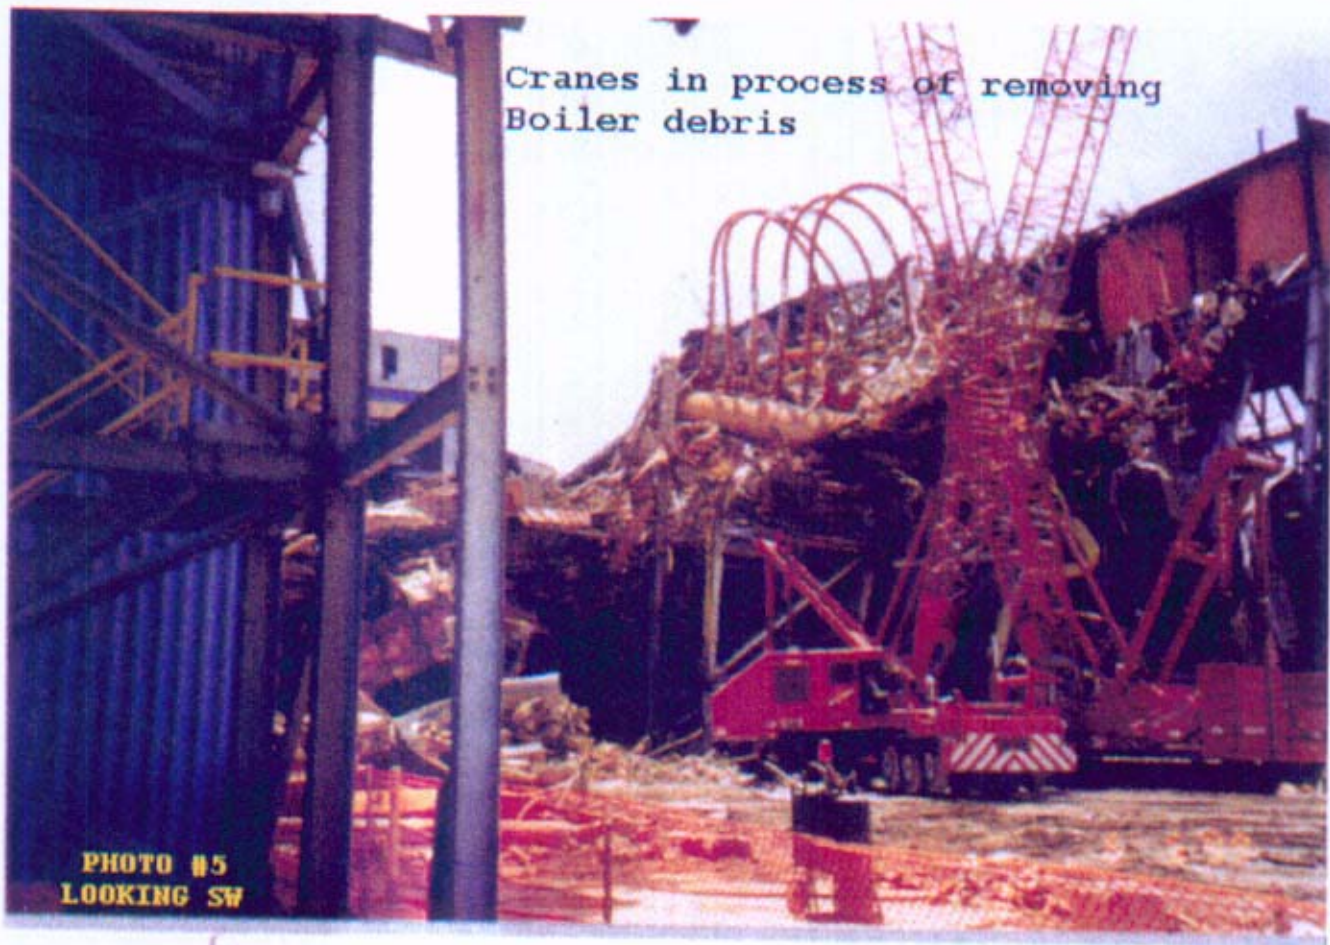
PHOTO #5
LOOKING SW

Cranes in process of removing
Boiler debris

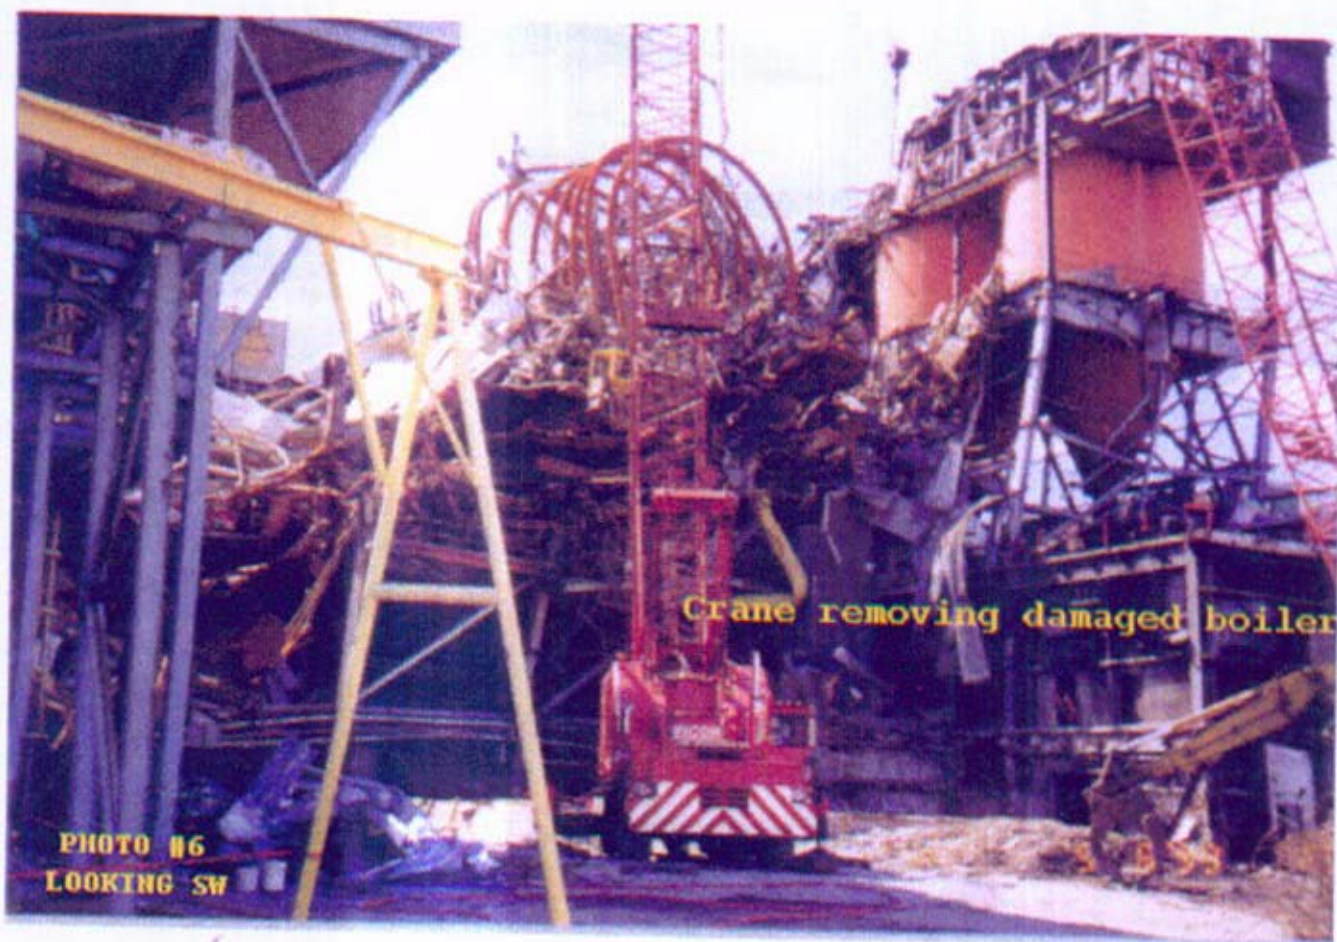
PHOTO #6
LOOKING SW

Crane removing damaged boiler

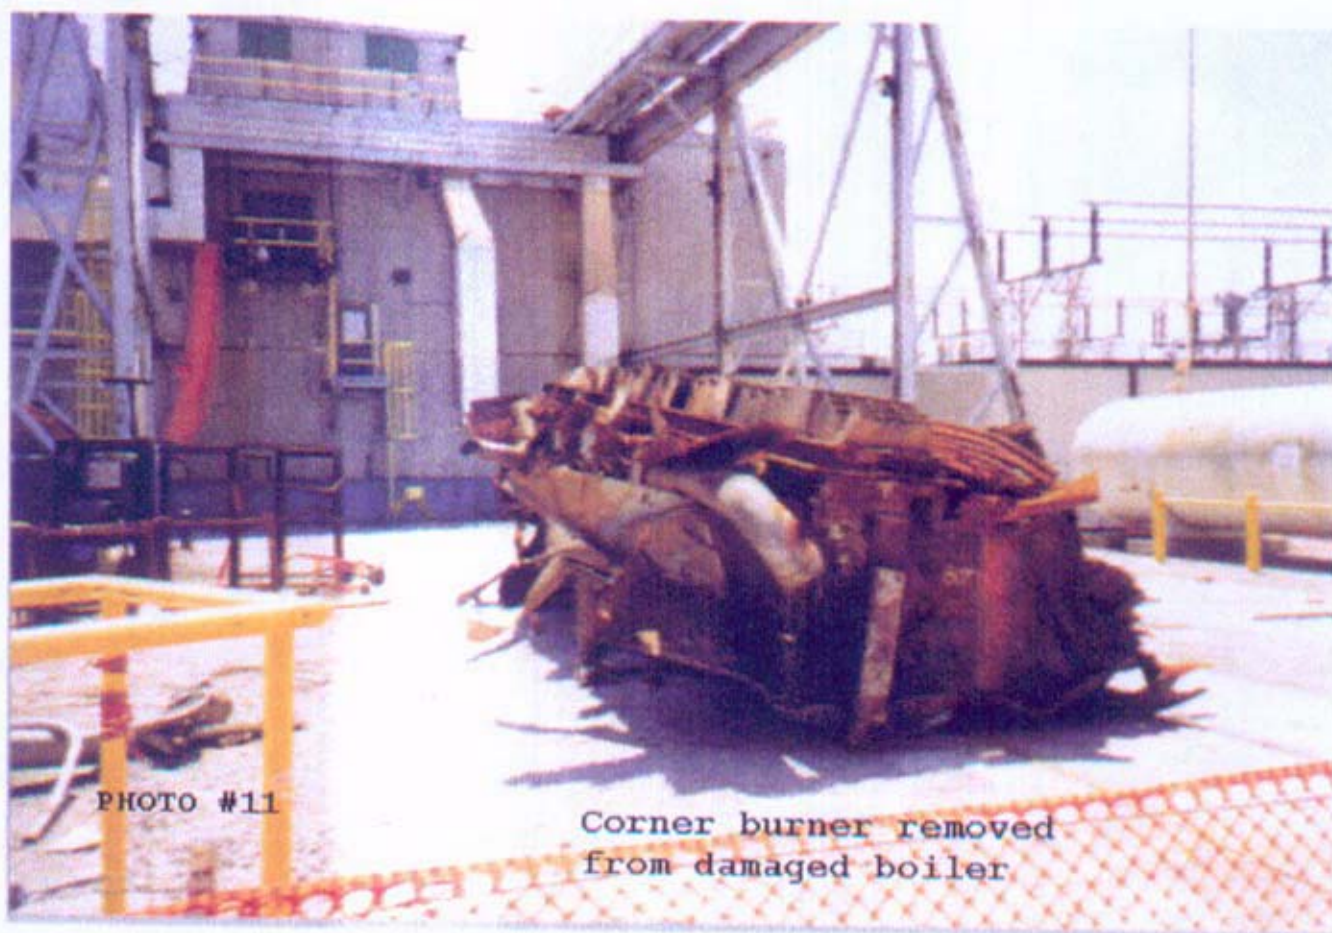
PHOTO #11

Corner burner removed
from damaged boiler

The destroyed boiler and associated structural steel have been removed. The coal and gas burners, gas piping, and all but one of the gas valves have been recovered and are in storage (See photographs 10 and 11, Appendix A), available for the investigation teams to examine.

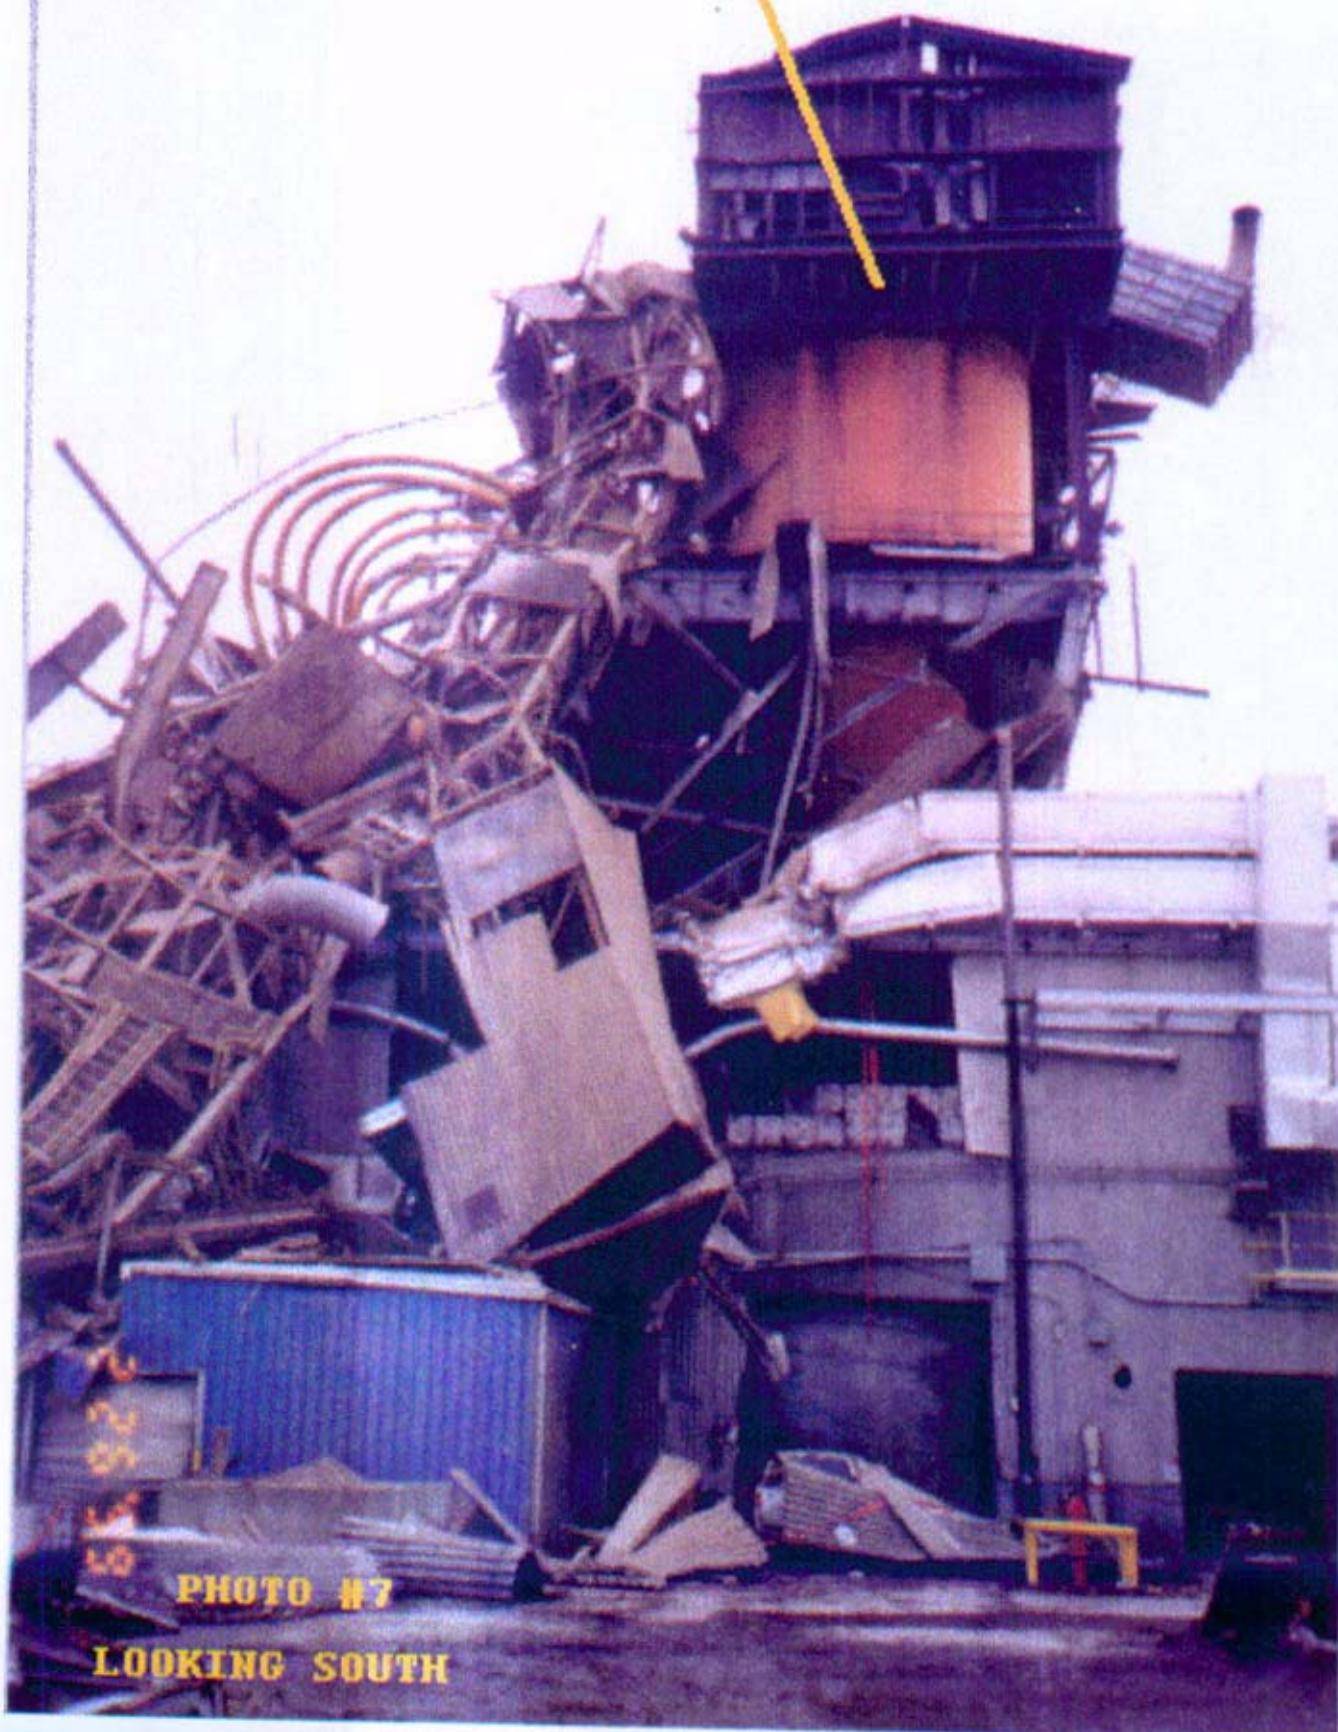
PHOTO #14
LOOKING SW

Coal Bunker structural steel

Coal bunkers leaning
toward turbine room

explosion. Work has begun at the plant for the installation of this new coal fired boiler. Most of the old foundations are being removed in order to install the new foundation to accommodate the new boiler. (See photograph 14 and 15, Appendix A). KCPL estimates the cost of a new replacement boiler to be approximately \$273 million, with a not-to-exceed estimate of \$340 million. KCPL notes that these costs do not include insurance cost recovery because estimates of insurance cost recovery are not available at this time.
