APPENDIX B: Figures

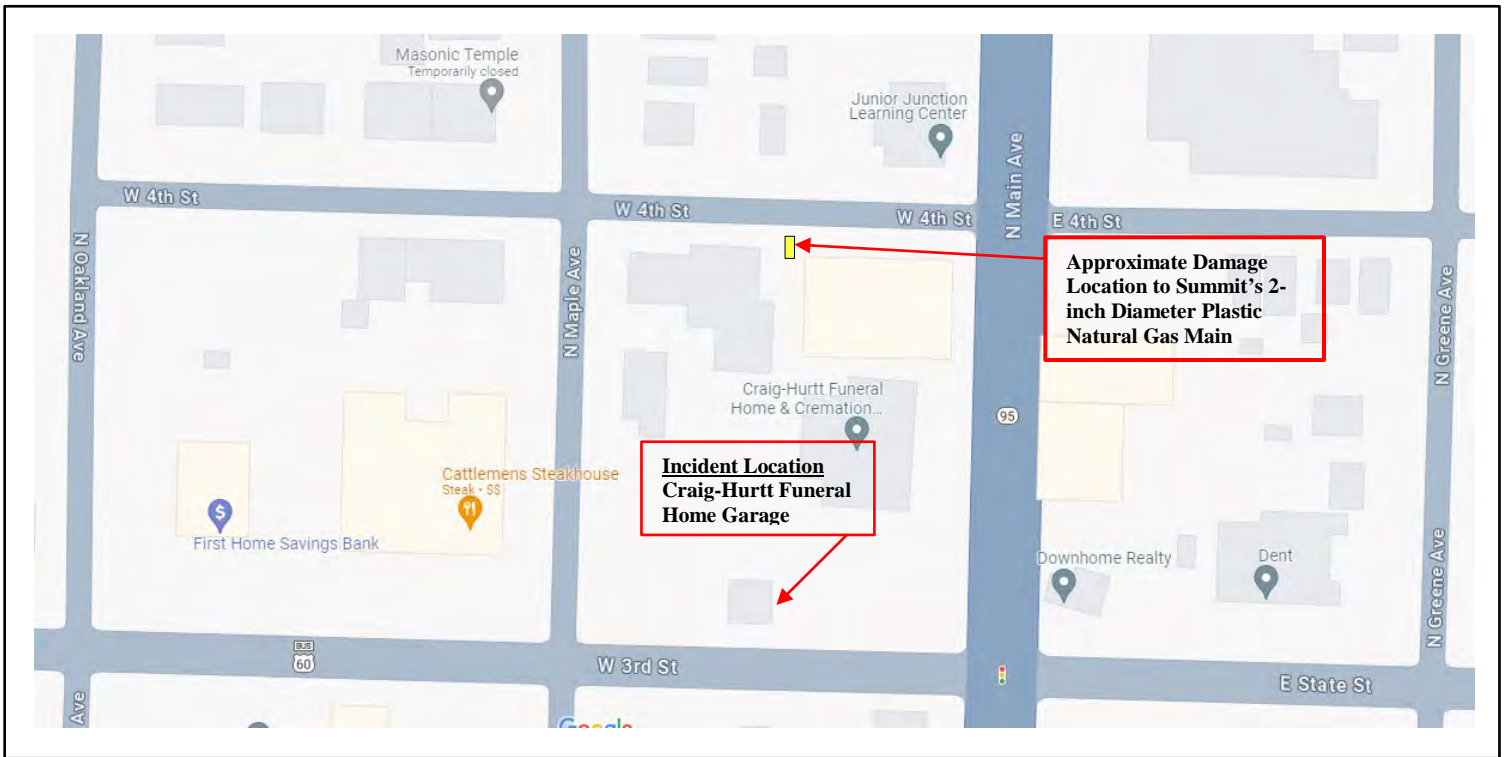
Figure 2: Approximate location of the June 26, 2023 natural gas incident at the Craig-Hurt Funeral Home garage in Mountain Grove, Missouri and the approximate location of damage to Summit's 2-inch diameter plastic natural gas main, Map View (**Source:** Google Maps; text boxes and arrows added by Staff)

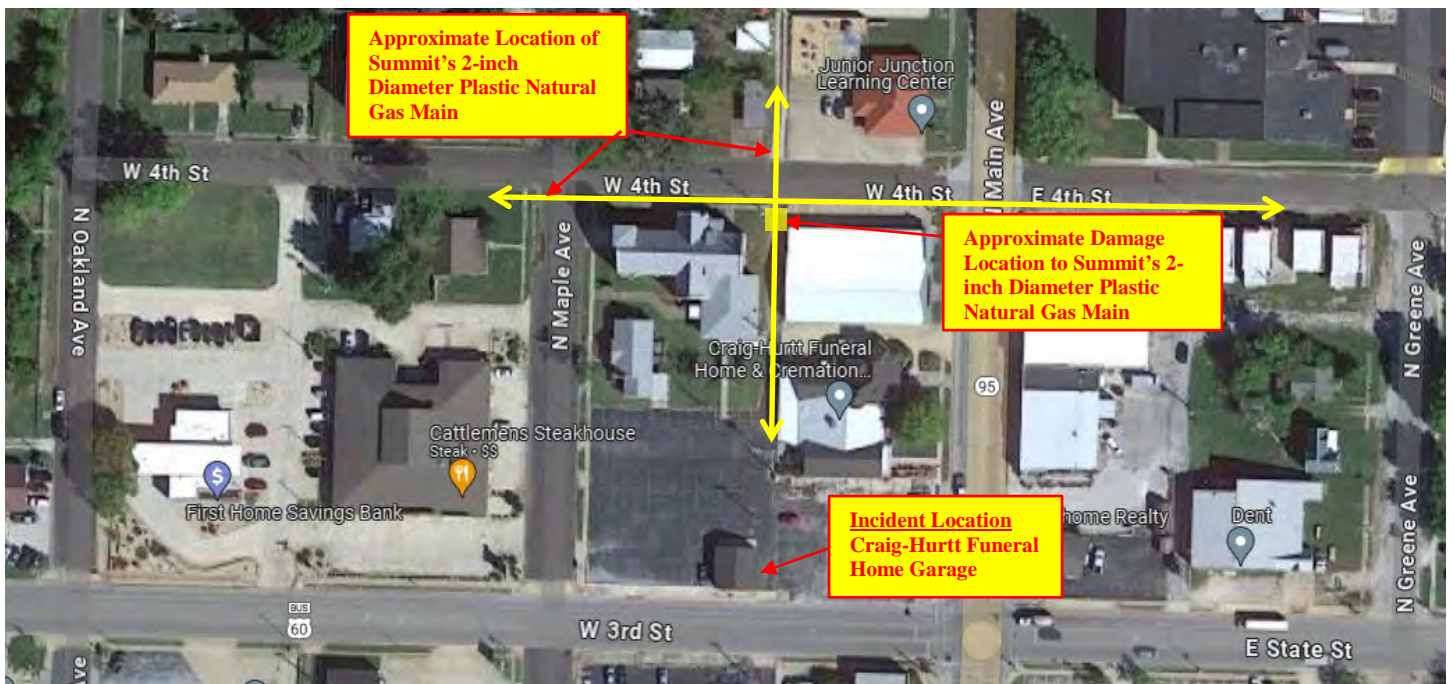
Figure 3: Satellite view showing the approximate location of the June 26, 2023 natural gas incident at the Craig-Hurt Funeral Home garage in Mountain Grove, Missouri, and the approximate location of damage to Summit's 2-inch diameter plastic natural gas main, Map View (**Source:** Google Maps; text boxes and arrows added by Staff)

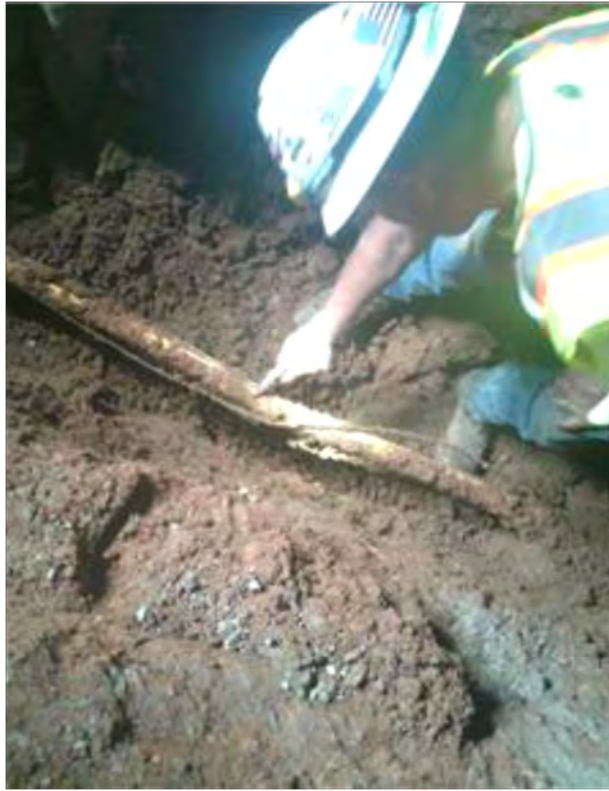
Figure 4: Photograph of Summit's 2-inch diameter plastic natural gas main and tracer wire that was damaged by A&A Cable (contractor working for MasTec) on June 26, 2023 during a directional bore operation. The damage location occurred just south of W 4th Street in an alley between N Maple Avenue and N Main Avenue in Mountain Grove, Missouri. (Source: Summit Photograph)

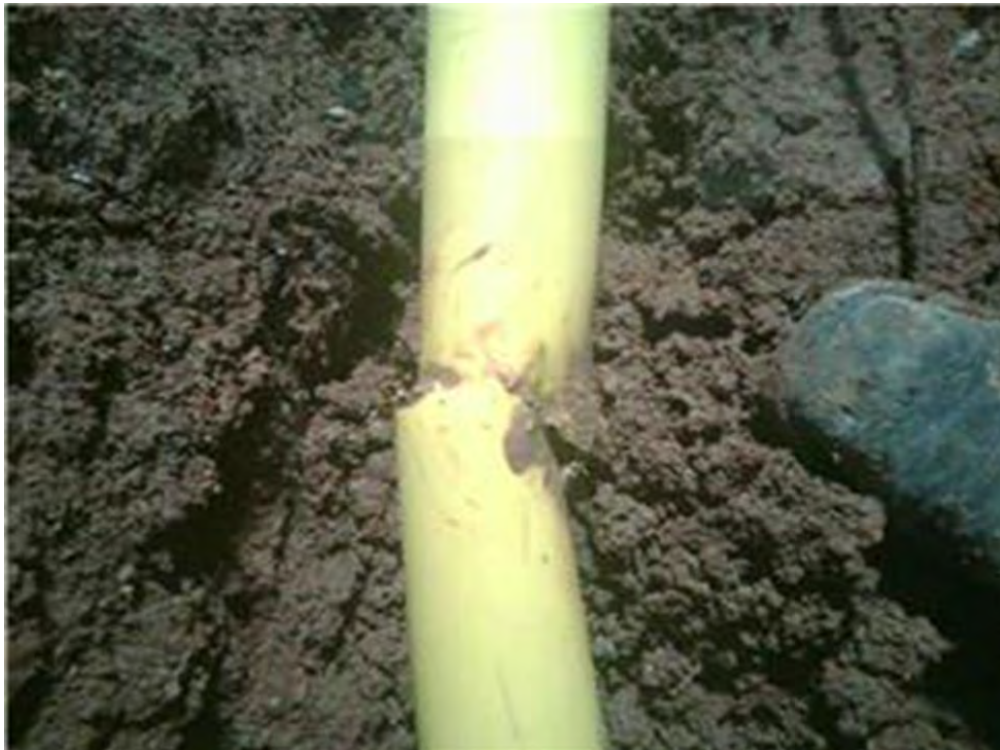
Figure 5: Photograph of Summit's 2-inch diameter plastic natural gas main that was damaged by A&A Cable

on June 26, 2023 in Mountain Grove, Missouri. (Source SNGMO)

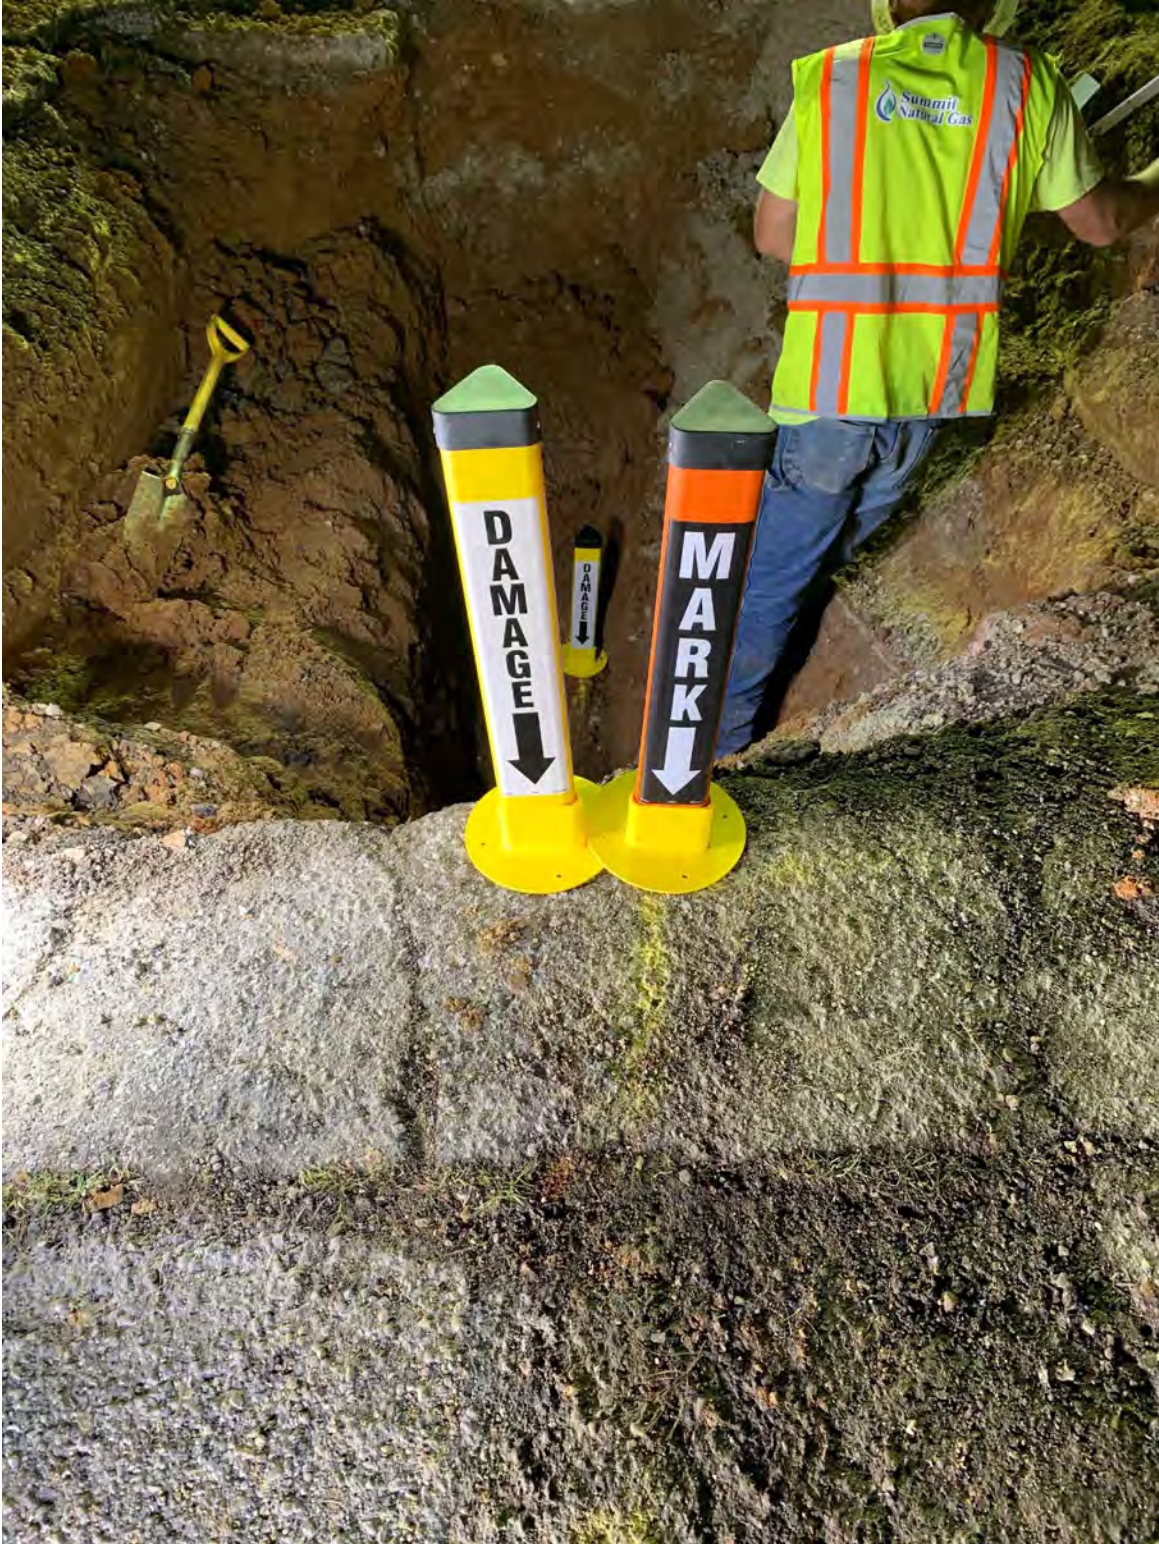
Figure 6: Photograph showing view of Summit’s 2-inch diameter plastic natural gas main, exposed where the damage occurred. “DAMAGE” cones were placed above the located natural gas main, and a “MARK” cone was placed above locate lines painted on the ground. (Source: SNGMO)

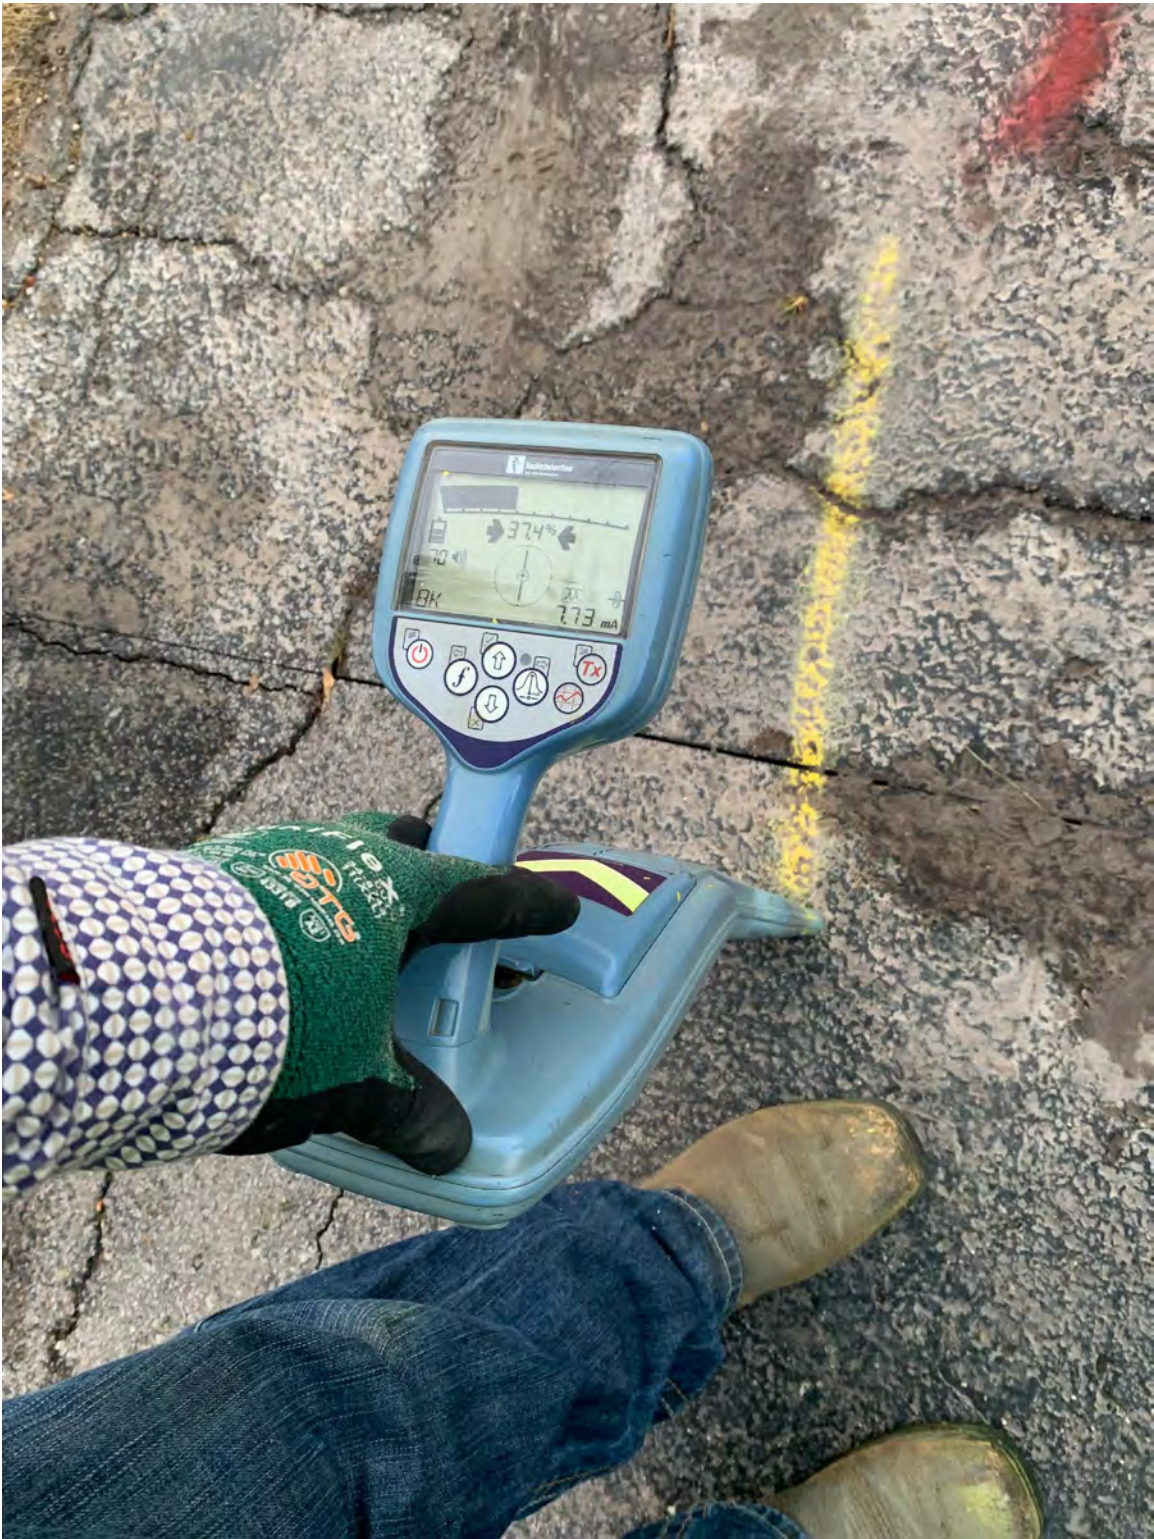
Figure 7: Photograph of SNGMO locating its' natural gas main following the incident to verify the accuracy of previously painted locate lines at the location of the incident. (Source: SNGMO)
