**BEFORE THE PUBLIC SERVICE COMMISSION  
OF THE STATE OF MISSOURI**

**STAFF'S REPORT**

## Gas Incident Report

**West Central Energy  
Case No. GS-2005-0246**

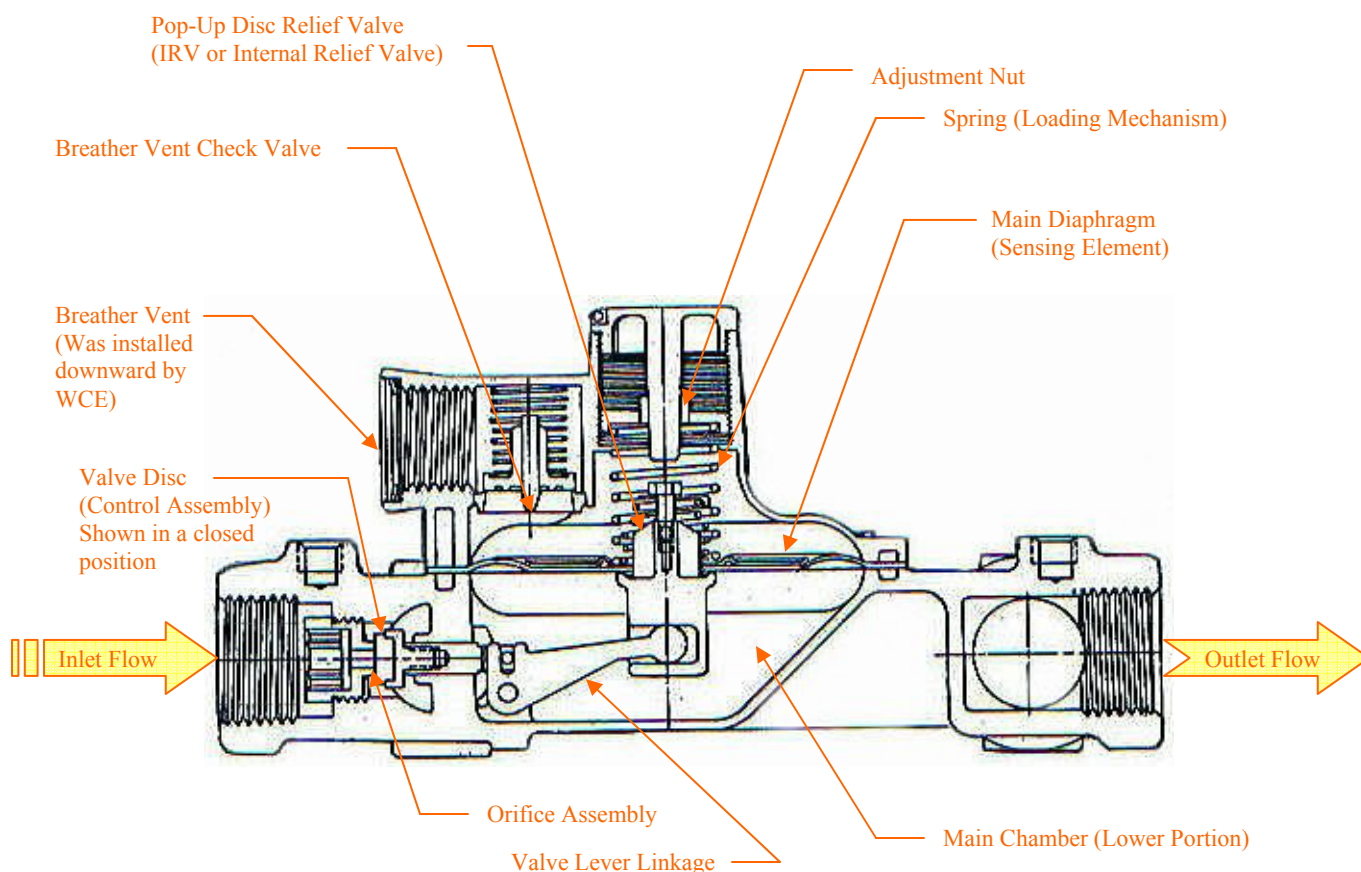
**Figure 1- Sectional View of a Fisher S-254 Service Regulator**

The service regulator involved in each incident was a ¾-inch Fisher S-254 that had 1/8-inch orifice assembly installed. Both service regulators contained breather vent check valves and internal relief valve mechanisms that were designed to vent to the atmosphere. A single vent opening (breather vent) was provided for both relief valves to relieve excess pressure from the top side of the regulator diaphragm. The breather vent allows air to be expelled from or drawn into the regulator when the diaphragm moves, which is necessary for proper operation. (A schematic of the Fisher S-254 regulator can be found within **Appendix C**, on page 2, **Figure 1-Sectional View of a Fisher S-254 Service Regulator.**)

As a means of providing over-pressure protection to the customer’s fuel line piping and downstream natural gas appliances, most residential service regulators are equipped with some type, or combinations, of relief valves. The Fisher S-254 service regulator is equipped with an emergency pop-up disc relief valve (IRV or internal relief valve) which vents excess gas to the top chamber that normally contains atmospheric air. In addition to this relief valve, the service regulator also has a breather vent check valve that vents excess gas through the breather vent assembly. Both the IRV and breather vent check valve typically have a slightly higher set point value than the set pressure of the service regulator so gas will not vent during normal operation. Both the IRV and breather vent check valve consist of a spring, a valve, and an orifice assembly.
