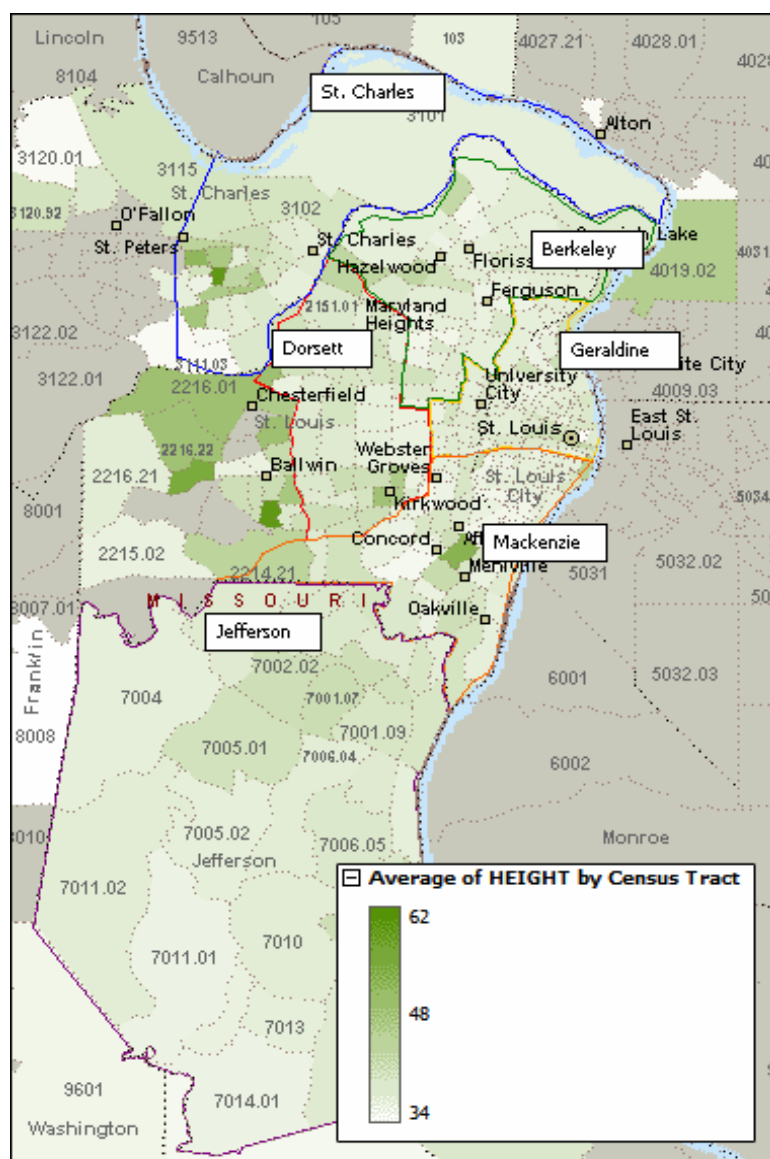
**Exhibit 3-8: Average Pole Height (ft)**

The areas with lower pole class (stronger poles) coincide with taller poles. This phenomenon exists in the St. Charles, Dorsett and Jefferson districts.

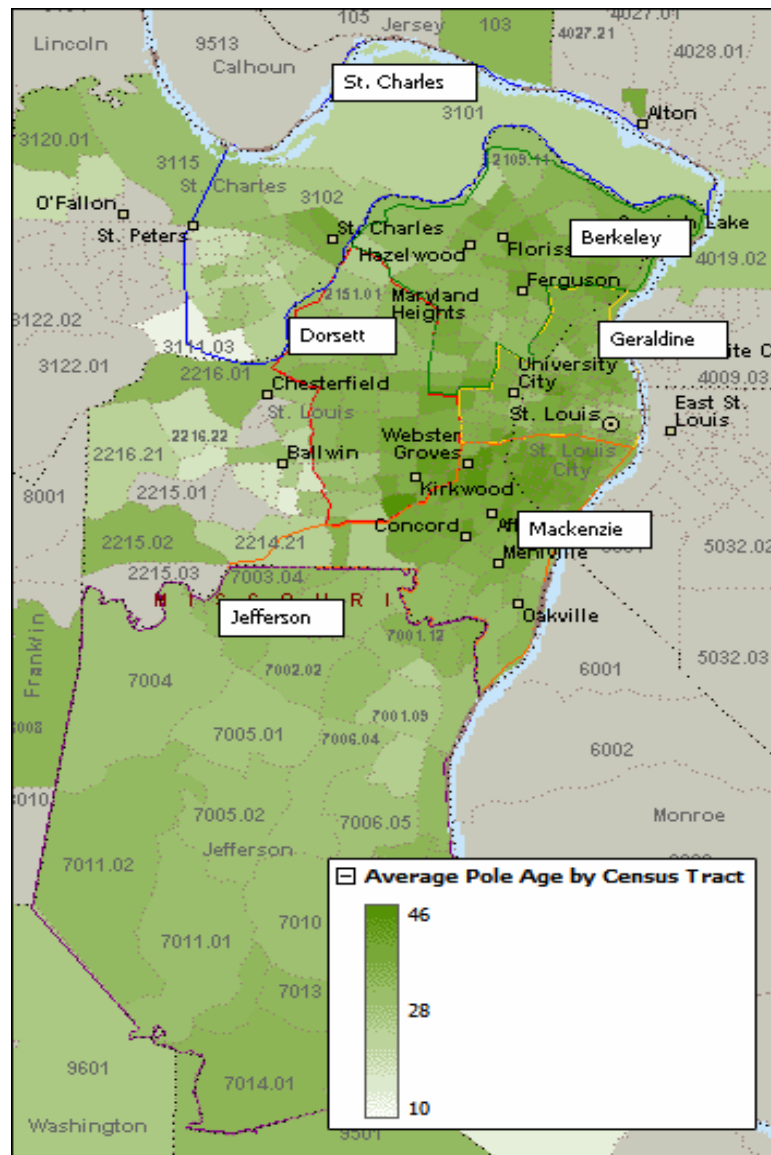
**Exhibit 3-9: Average Pole Age (yr)**

The average pole age tends to correlate positively with pole failure rates. As poles age, they potentially weaken and become more susceptible to the elements. It is therefore beneficial to determine the age of the poles (and later condition of the poles) in the areas affected by the storm. Exhibit 3-9 provides the results. St. Charles and Jefferson appear to have a relatively younger age distribution of

poles, indicating that they, assuming all else is equal, should experience relatively less structural damage. The fact that Jefferson did have weaker poles on average may be negated by the fact that these poles were younger on average as well.

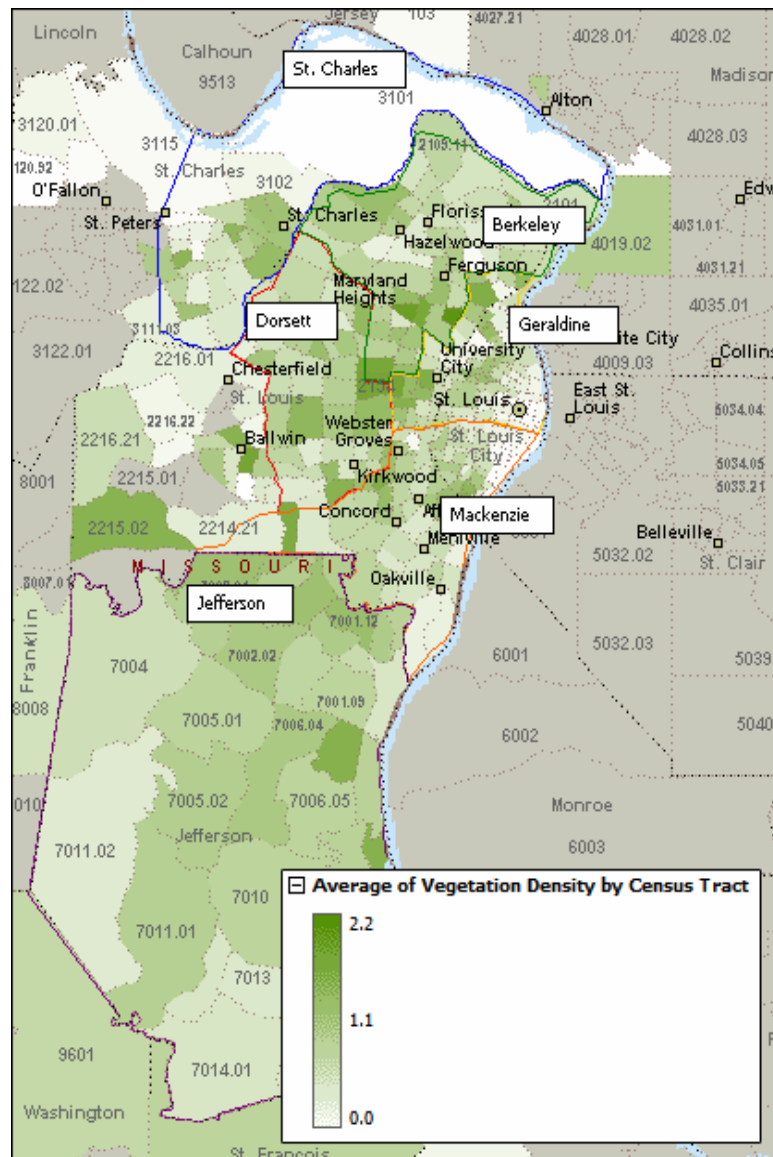
**Exhibit 3-10: Average Vegetation Density**

form of debris (loosened branches) at high wind speeds. Vegetation density, as shown in Exhibit 3-10, is determined by a weighted average of the subjective vegetation assessments as per pole audit. This weighted average is divided by the square miles for the area of interest. The St. Charles district appears to have less vegetation relative to other districts; therefore, expected to experience less damage, assuming all other factors are equal.

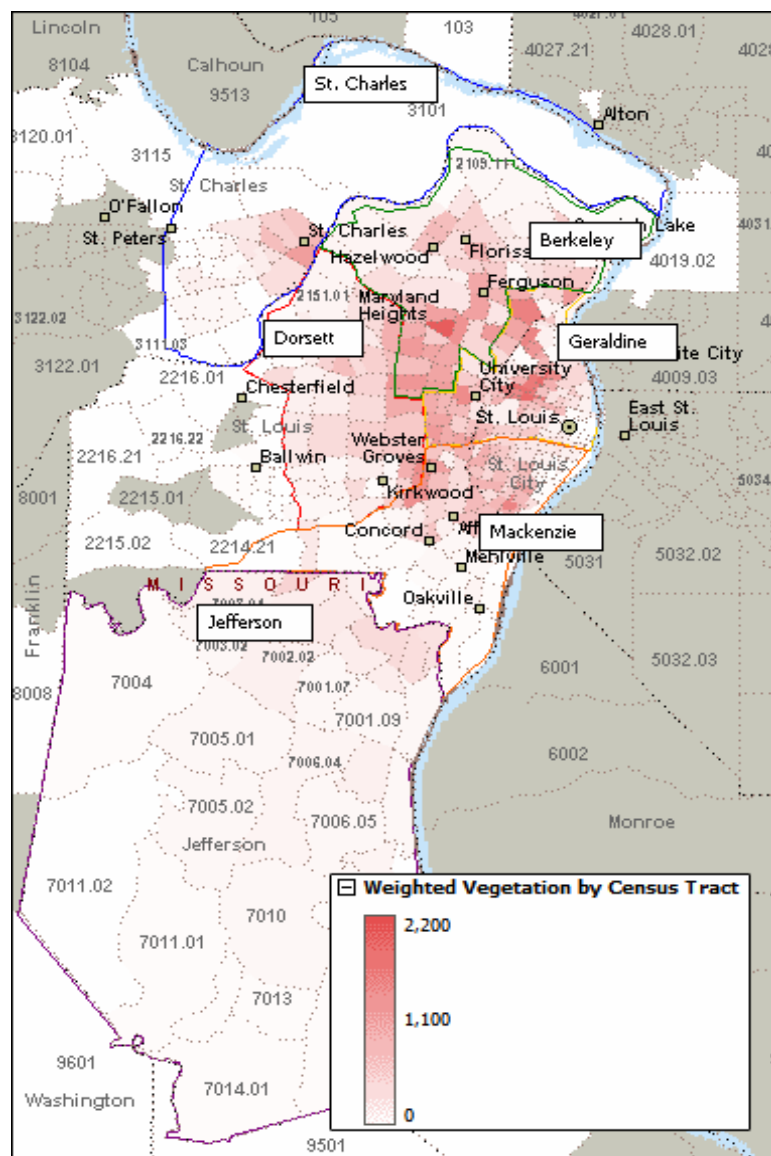
**Exhibit 3-11: Vegetation Density Weighted by Pole Density**

In order to determine which areas are at risk for outages caused by vegetation it is important to capture the amount of vegetation and the amount of customers in the areas of interest. Vegetation densities are weighted by pole densities (as a proxy for customer density), as displayed in Exhibit 3-11. Because Berkeley, Geraldine, Mackenzie and to an extent Dorsett are densely populated with trees and have high pole (customer) densities, it is expected that these areas are more susceptible to damage and (impact of) outages by trees.

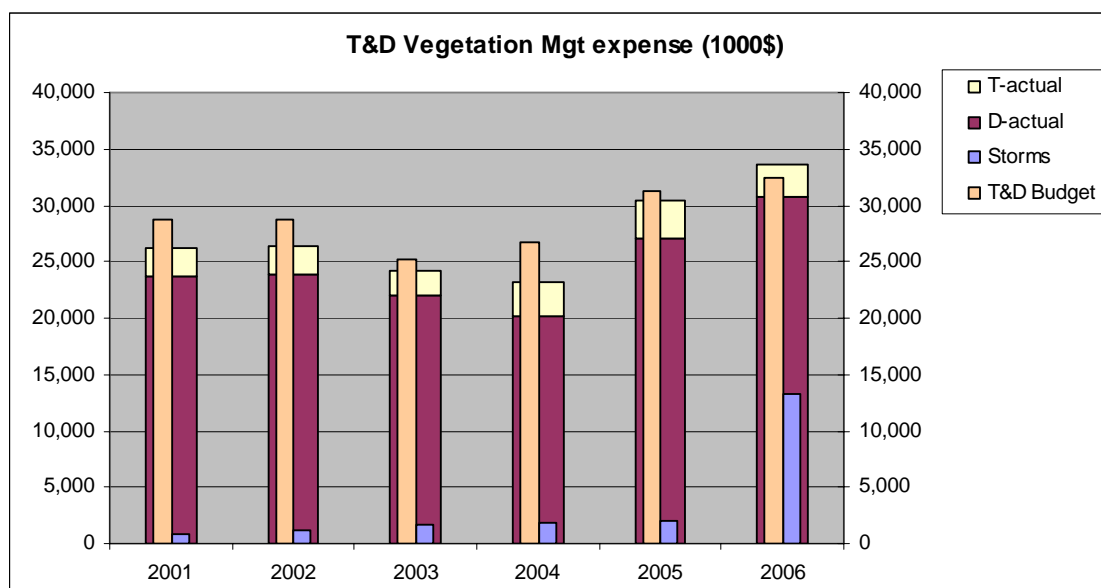
**Exhibit 3-14: Trend in Vegetation Management budget and spend**

Evaluation of AmerenUE's vegetation management budget and spending results in the apparent absence of a storm reserve (refer to Exhibit 3-14). AmerenUE does not maintain reserves for any storm related spending as severe storms rarely occurred in the area. Prior to the 2006 July storm, AmerenUE had experienced only a maximum of 3.5 storm days. The restoration time target is less than 72 hours.

It can be observed that the budget is not fully used except for the most recent year (2006). This could lead to the interpretation that AmerenUE may withhold a storm reserve throughout the year within the business lines and consequently does not spend the full budget on cycle work. This coincides with the fact that cycle work backlog exists and was growing until 2005. However, the true interpretation of the under-spending has to do with resource unavailability, storm expenditures (including resources) and mutual aid. AmerenUE's vegetation management budget has been ramping up since 2004 (after a budget cut in 2003 that coincided with the budget cut related to the pole inspection program) and has reduced the growth of cycle work backlog since then but has been hampered by increasing storm related spending and a loss of available labor resources due to hurricane assistance as part of the mutual aid arrangements.

The extremely high storm expense in 2006 is noted as well as the fact that, even with the high storm incidence that year, the company was still able to complete more cycle work than in previous years.

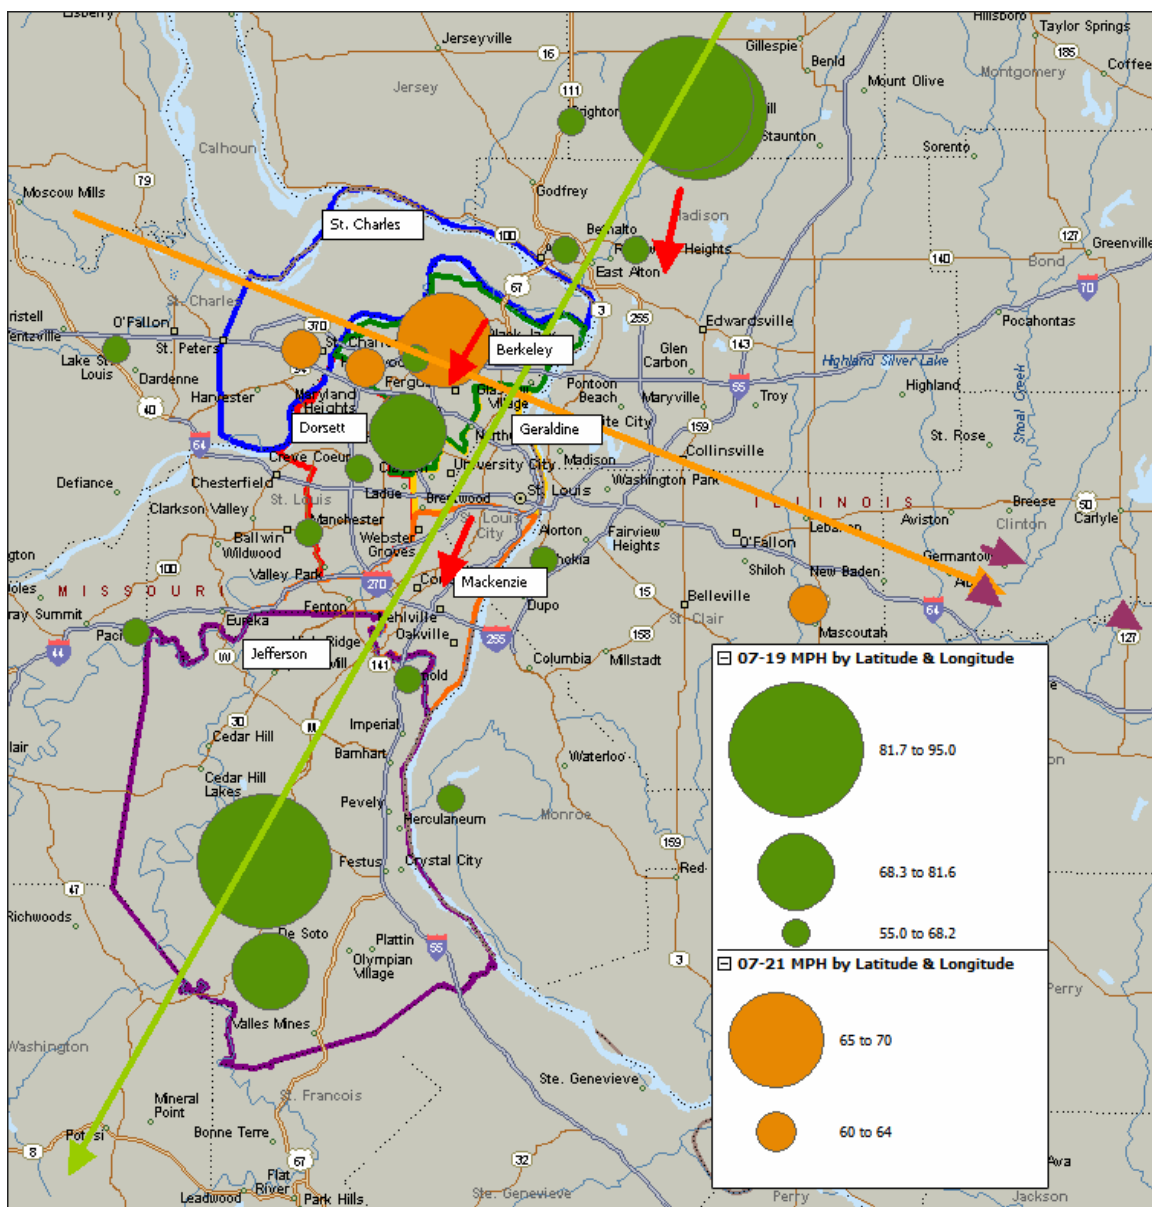
**Exhibit 3-18: July Storm Events**

The storm's summary along with local storm reports that contain measured wind speed in miles per hour along with latitude and longitude to define the location, reference Exhibit 3-18. Larger circles indicate higher wind speeds. The green storm path and associated wind speeds relate to the July 19<sup>th</sup> storm, the orange is the July 21<sup>st</sup> event. In the area of review we see higher reported wind speeds in Berkeley, on the edge of Dorsett and Jefferson. Downbursts, denoted by red and purple arrows for the July 19<sup>th</sup> and 21<sup>st</sup> storms respectively, were experienced in small areas within the Berkeley and Mackenzie districts. Note, that this graph only represents recorded wind speeds. The number of locations is limited

by the lack of additional weather stations and trained spotters. Most likely, there are other areas affected by high wind speeds that went unrecorded.
