Missouri Public Service Commission

Staff's Gas Incident Report

910 W 48<sup>th</sup> Street  
Kansas City, Missouri  
February 19, 2013

**Missouri Gas Energy**  
**Case No. GS-2013-0400**

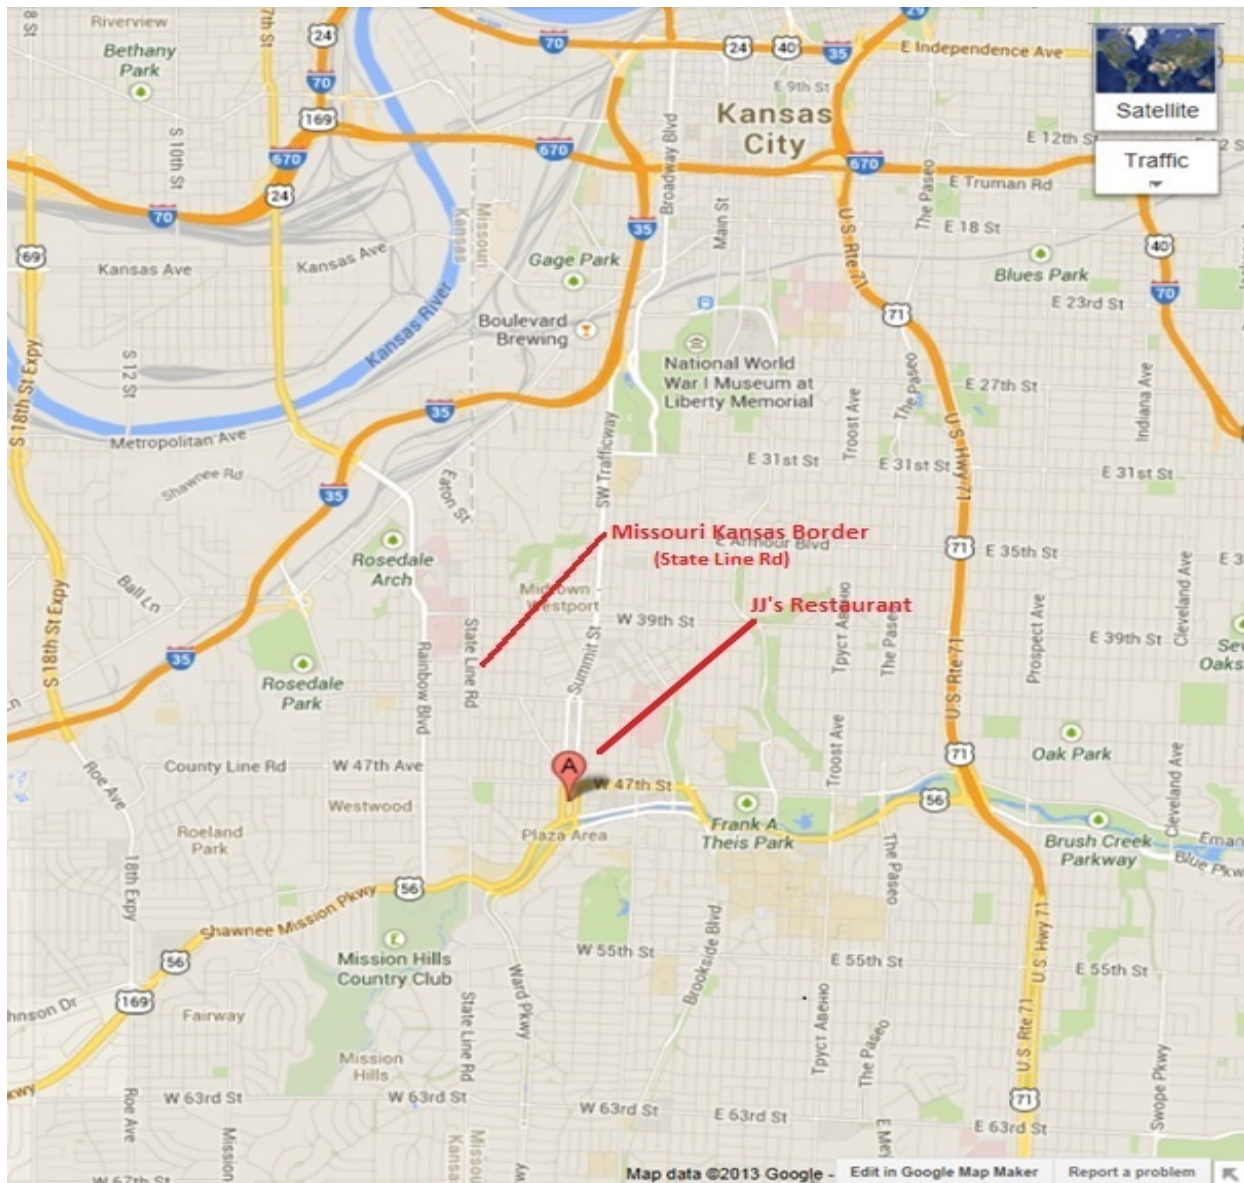
JJ's Restaurant is located at 910 W. 48<sup>th</sup> Street (the northeast corner of W. 48<sup>th</sup> Street and Belleview Avenue) in Kansas City, Missouri near the west end of the area known as the Plaza (See Appendix B, Figure 3). W. 48<sup>th</sup> Street runs in an east/west direction. There are several

Figure 3 - Overall location of 910 W. 48<sup>th</sup> Street, as shown at Point A, with respect to Kansas City, Missouri and surrounding highways (Map provided by Google Maps).

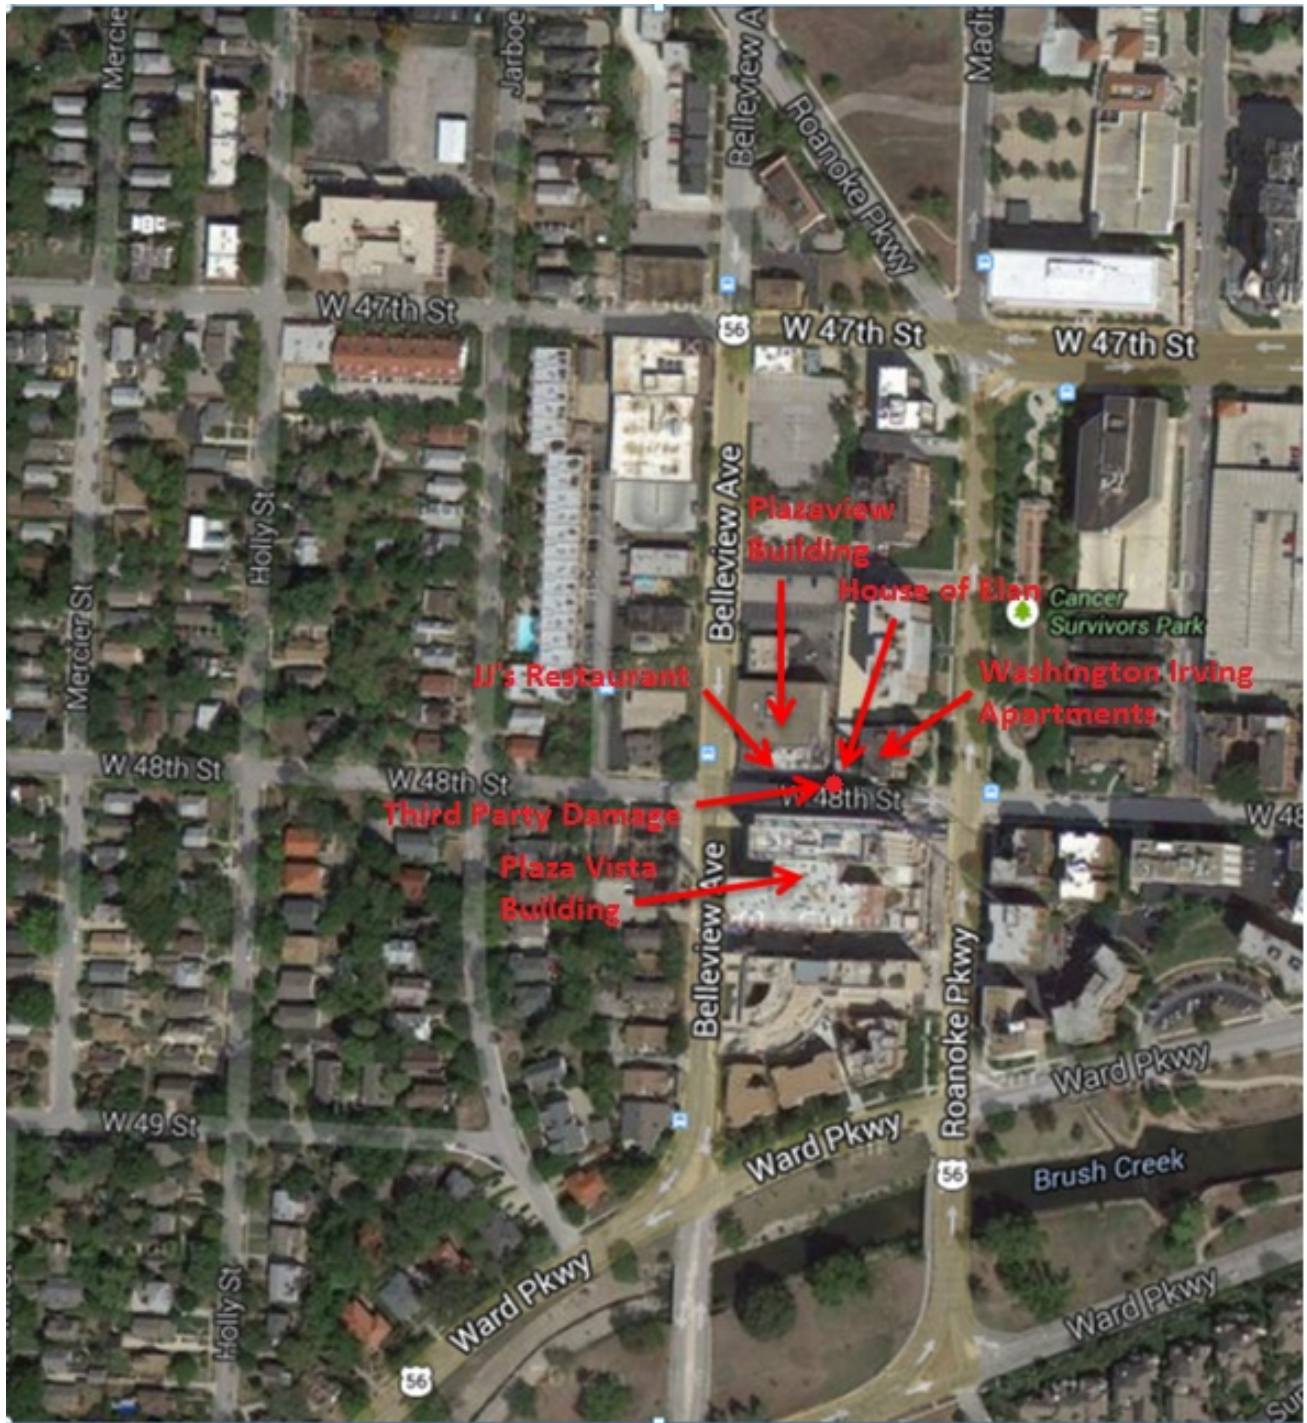
1 structures surrounding JJ's Restaurant: commercial businesses, single-family residences and  
2 apartment buildings (See Appendix B, Figure 4). The main entrance to JJ's Restaurant faced  
3 south toward W. 48<sup>th</sup> Street; however, there were also entrances at the southwest corner of JJ's  
4 Restaurant and near the northeast corner of JJ's Restaurant facing the alley.

Figure 4 - Incident Site and Buildings Immediately Surrounding the Area (Map provided by Google Maps).
