Staff Final Electric Incident Report

**Kansas City Power & Light Company
Case No. ES-99-581**

**Hawthorn Station
Boiler No. 5 Explosion
Kansas City, Missouri
February 17, 1999**

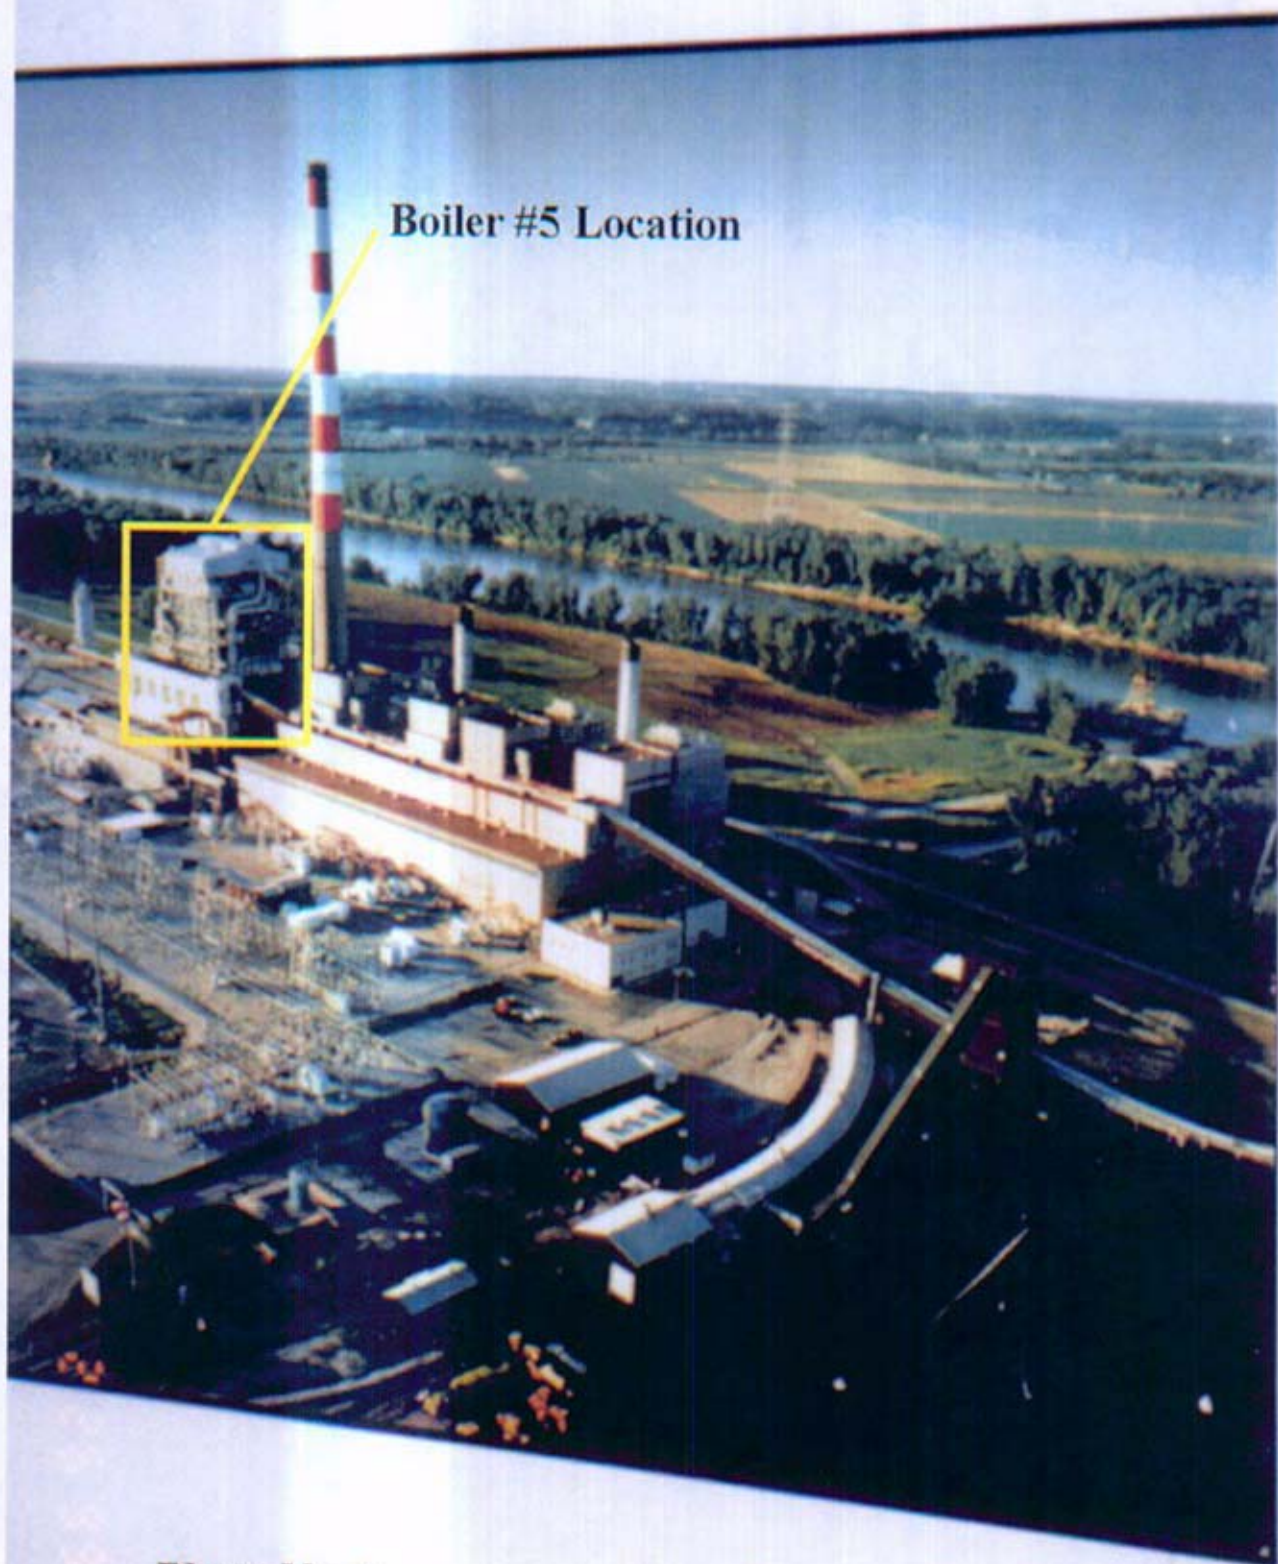
Photo No. 1

The Hawthorn Station, prior to the time of the explosion, consisted of a steam boiler and a turbine-generator identified as Unit #5, and one combustion turbine identified as Unit #6. The plant is owned and operated by KCPL, of Kansas City, Missouri. The plant is located near the Missouri River in Kansas City, Missouri (see photograph 1 in Appendix A).

Boiler #5 Control Room

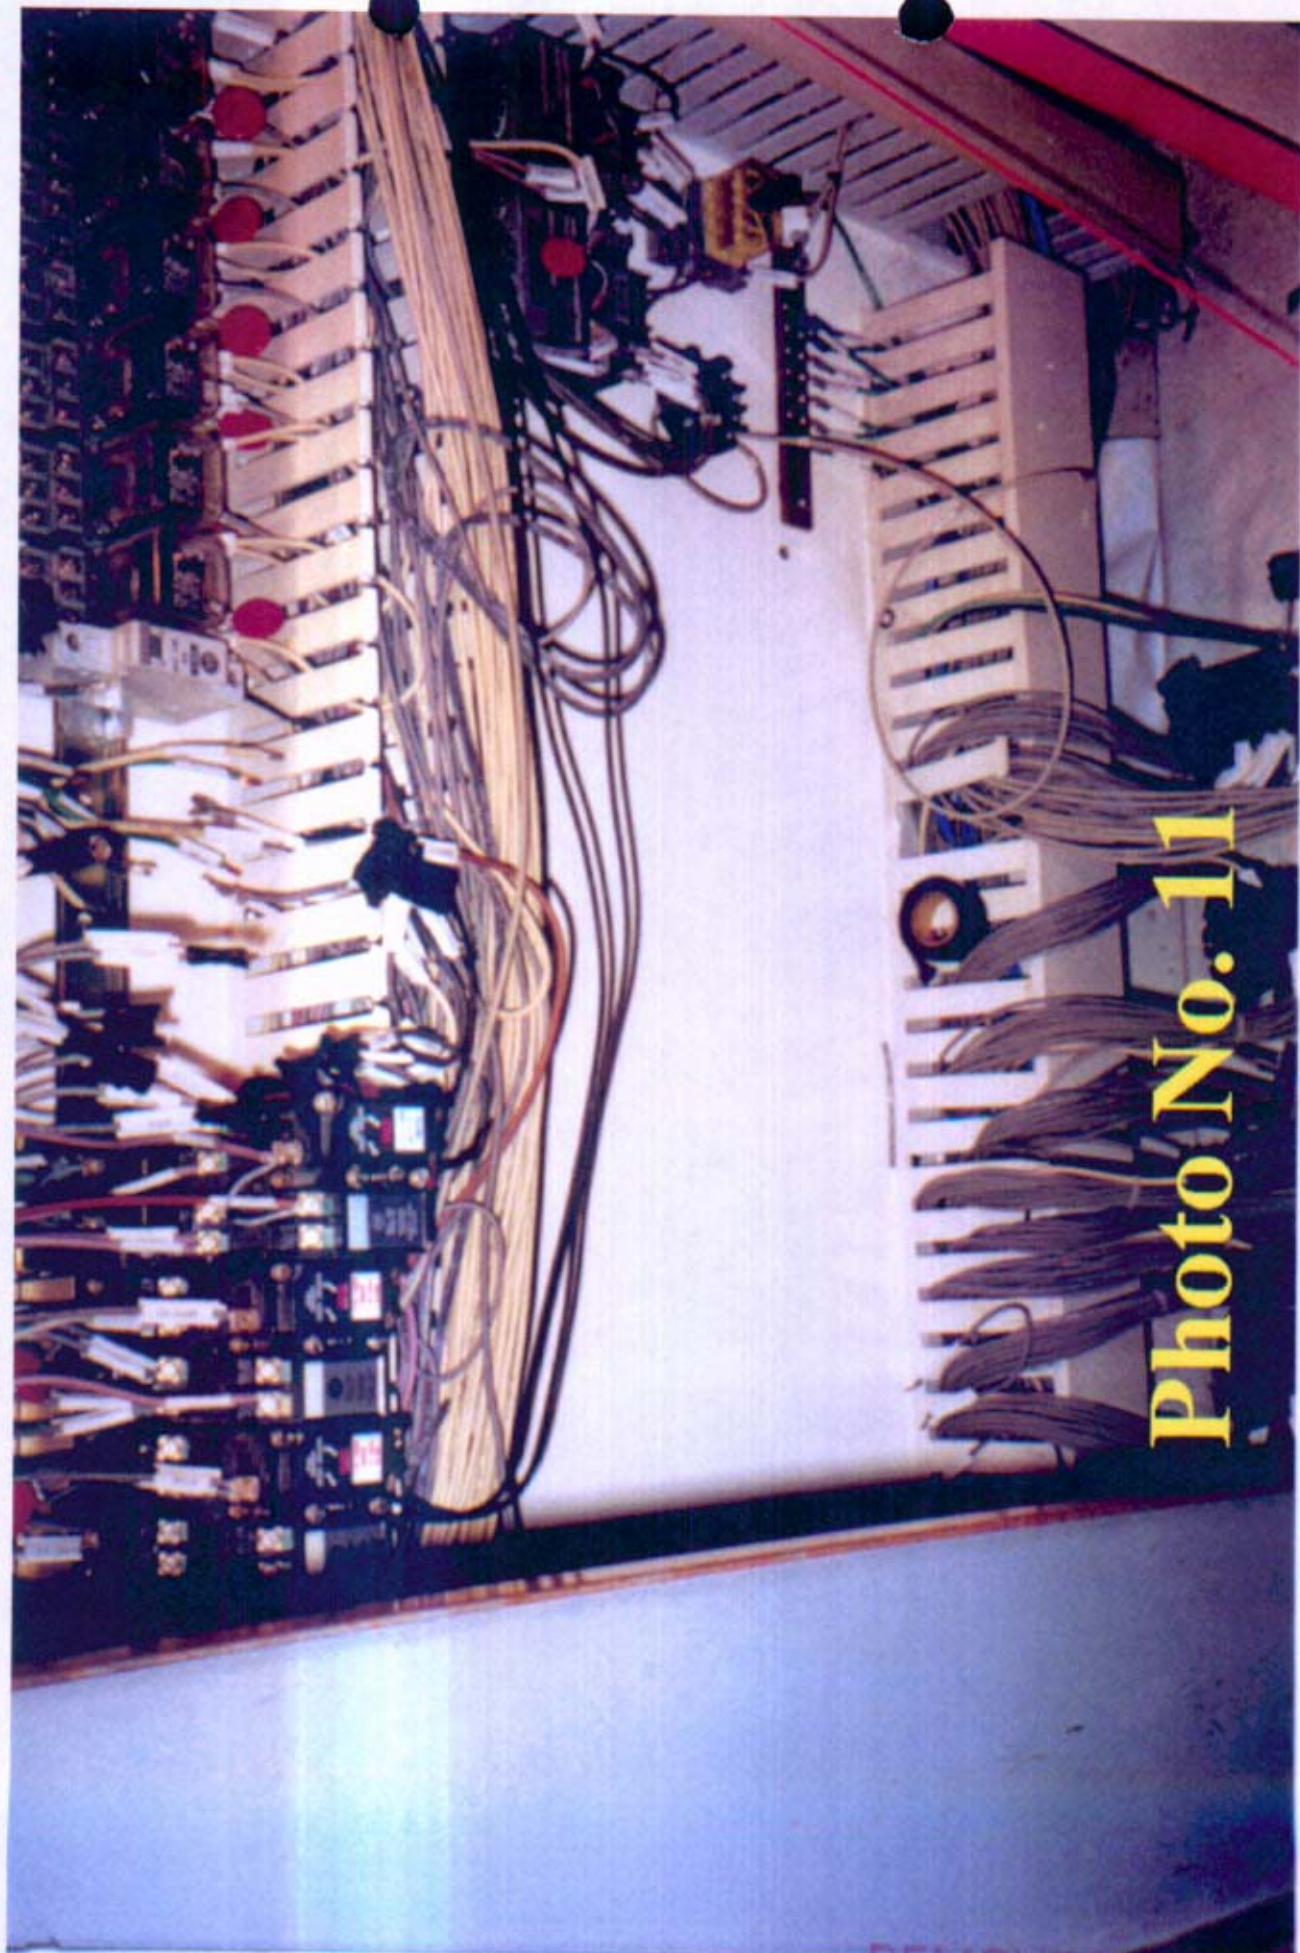
Photo No. 11

The BMS control cabinets contained wiring, terminal strips, relays, solenoid coil monitoring (SCM) devices, and the PLC racks which contain electronic control cards (see photographs 11, and 12 in Appendix A). Water got into racks #1 and #2 of the PLC and the BMS began giving alarms, and fault indications. The water also tripped an AC circuit breaker and shorted out the SCM-3 device located in the BMS cabinets (see figure 1-2 in Appendix B). The water overflow stopped at approximately 3:00 p.m. on February 16, 1999.

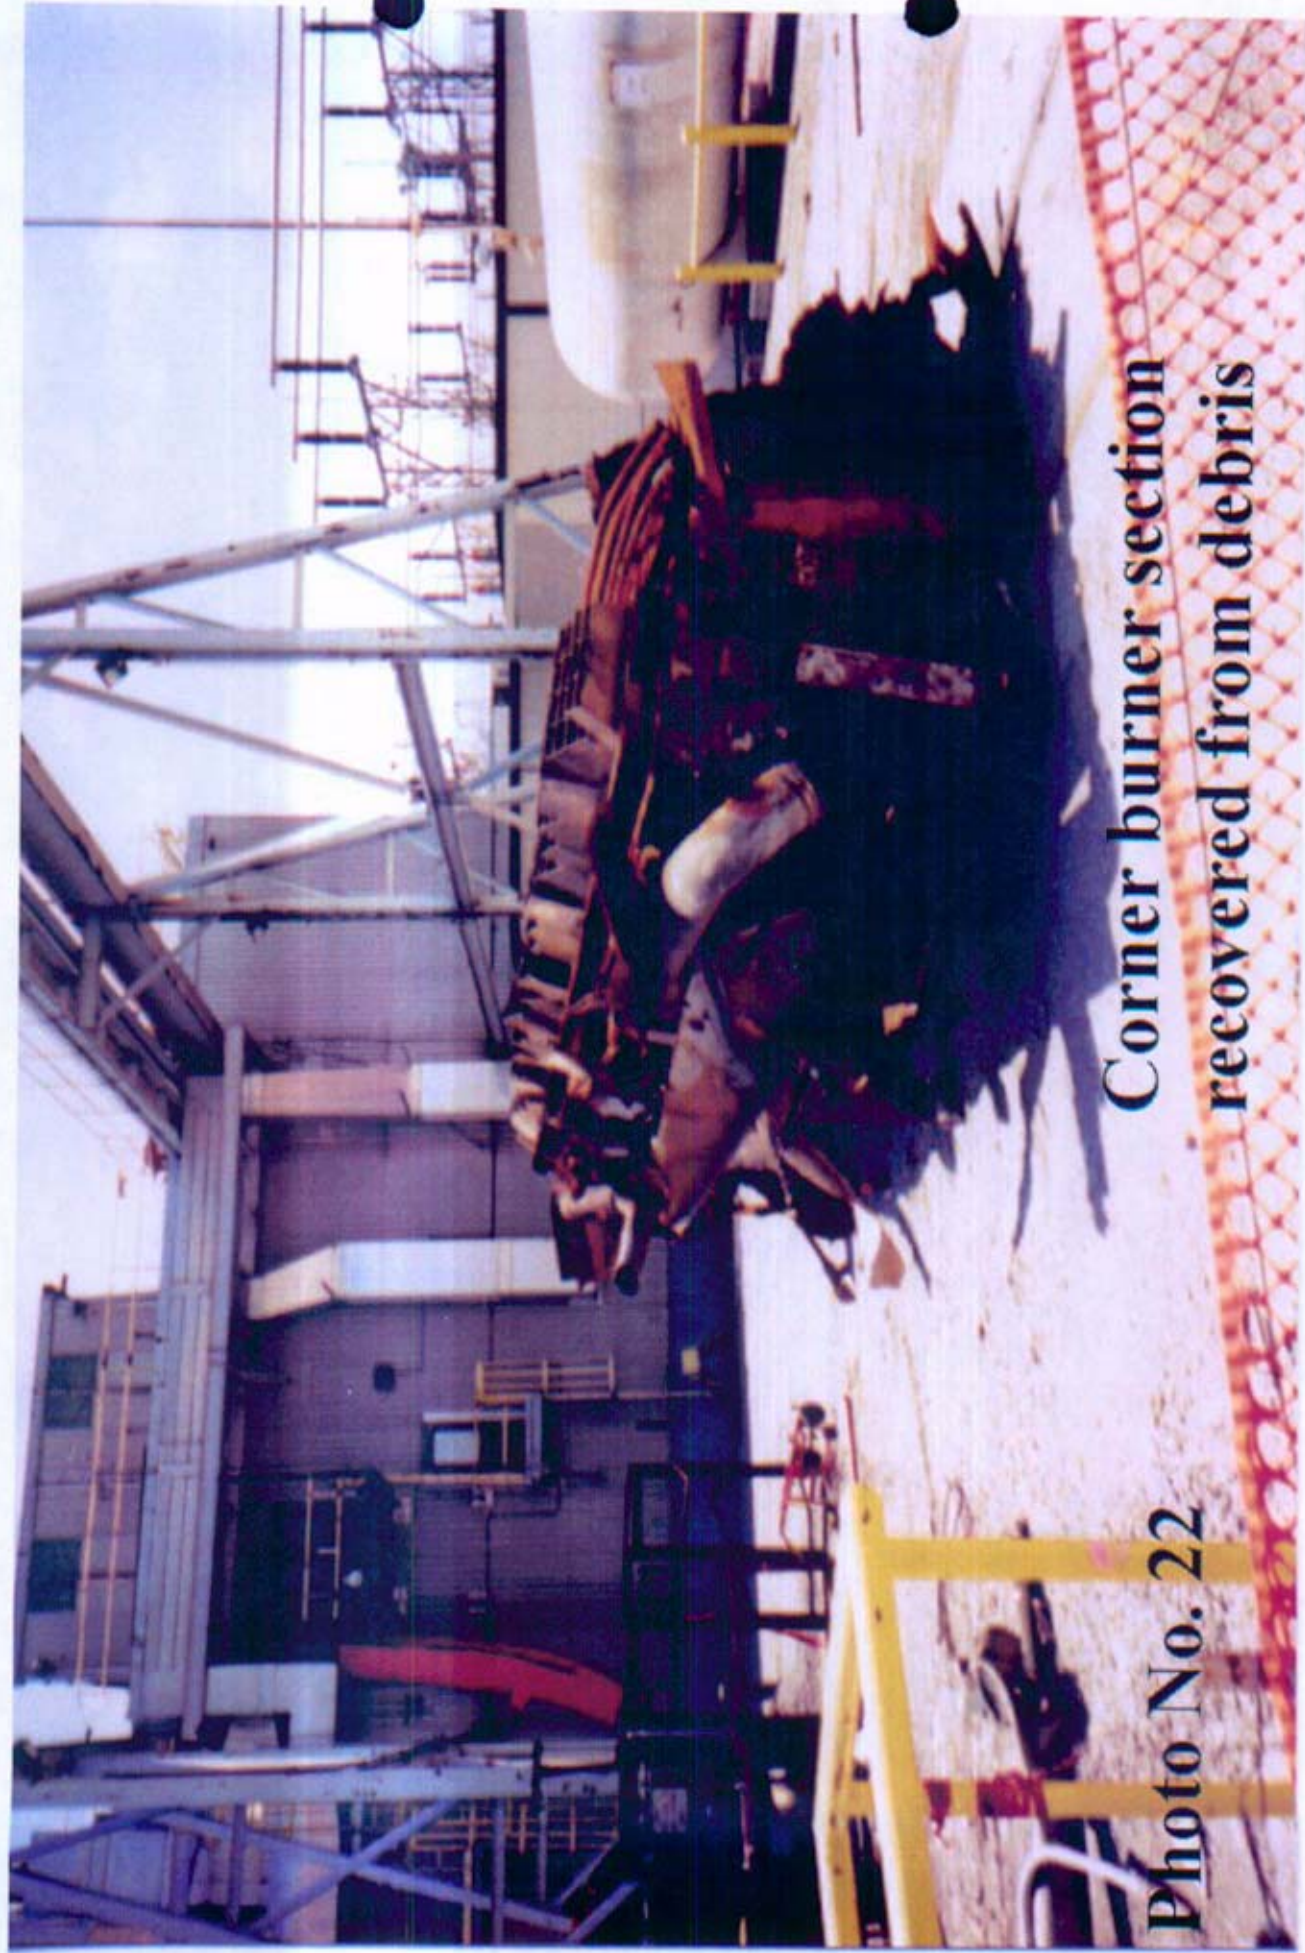
Photo No. 23
Looking East

Coal bunkers removed

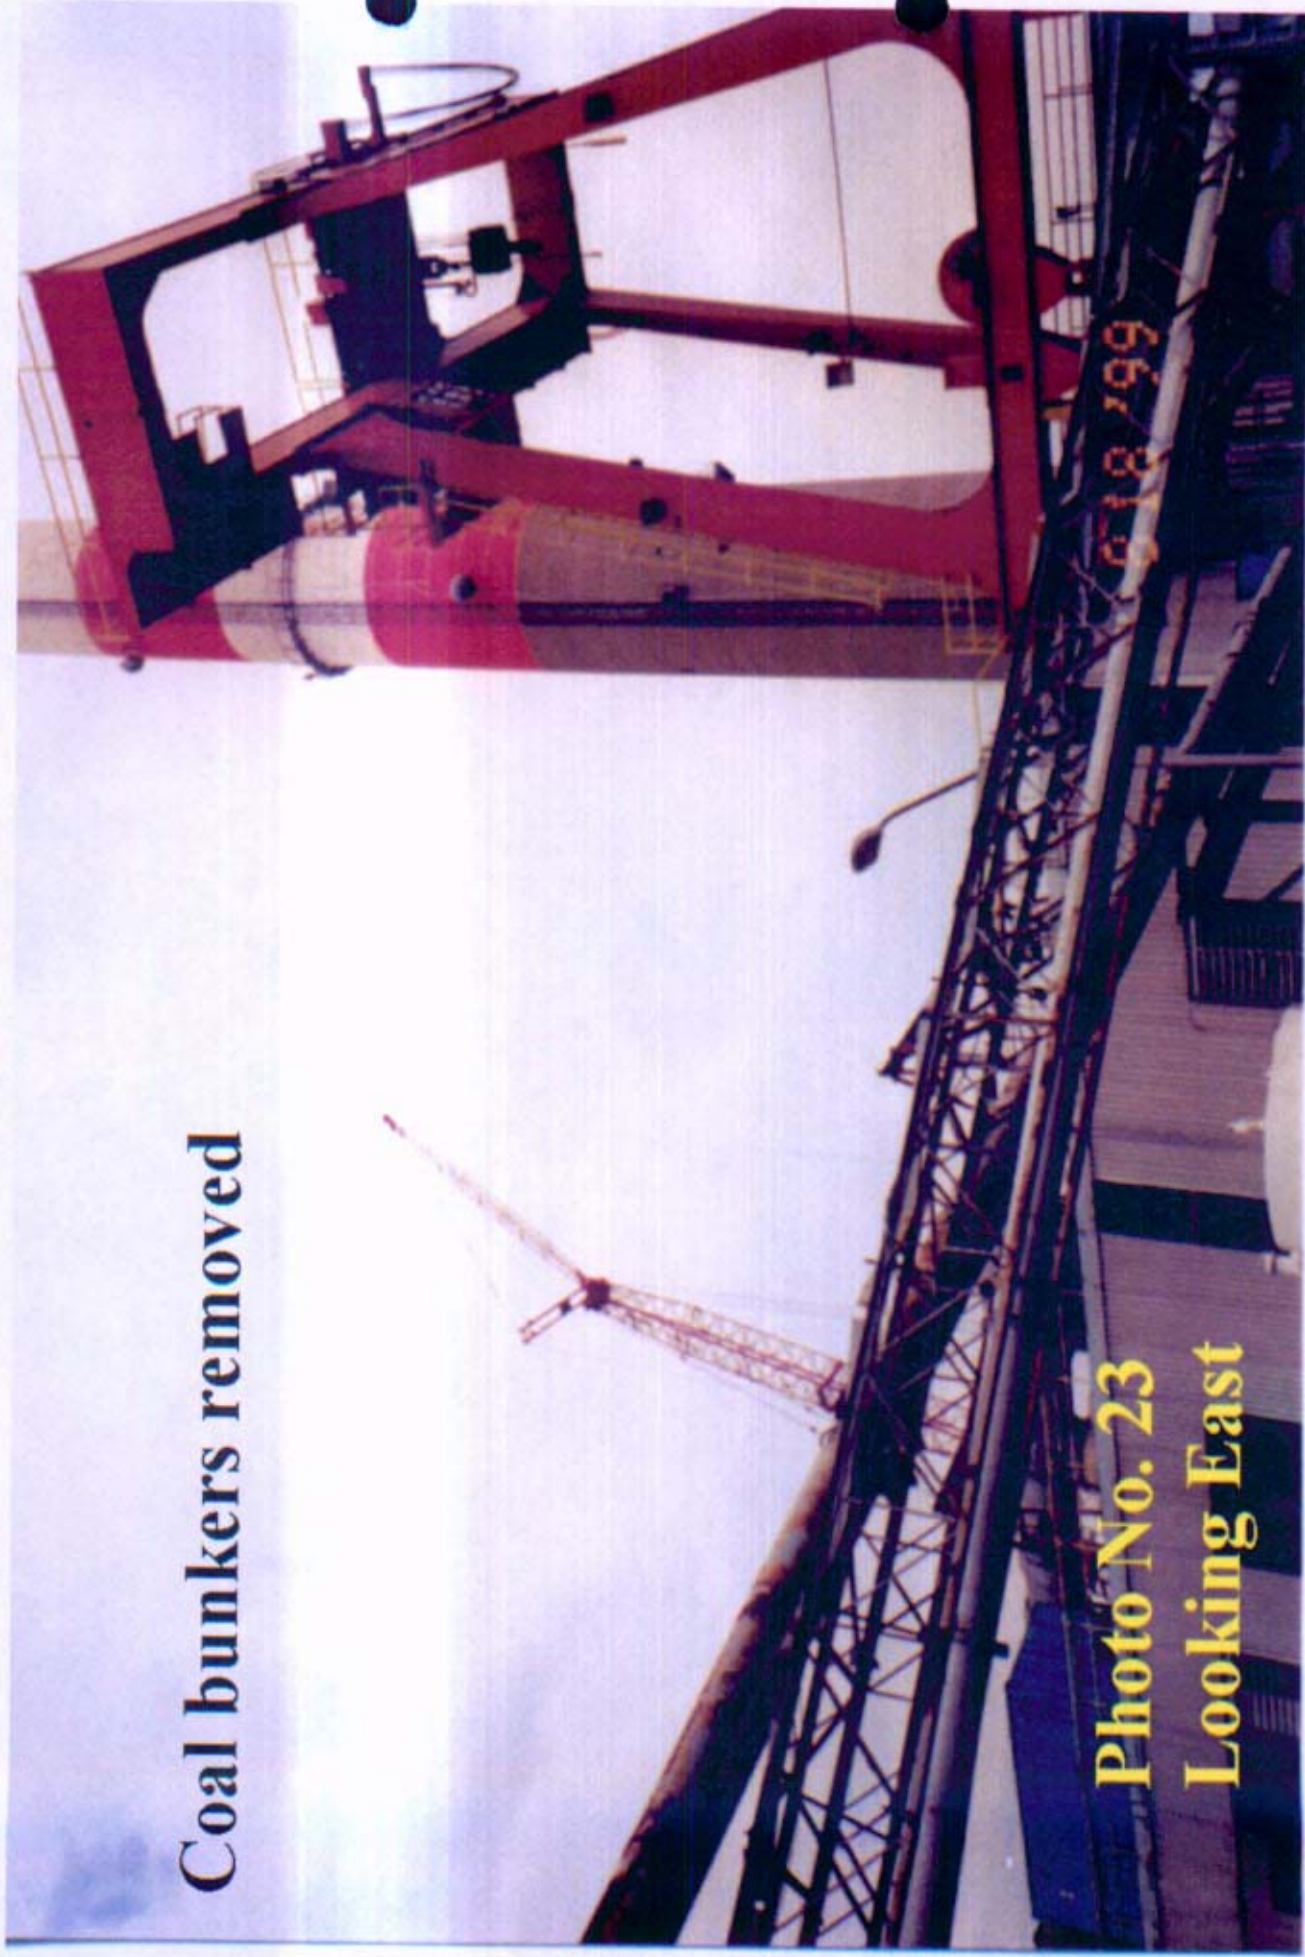
**Photo No. 24
Looking South**

Coal bunkers removed

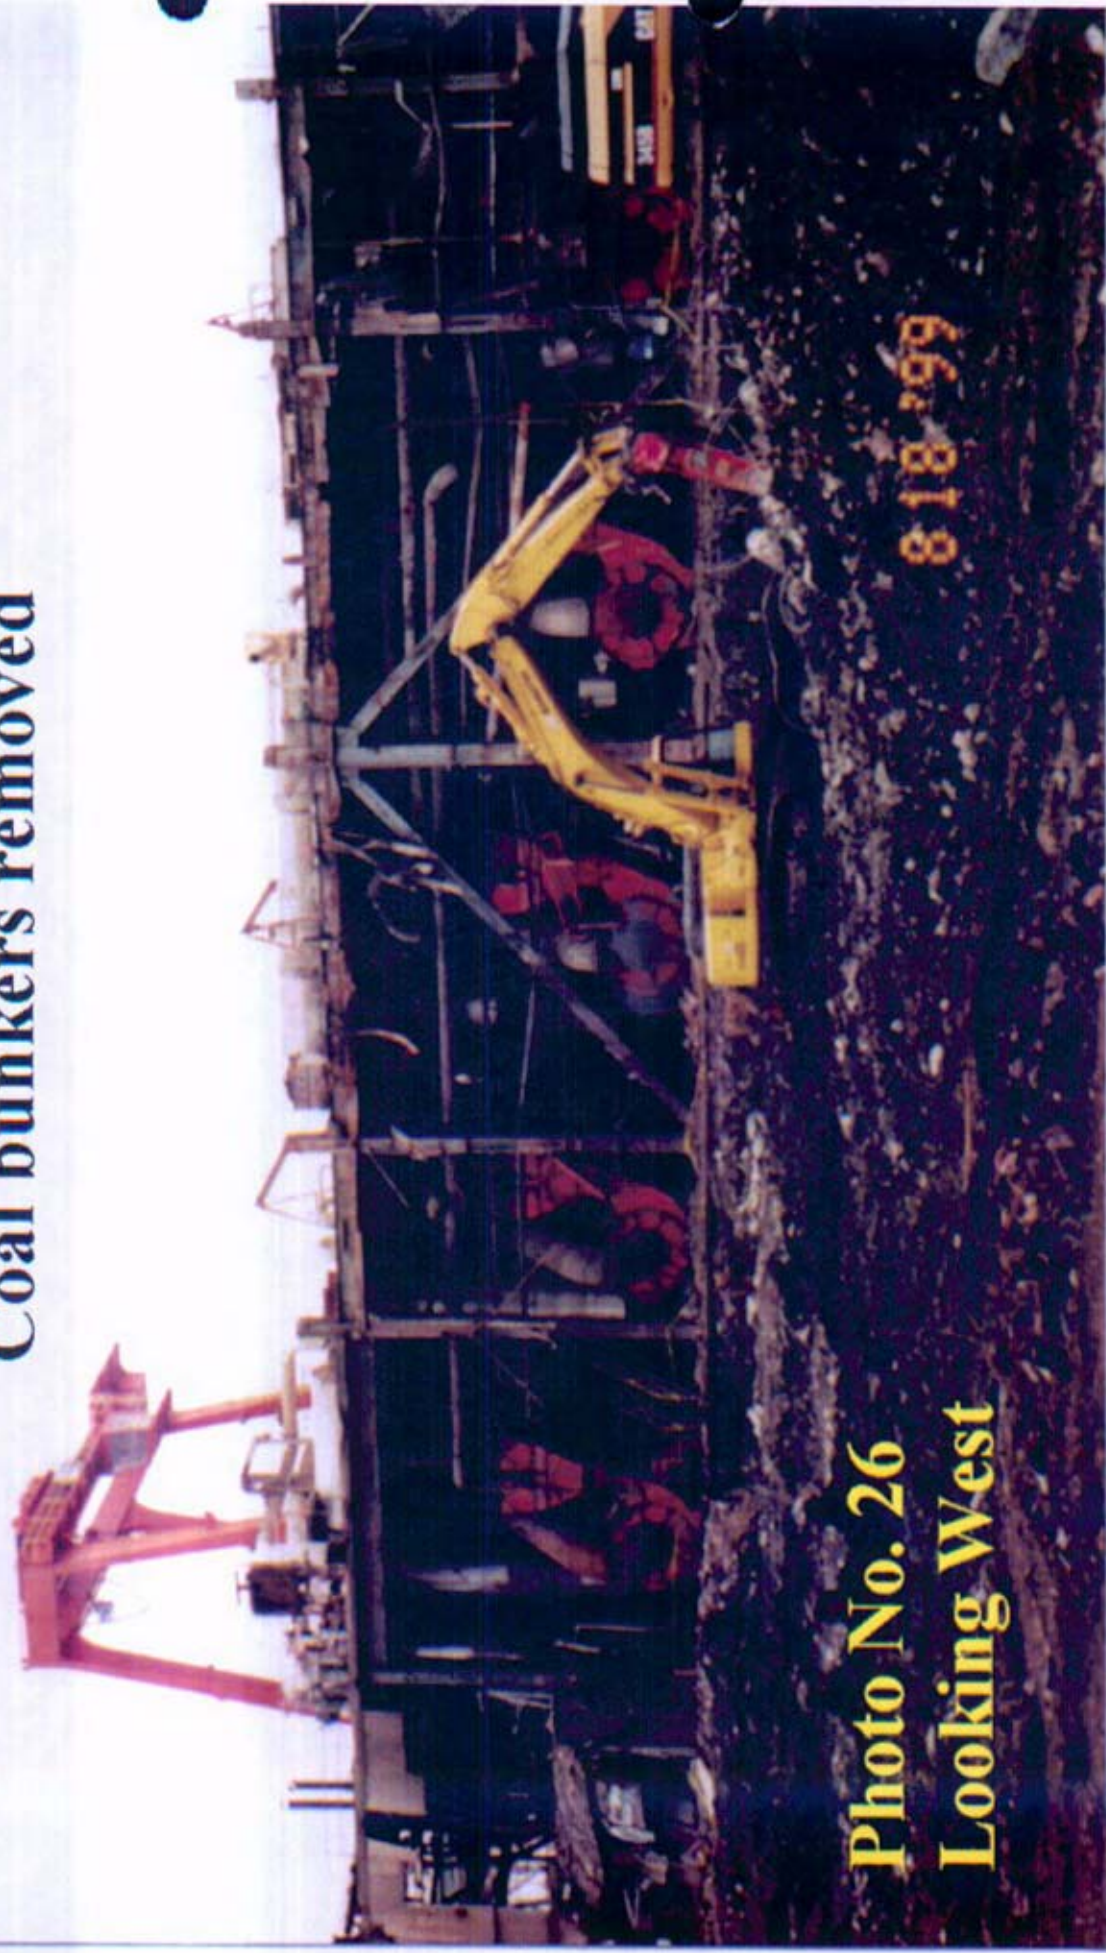
**Photo No. 26
Looking West**

**Boiler removed
Coal bunkers removed**

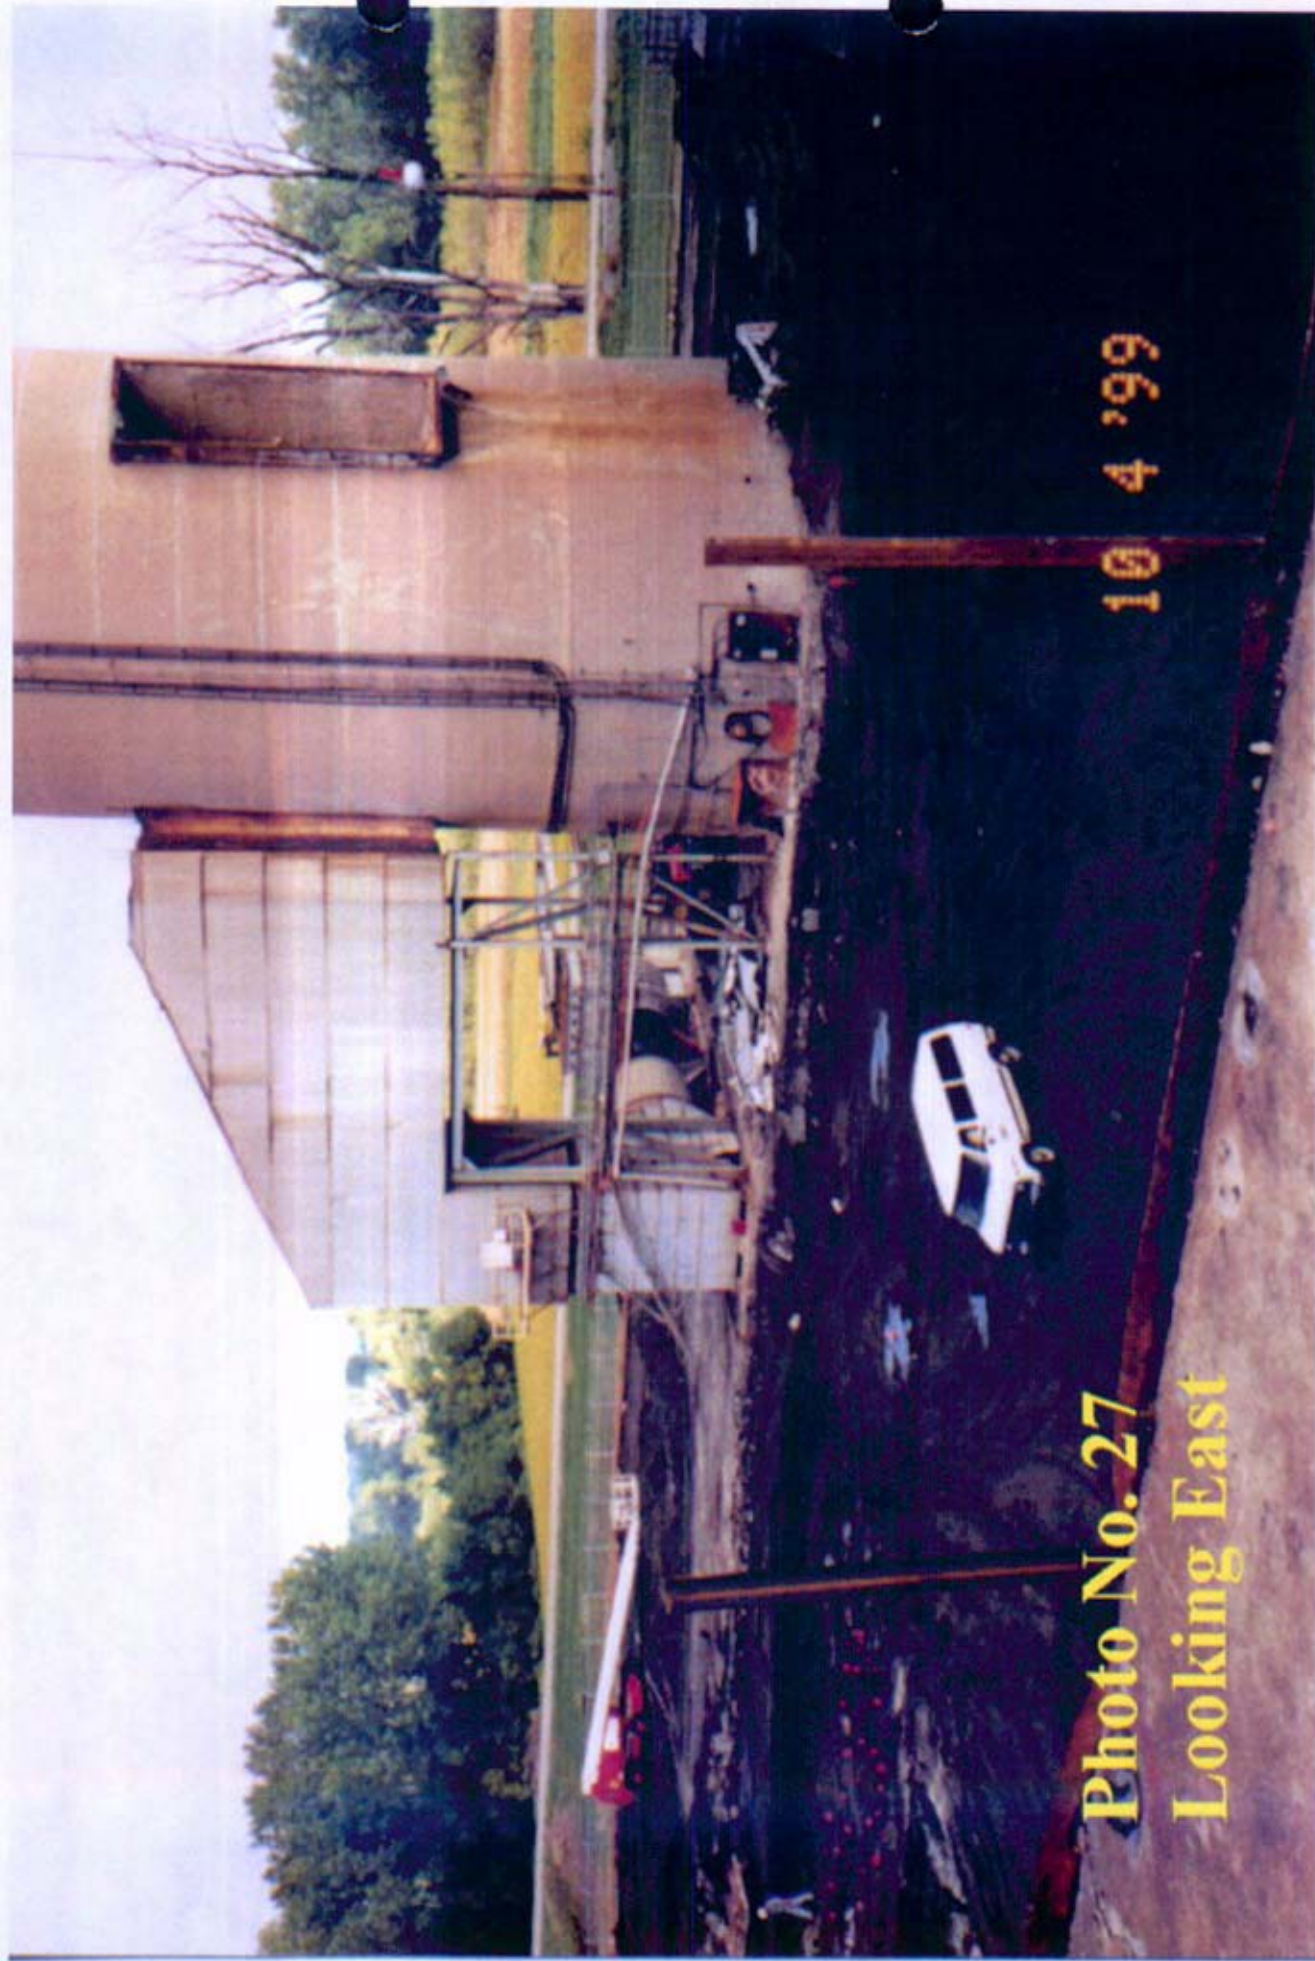
Photo No. 27
Looking East

KCPL undertook an investigation into the cost of building a new boiler in the same location and determined it was economically feasible to do so. Construction of a new boiler began in October 1999, with a projected operation in-service date of June 2001 (see photographs 27 and 28 in Appendix A).

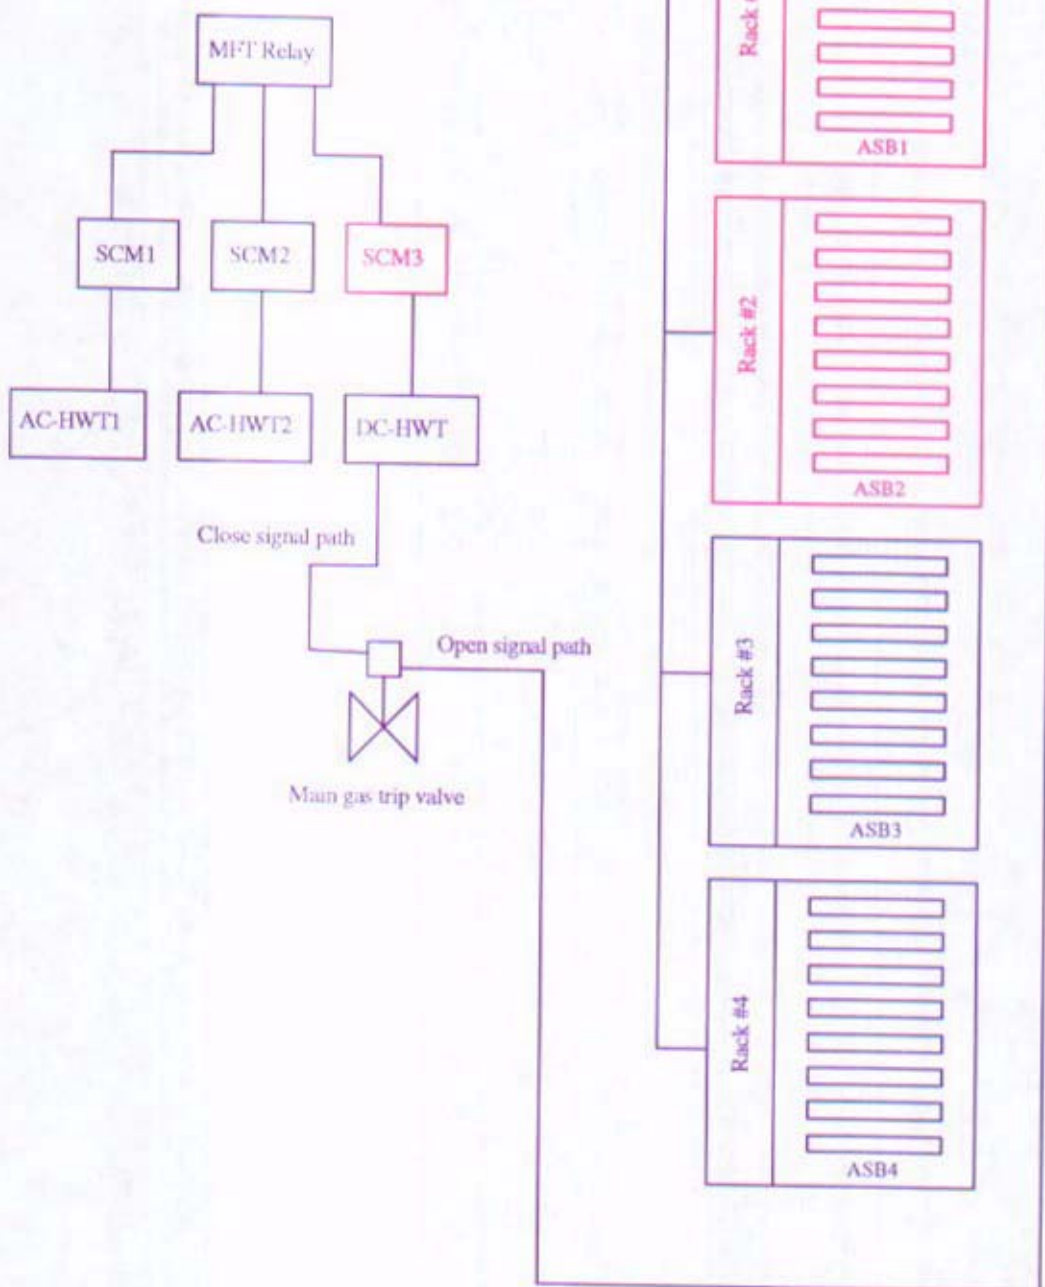
Figure 1-2

Identifying components affected
by the waste water overflow

Items in red are the devices
affected by the waste water overflow

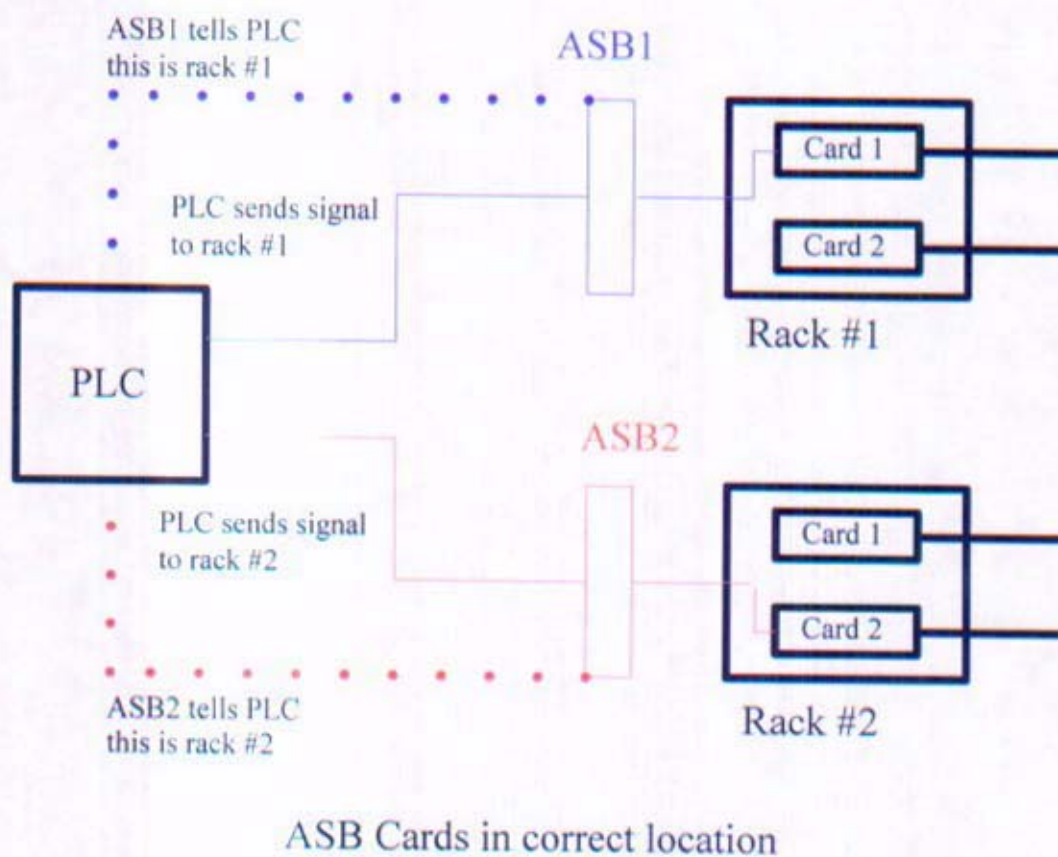
Figure 1-3

The PLC has the capability to have many input signals and output signals. Each of these input and output signals enter and leave the PLC through computer cards positioned in slots located in racks. External electrical control wires from devices in the plant are connected to a specific card location on the racks. The communication addressing cards are designed to route specific signals from the PLC to a specific card location in the rack, where the signal goes out on the electrical control wire. The communication addressing cards also are designed to route specific signals to the PLC from a specific location in the rack, where the signals come from field devices in the plant. Thus when the PLC software sends a signal to close a valve, that signal is routed by the communication addressing card to the proper rack and to a specific card location, which has the correct hard wired path to the valve (see figure 1-3 in Appendix B).

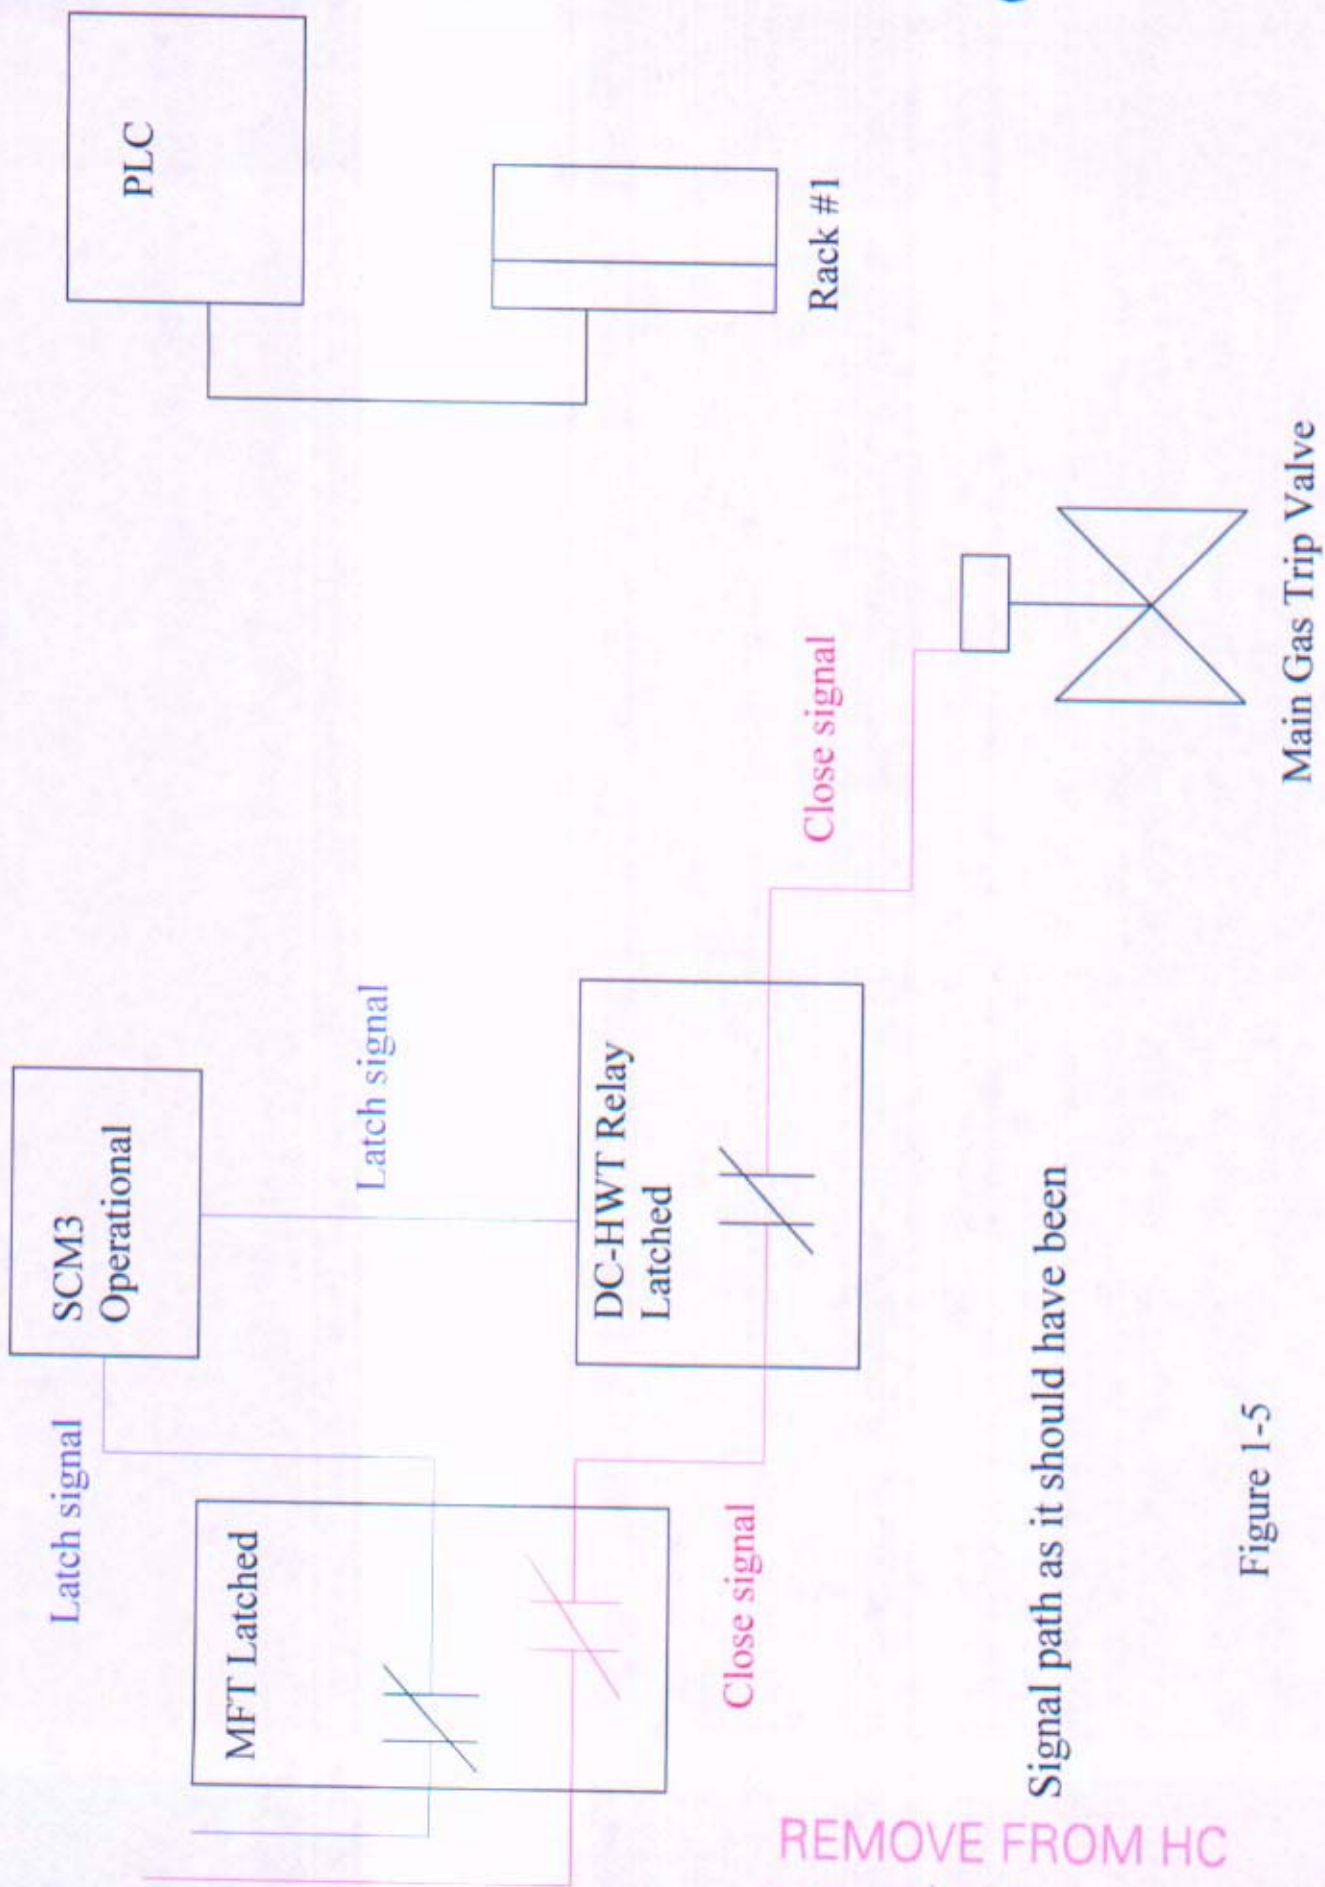
Figure 1-5

On February 16, 1999, when the KCPL operations personnel manually pushed the reset button, the DC-HWT relay unlatched and remained unlatched. With the DC-HWT relay in the unlatched position, the main gas trip valve remained closed but there was no close signal to keep it closed (see figures 1-5, 1-6, and 1-7). Therefore, when a PLC signal was rerouted by the switched ASB cards, the main gas trip valve only had an open signal, and the valve partially opened.
