Ameren Missouri 20 CSR 4240-23.010 Electric Utility System Reliability Monitoring and Reporting Submission Requirements – Annual Reliability Report

This report details Union Electric (dba Ameren Missouri) Company's annual reliability metrics and worst performing circuits for calendar year 2022 as required by Missouri Public Service Commission Rule 20 CSR 4240-23.020, Electric Utility System Reliability Monitoring and Reporting Submission Requirements (referred to in the remainder of this document as "the Rule"). This report is required by Sections (2), (7), and (8) of the Rule which state, "*The information required by section (1) shall be filed annually by the last business day of April of the calendar year following the calendar year for which the information was accumulated.... The information developed in accordance with section (6) shall be reported as part of the annual report required by section (2).... If on or after the time the annual report required by section (7) for calendar year 2011 is filled, a circuit has been on the worst performing circuit list for two (2) of the three (3) most recent consecutive calendar years the electrical corporation shall include detailed p

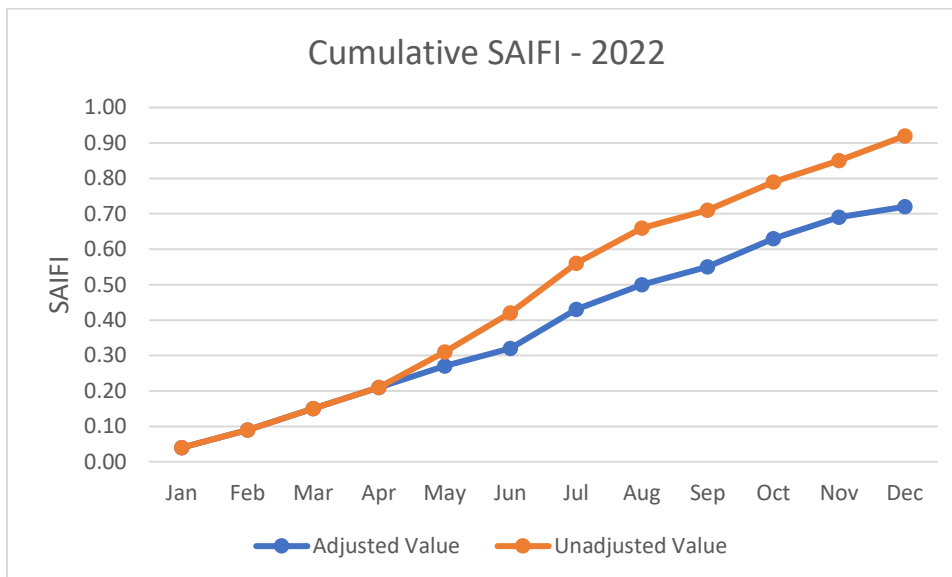
SAIFI:

Month	Adjusted Value	Unadjusted Value
Jan	0.04	0.04
Feb	0.09	0.09
Mar	0.15	0.15
Apr	0.21	0.21
May	0.27	0.31
Jun	0.32	0.42
Jul	0.43	0.56
Aug	0.50	0.66
Sep	0.55	0.71
Oct	0.63	0.79
Nov	0.69	0.85
Dec	0.72	0.92

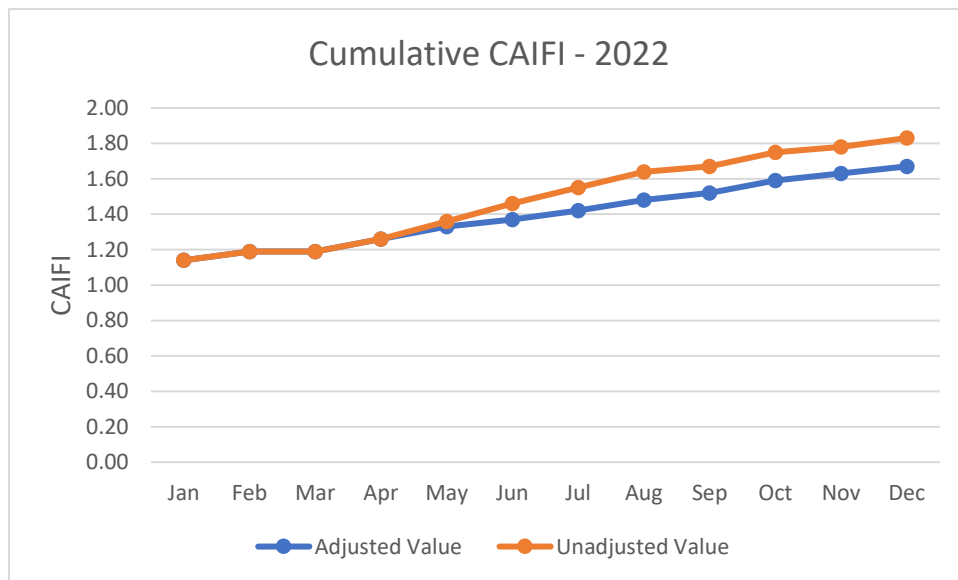
CAIFI:

Month	Adjusted Value	Unadjusted Value
Jan	1.14	1.14
Feb	1.19	1.19
Mar	1.19	1.19
Apr	1.26	1.26
May	1.33	1.36
Jun	1.37	1.46
Jul	1.42	1.55
Aug	1.48	1.64
Sep	1.52	1.67
Oct	1.59	1.75
Nov	1.63	1.78
Dec	1.67	1.83

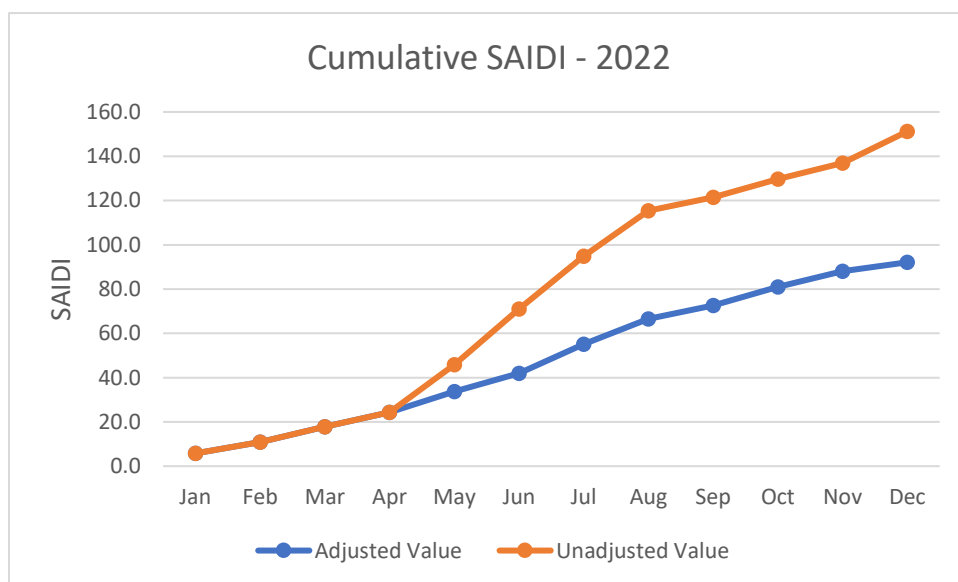
SAIDI:

Month	Adjusted Value	Unadjusted Value
Jan	5.8	5.8
Feb	10.9	10.9
Mar	17.9	17.9
Apr	24.4	24.4
May	33.8	45.8
Jun	41.9	71.0
Jul	55.1	94.8
Aug	66.6	115.4
Sep	72.6	121.4
Oct	81.0	129.7
Nov	88.1	136.9
Dec	92.1	151.2

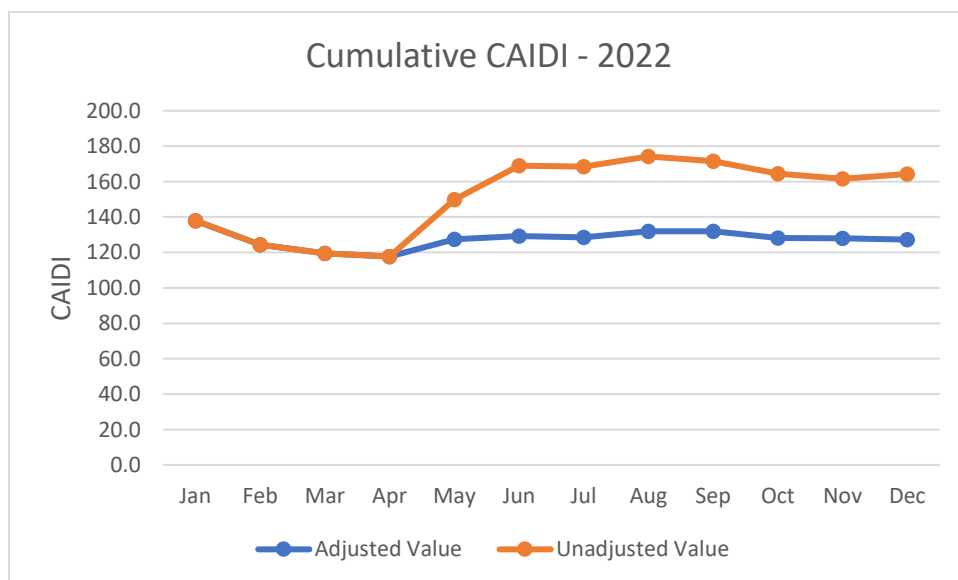
CAIDI:

Month	Adjusted Value	Unadjusted Value
Jan	137.9	137.9
Feb	124.3	124.3
Mar	119.5	119.5
Apr	117.7	117.7
May	127.4	149.9
Jun	129.2	169.0
Jul	128.5	168.4
Aug	132.0	174.2
Sep	132.0	171.5
Oct	128.2	164.4
Nov	127.9	161.6
Dec	127.2	164.3
