Ameren Missouri 4 CSR 240-23.010 Electric Utility System Reliability Monitoring and Reporting Submission Requirements – Annual Reliability Report

This report details Union Electric (dba Ameren Missouri) Company's annual reliability metrics and worst performing circuits for calendar year 2011 as required by Missouri Public Service Commission Rule 4 CSR 240-23.010, Electric Utility System Reliability Monitoring and Reporting Submission Requirements (referred to in the remainder of this document as "the Rule"). This report is required by Sections (2), (7), and (8) of the Rule which state, "*The information required by section (1) shall be filed annually by the last business day of April of the calendar year following the calendar year for which the information was accumulated.... The information developed in accordance with section (6) shall be reported as part of the annual report required by section (2).... If on or after the time the annual report required by section (7) for calendar year 2011 is filled, a circuit has been on the worst performing circuit list for two (2) of the three (3) most recent consecutive calendar years the electrical corporation shall include detailed plans

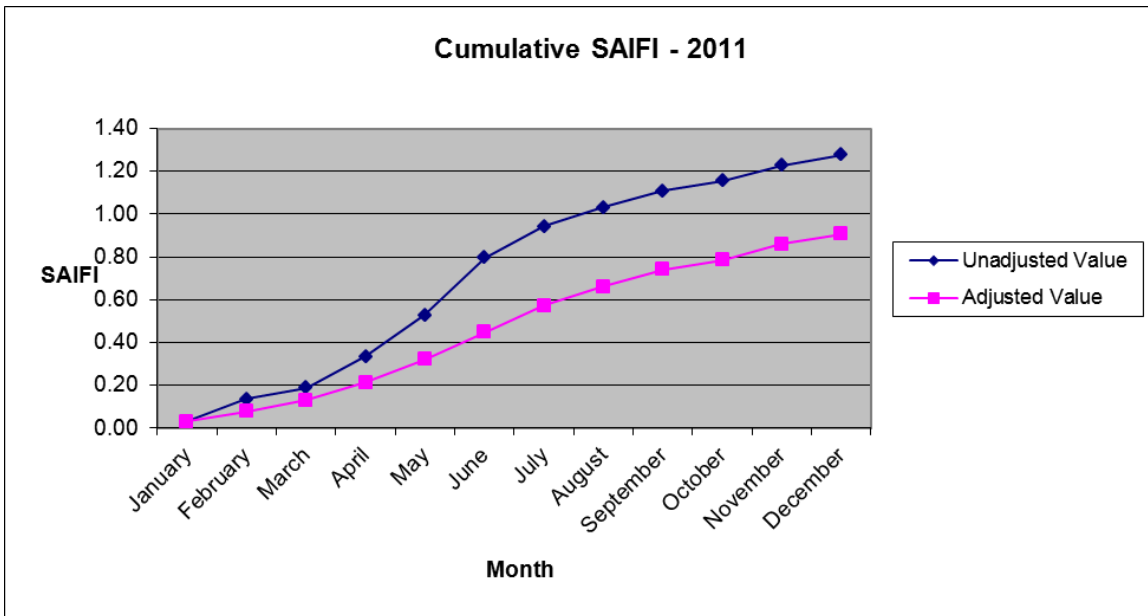
SAIFI:

Month	Unadjusted Value	Adjusted Value
January	0.03	0.03
February	0.14	0.08
March	0.19	0.13
April	0.34	0.21
May	0.53	0.32
June	0.80	0.45
July	0.94	0.57
August	1.03	0.66
September	1.11	0.74
October	1.16	0.79
November	1.23	0.86
December	1.28	0.91

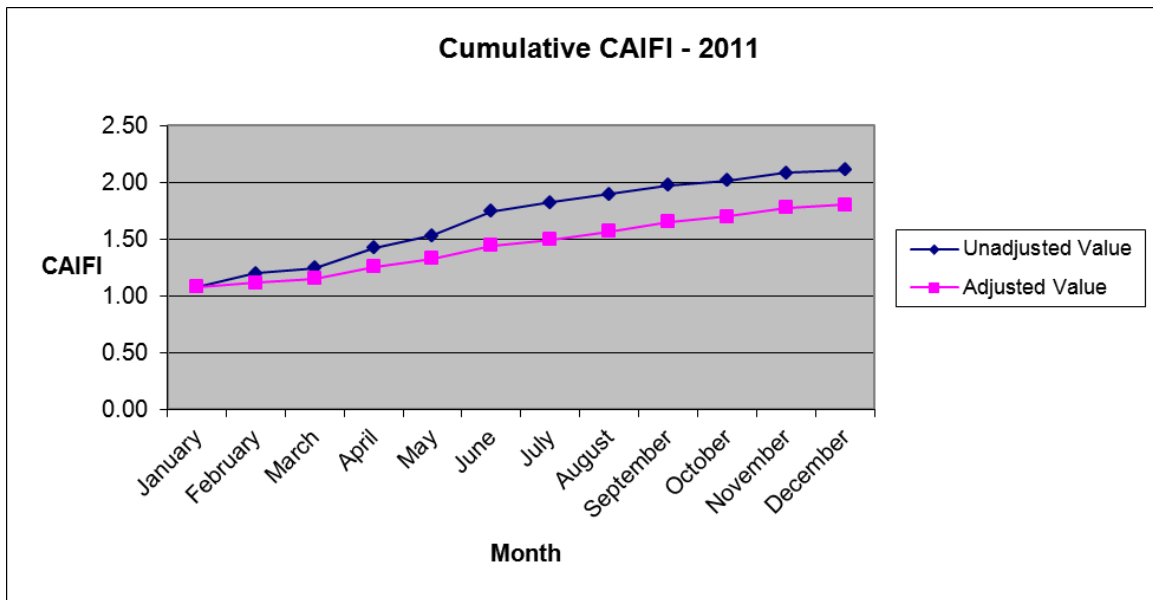
CAIFI:

Month	Unadjusted Value	Adjusted Value
January	1.08	1.08
February	1.20	1.11
March	1.25	1.15
April	1.43	1.26
May	1.53	1.33
June	1.75	1.44
July	1.83	1.50
August	1.90	1.57
September	1.98	1.65
October	2.02	1.70
November	2.09	1.78
December	2.11	1.80

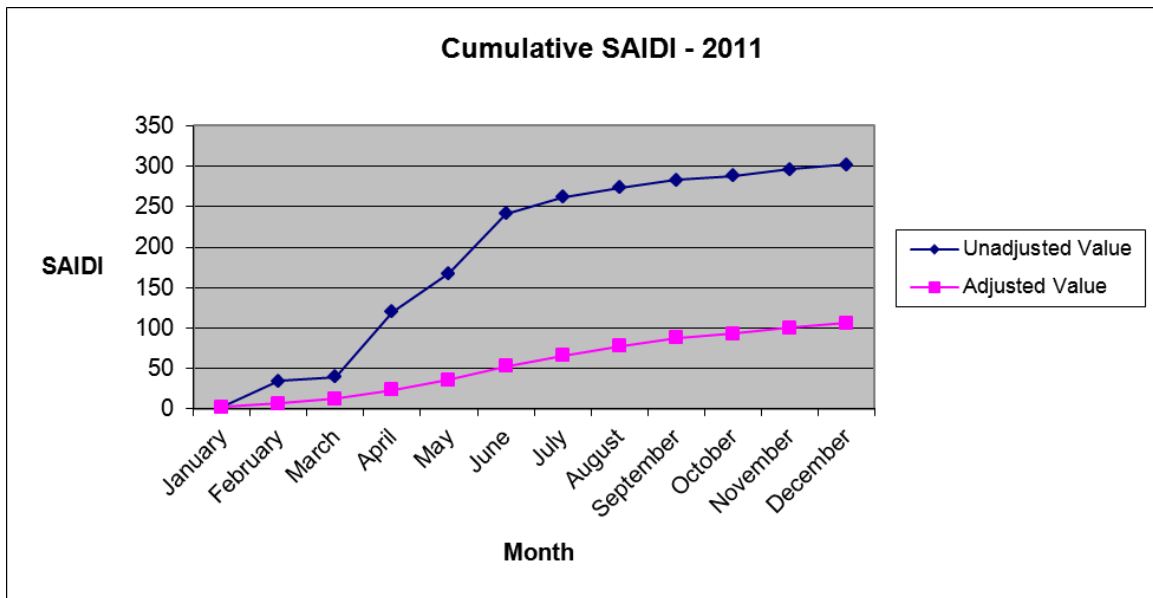
SAIDI:

Month	Unadjusted Value	Adjusted Value
January	3	3
February	35	7
March	40	12
April	120	24
May	168	36
June	242	53
July	262	66
August	273	78
September	283	88
October	288	93
November	296	101
December	302	106

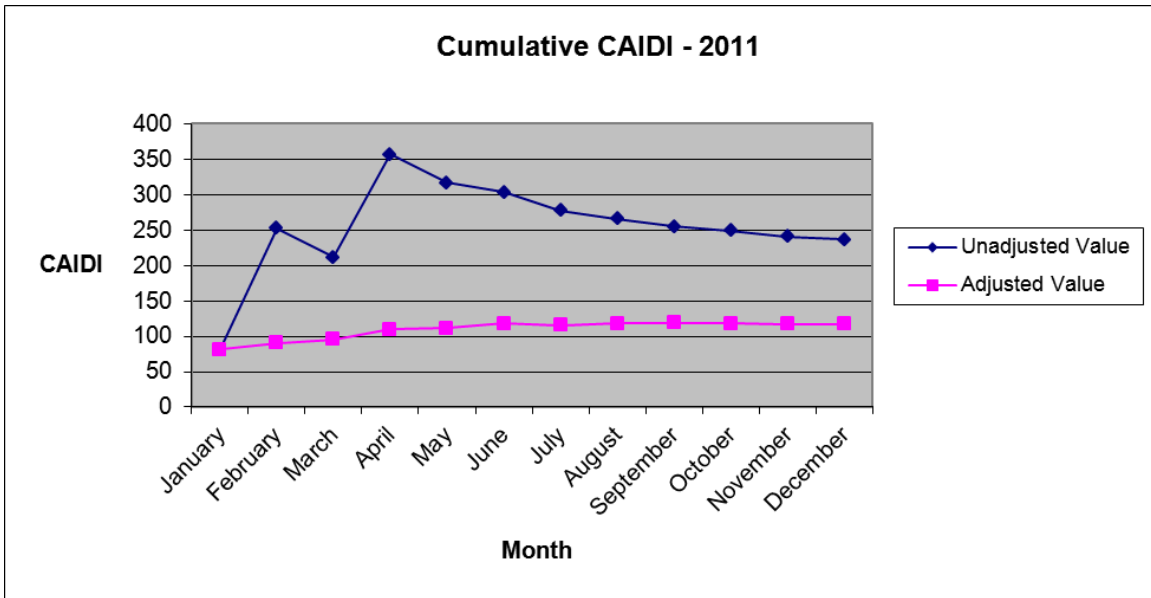
CAIDI:

Month	Unadjusted Value	Adjusted Value
January	81	81
February	252	90
March	212	96
April	357	110
May	317	111
June	304	118
July	278	116
August	265	118
September	255	119
October	249	118
November	241	117
December	236	117
