Ameren Missouri 20 CSR 4240-23.010 Electric Utility System Reliability Monitoring and Reporting Submission Requirements – Annual Reliability Report

This report details Union Electric (dba Ameren Missouri) Company's annual reliability metrics and worst performing circuits for calendar year 2023 as required by Missouri Public Service Commission Rule 20 CSR 4240-23.010, Electric Utility System Reliability Monitoring and Reporting Submission Requirements (referred to in the remainder of this document as "the Rule"). This report is required by Sections (2), (7), and (8) of the Rule which state, *"The information required by section (1) shall be filed annually by the last business day of April of the calendar year following the calendar year for which the information was accumulated.... The information developed in accordance with section (6) shall be reported as part of the annual report required by section (2).... If on or after the time the annual report required by section (7) for calendar year 2011 is filled, a circuit has been on the worst performing circuit list for two (2) of the three (3) most recent consecutive calendar years the electrical corporation shall include detailed p

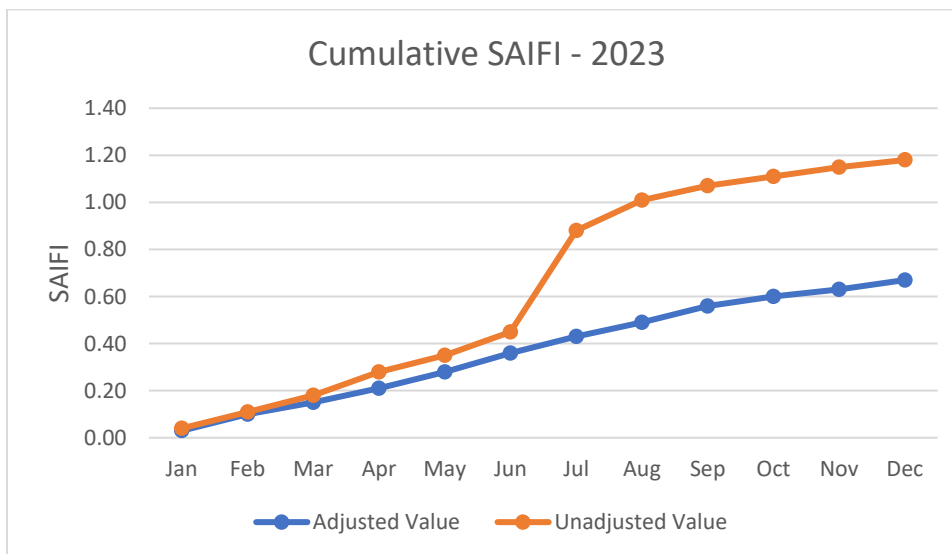
SAIFI:

MONTH	Adjusted Value	Unadjusted Value
Jan	0.03	0.04
Feb	0.10	0.11
Mar	0.15	0.18
Apr	0.21	0.28
May	0.28	0.35
Jun	0.36	0.45
Jul	0.43	0.88
Aug	0.49	1.01
Sep	0.56	1.07
Oct	0.60	1.11
Nov	0.63	1.15
Dec	0.67	1.18

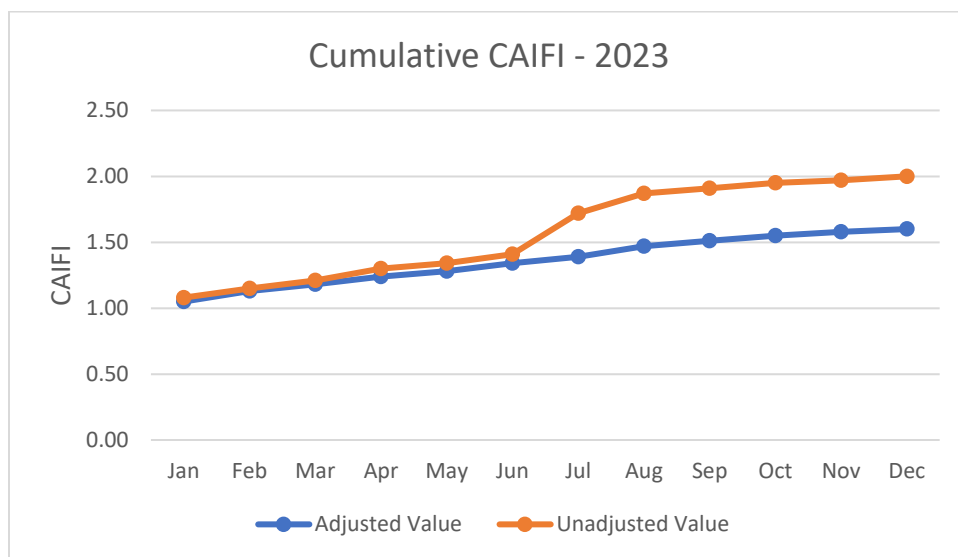
CAIFI:

MONTH	Adjusted Value	Unadjusted Value
Jan	1.05	1.08
Feb	1.13	1.15
Mar	1.18	1.21
Apr	1.24	1.30
May	1.28	1.34
Jun	1.34	1.41
Jul	1.39	1.72
Aug	1.47	1.87
Sep	1.51	1.91
Oct	1.55	1.95
Nov	1.58	1.97
Dec	1.60	2.00

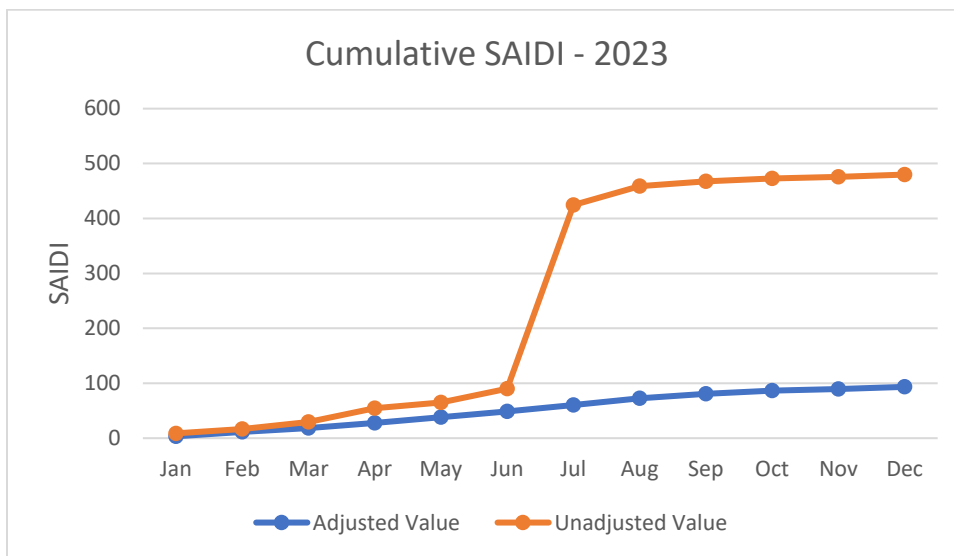
SAIDI:

MONTH	Adjusted Value	Unadjusted Value
Jan	3	9
Feb	12	17
Mar	19	30
Apr	28	55
May	38	65
Jun	49	90
Jul	60	425
Aug	73	459
Sep	81	467
Oct	86	473
Nov	89	476
Dec	93	480

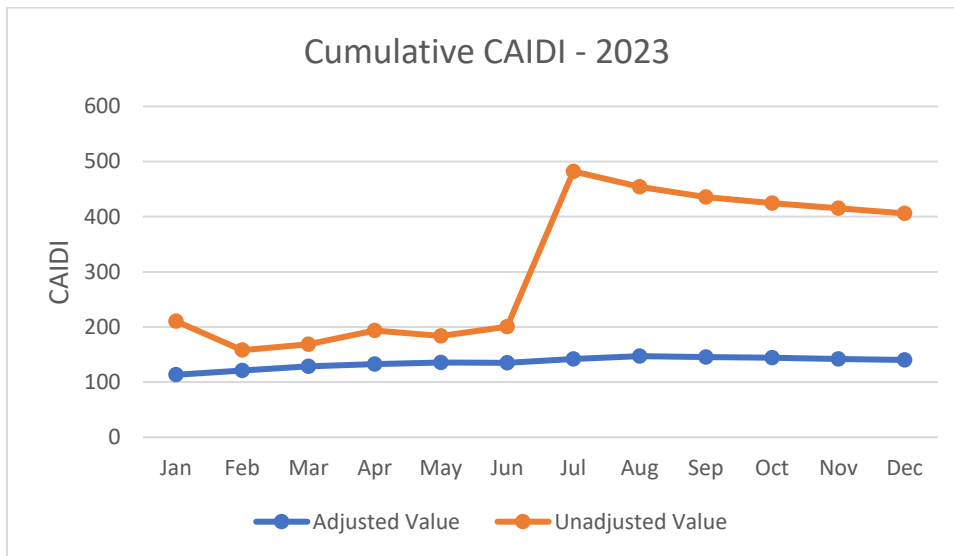
CAIDI:

MONTH	Adjusted Value	Unadjusted Value
Jan	113	211
Feb	121	158
Mar	128	169
Apr	133	194
May	136	184
Jun	135	200
Jul	142	482
Aug	147	454
Sep	145	436
Oct	145	425
Nov	142	415
Dec	140	406
