Ameren Missouri 20 CSR 4240-23.010 Electric Utility System Reliability Monitoring and Reporting Submission Requirements – Annual Reliability Report

This report details Union Electric (dba Ameren Missouri) Company's annual reliability metrics and worst performing circuits for calendar year 2024 as required by Missouri Public Service Commission Rule 20 CSR 4240-23.010, Electric Utility System Reliability Monitoring and Reporting Submission Requirements (referred to in the remainder of this document as "the Rule"). This report is required by Sections (2), (7), and (8) of the Rule which state, *"The information required by section (1) shall be filed annually by the last business day of April of the calendar year following the calendar year for which the information was accumulated.... The information developed in accordance with section (6) shall be reported as part of the annual report required by section (2).... If on or after the time the annual report required by section (7) for calendar year 2011 is filled, a circuit has been on the worst performing circuit list for two (2) of the three (3) most recent consecutive calendar years the electrical corporation shall include detailed p

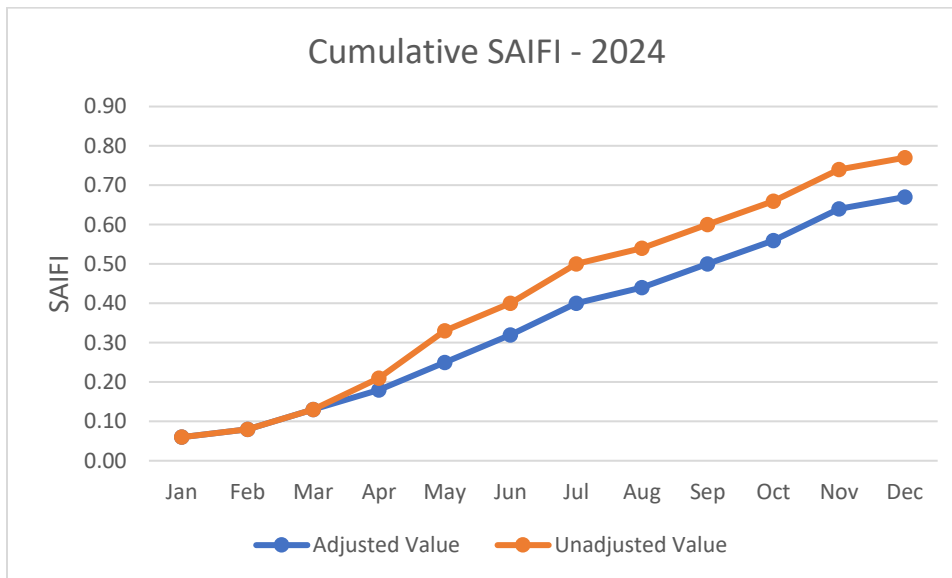
SAIFI:

Month	Adjusted Value	Unadjusted Value
Jan	0.06	0.06
Feb	0.08	0.08
Mar	0.13	0.13
Apr	0.18	0.21
May	0.25	0.33
Jun	0.32	0.40
Jul	0.40	0.50
Aug	0.44	0.54
Sep	0.50	0.60
Oct	0.56	0.66
Nov	0.64	0.74
Dec	0.67	0.77

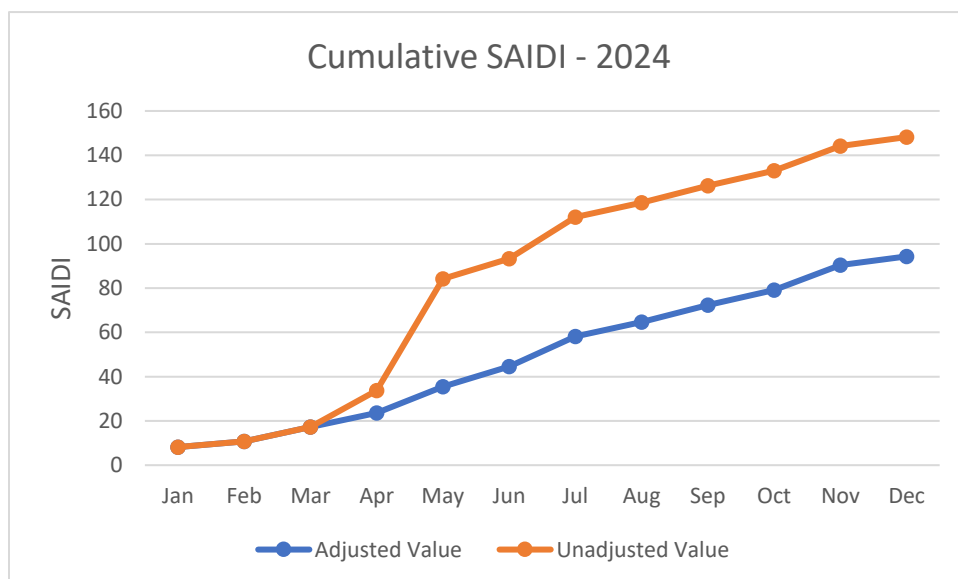
SAIDI:

Month	Adjusted Value	Unadjusted Value
Jan	8	8
Feb	11	11
Mar	17	17
Apr	24	34
May	35	84
Jun	45	93
Jul	58	112
Aug	65	119
Sep	72	126
Oct	79	133
Nov	90	144
Dec	94	148

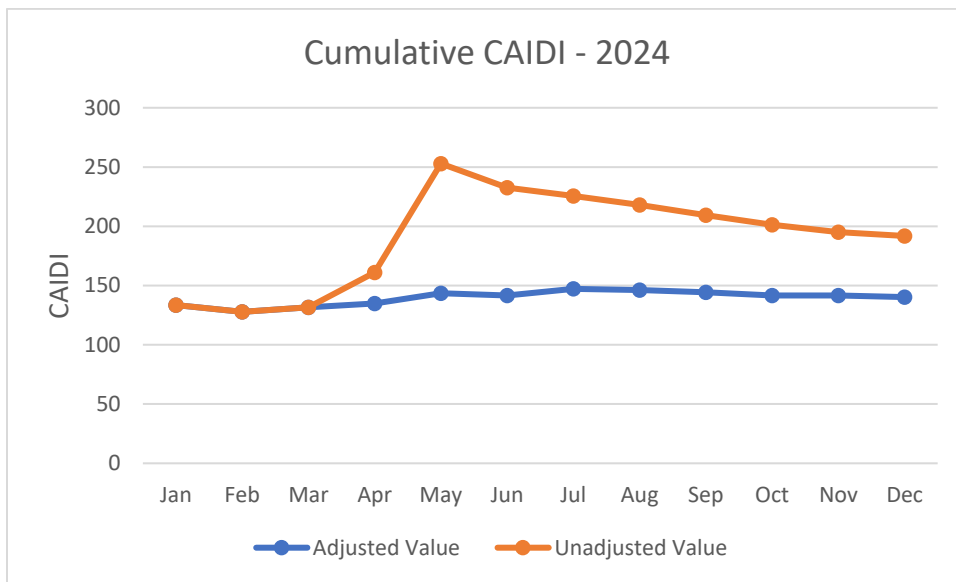
CAIDI:

Month	Adjusted Value	Unadjusted Value
Jan	133	133
Feb	128	128
Mar	132	132
Apr	135	161
May	144	253
Jun	142	233
Jul	147	226
Aug	146	218
Sep	144	210
Oct	142	201
Nov	142	195
Dec	140	192
