ADVISORY NOTICE

From: Missouri Public Service Commission, Safety Engineering Staff

Subject: **Advisory Regarding Installation of Underground Cable and Conduit**

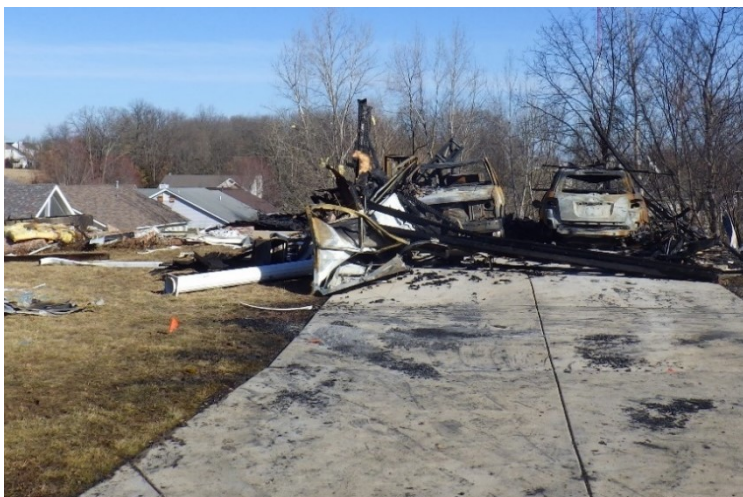
Figure 1: View of 3 Miller's Ct. driveway and debris from house explosion, taken on March 2, 2022 following the incident (Source: Appendix B of Staff Incident Report filed April 26, 2023 in Case No. GS-2023-0372)

On March 1, 2022, in O'Fallon Missouri, a natural gas pipeline was damaged by an excavator installing a fiber line using horizontal directional drilling. Gas escaping from the damaged pipeline migrated underground and into nearby residences. One residence was destroyed when the accumulated gas ignited (see Figure 1), and other nearby residences were also damaged. The location of the natural gas pipeline had been accurately marked, but the excavator failed to maintain a safe distance from the marks (See the ***Applicable Standards*** section of this **Advisory Notice**).
